LISS PARISH COUNCIL

Minutes of the meeting of the Facilities Committee held on 14th July 2025, 7pm,
Village Hall

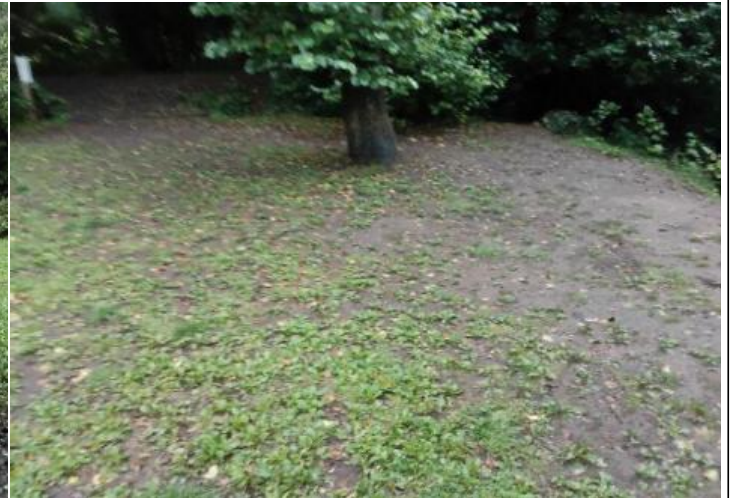
Finding: The surface has eroded in some areas and may be slippery in wet conditions
Action: Reinstate the surface

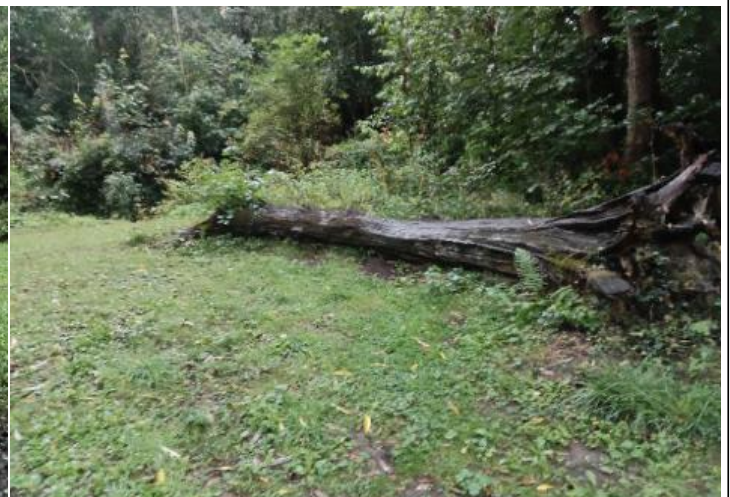
Finding: The play equipment is located within a natural environment and as such there are a number of natural hazards in close proximity. This includes loose logs / felled trees and overgrown / overhanging foliage. There is one log in particular that is likely to encourage climbing, the log is rotting, slippery and has sharp protrusions
Action: Ensure a suitable and sufficient risk assessment is in place and all control measures are implemented, we would recommend the area is formalised to extent to remove the worst of the current hazards

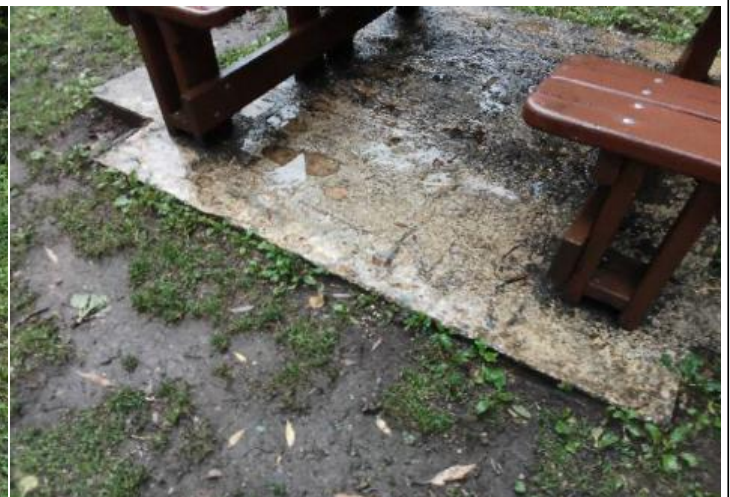
Finding: There are trip hazards at the edges of the surface

Action: Remove trip hazard

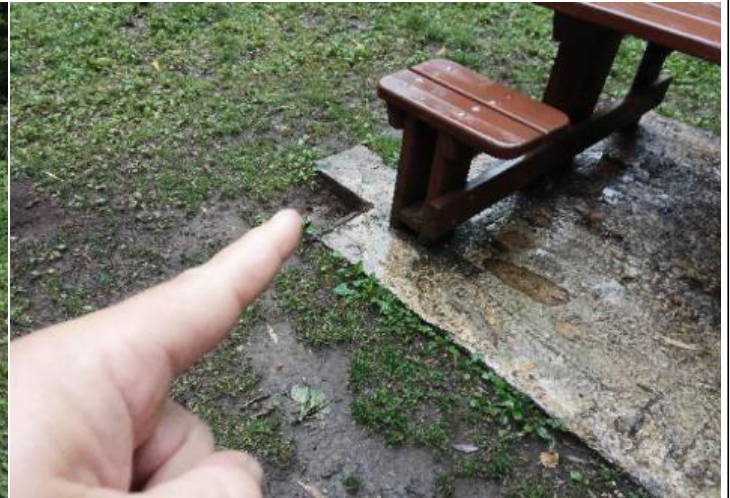
Finding: There are holes in the surface that may cause users to trip or roll ankles

Action: Infill to provide a sound reasonably level surface.

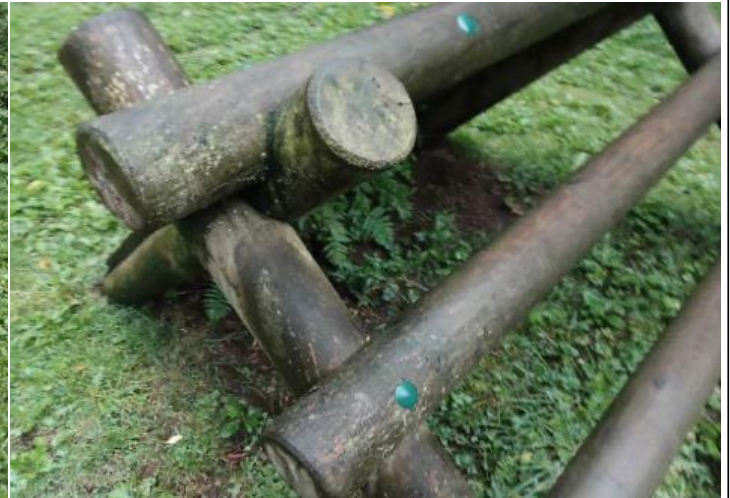
Finding: There is algae or moss on the surface of the equipment resulting in slippery conditions

Action: Clean and treat appropriately

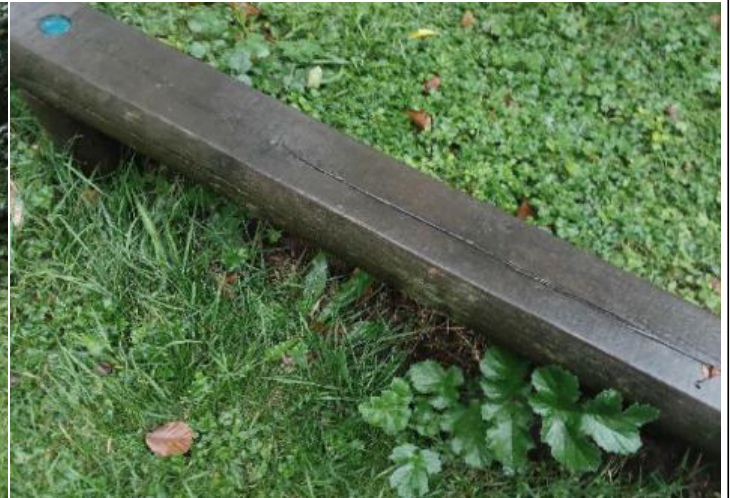
Finding: There is algae or moss on the surface of the equipment resulting in slippery conditions

Action: Clean and treat appropriately

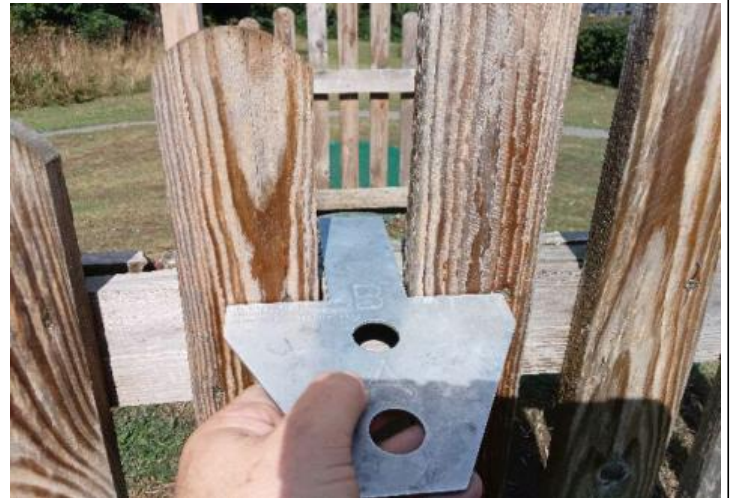
Finding: The item fails to meet the requirements of BS EN 1176 Part 1 4.2.7.2 for head and neck entrapment in the barriers

Action: Monitor - No action given the risk assessment

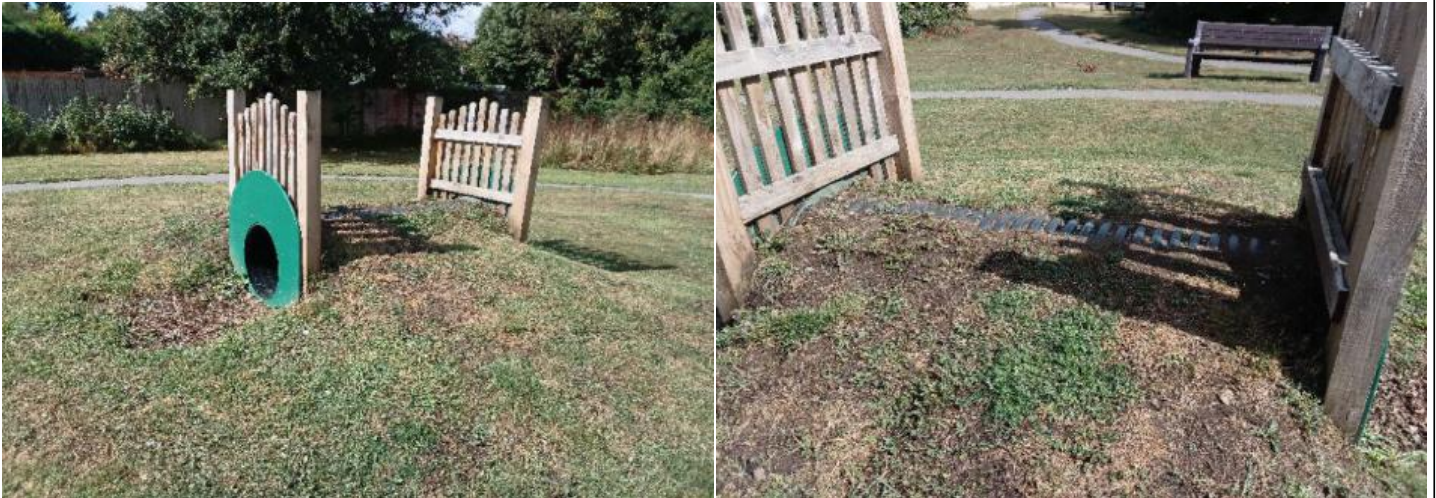
Finding: The surface has eroded in some areas and may be slippery in wet conditions
Action: Reinststate the surface

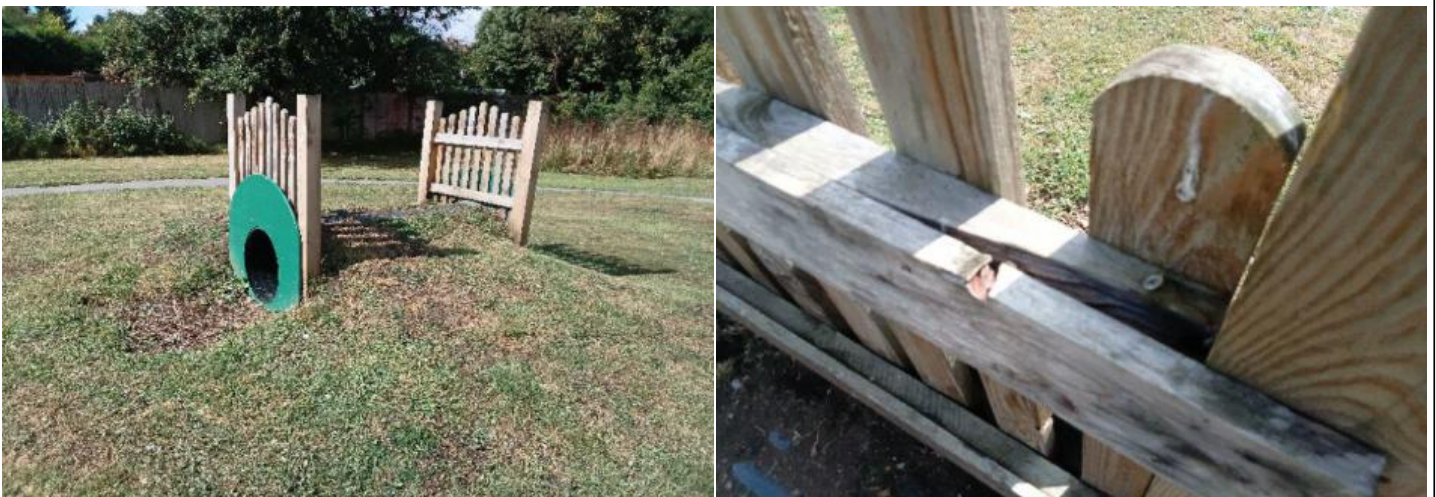
Finding: There is some damage to the barrier timbers
Action: Monitor for any further deterioration and repair as required

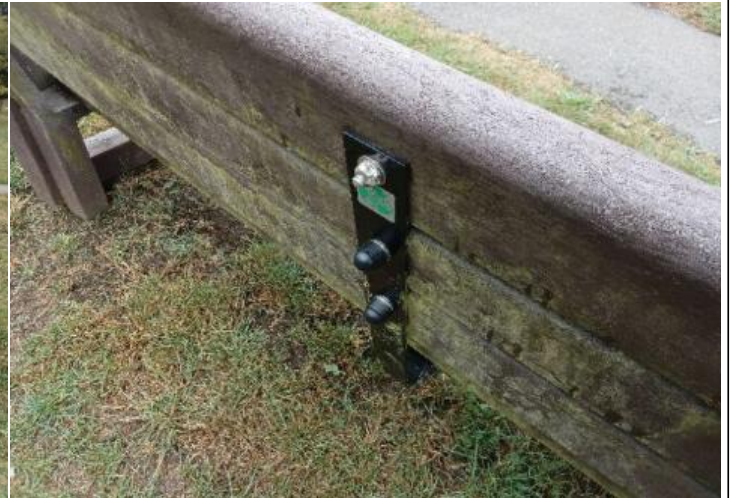
Finding: There is/are bolt cap covers missing or damaged on the item

Action: Replace missing or damaged bolt cap covers

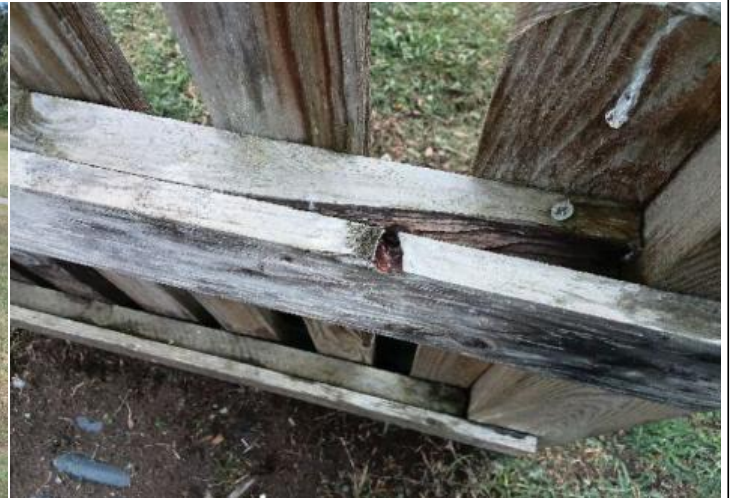
Finding: There is some damage to the barrier timbers

Action: Monitor for any further deterioration and repair as required

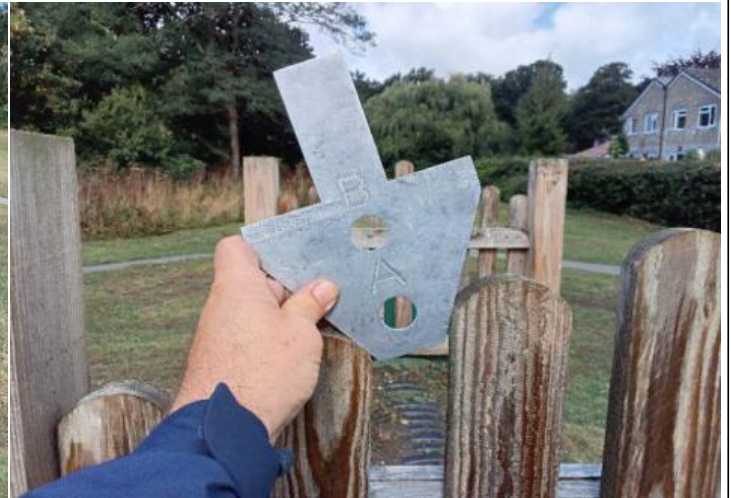
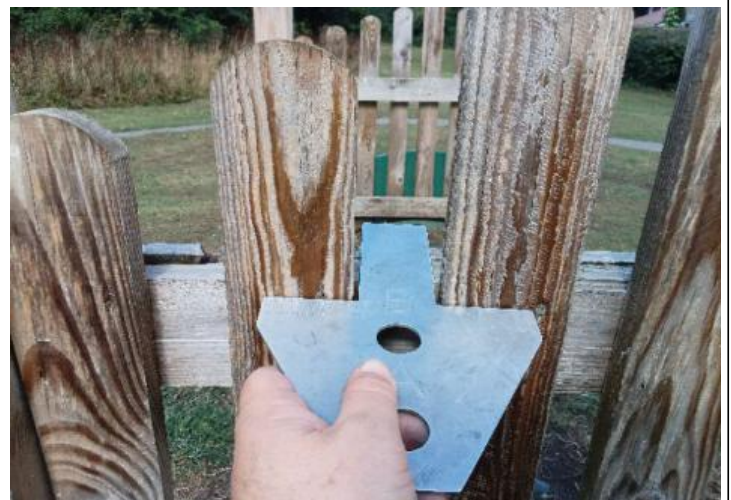
Finding: The item fails to meet the requirements of BS EN 1176 Part 1 4.2.7.2 for head and neck entrapment in the barriers

Action: Monitor - No action given the risk assessment

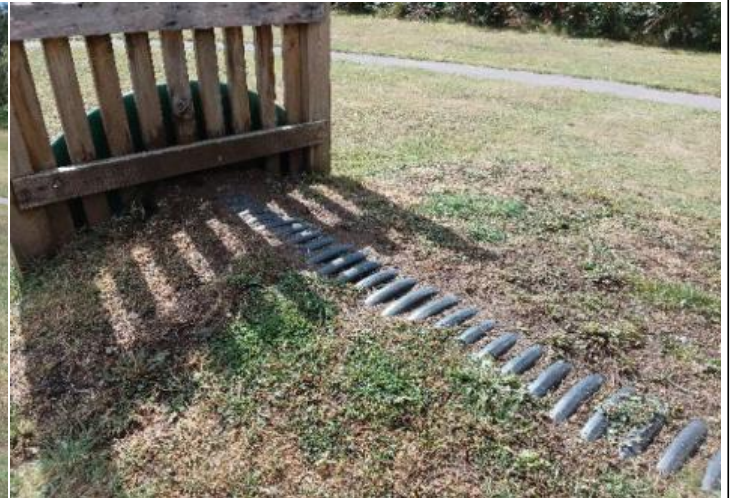
Finding: The surface has eroded in some areas and may be slippery in wet conditions
Action: Reinstate the surface

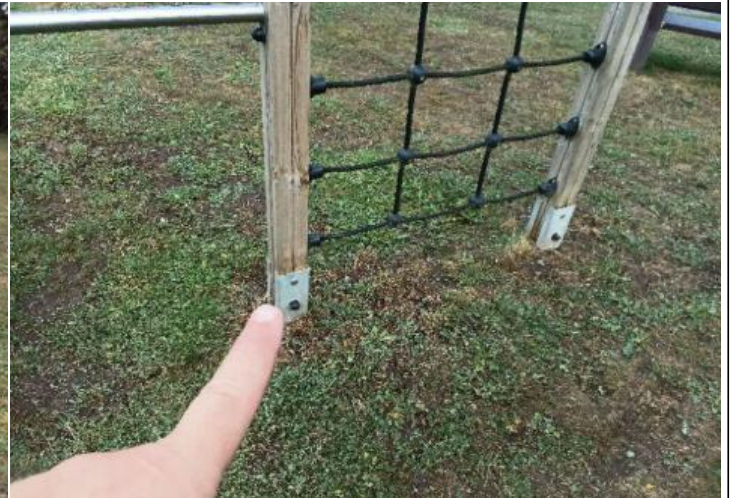
Finding: A number of fixing(s) have worked loose

Action: Secure all loose fixings

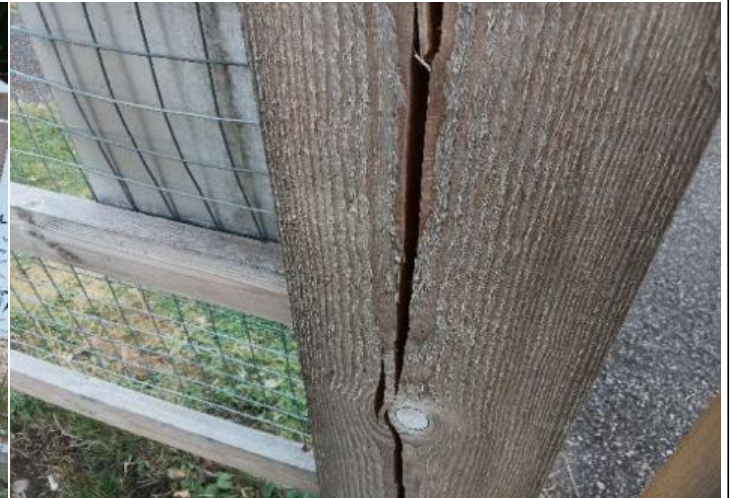
Finding: The timber has a number of splits/shakes or air cracks and this may affect the stability or allow water ingress which will accelerate the rotting process. Timber splits may also create rough / splintering edges.

Action: Monitor, sand down any rough edges and ensure the splits do not cross through fixing points of the structure and/or cause any instability

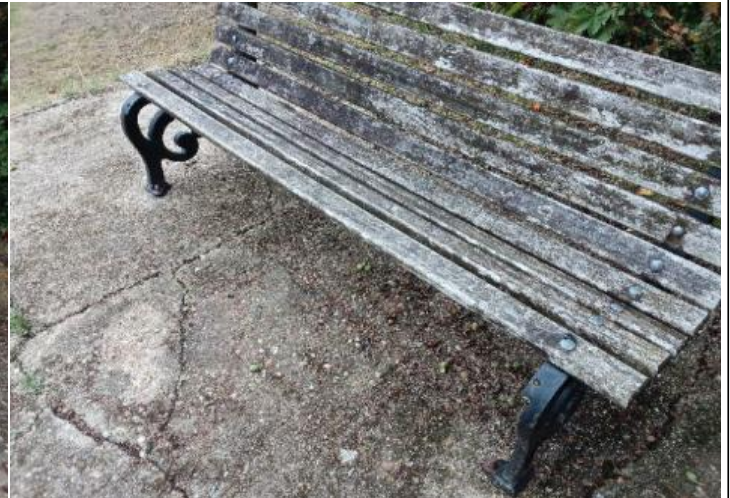
Finding: There is/are a number of missing or damaged slats.

Action: Repair or Replace as required

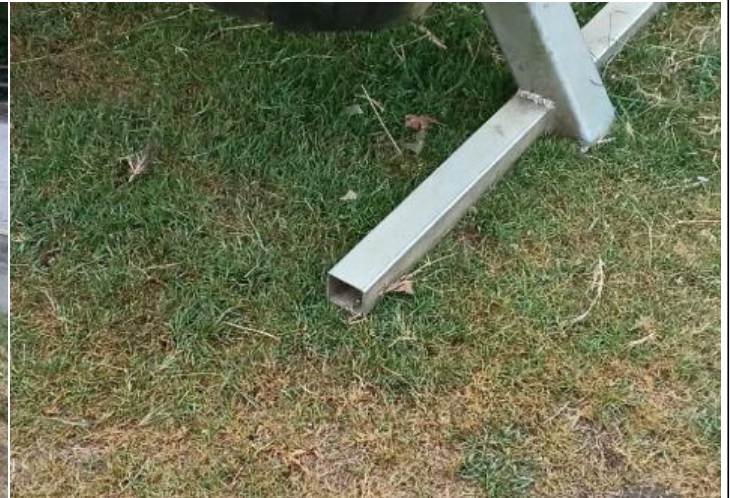
Finding: There are missing end caps

Action: Replace

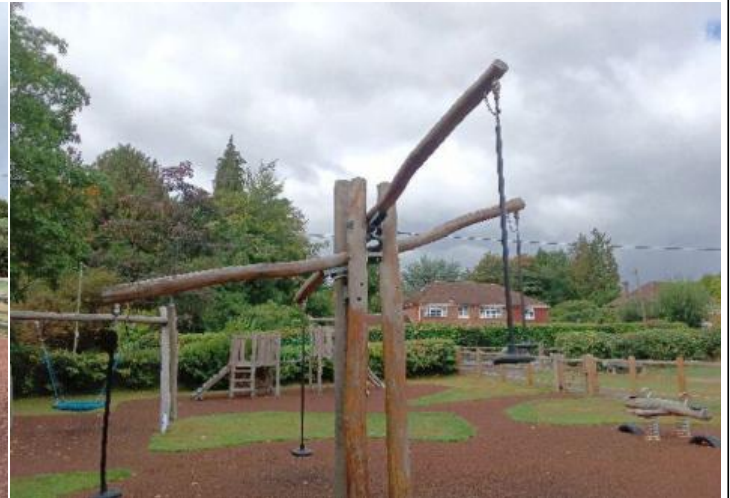
Finding: NOTE - The fixings or components for this item were in excess of 2.5m above the standing surface and could not be fully accessed by the inspector. We have completed a visual inspection of the fixings from ground level but a maintenance inspection should be undertaken to assess the condition, security and wear of the components at intervals in accordance with the manufacturers recommendations.

Action: Inspect in accordance with the manufacturers recommendations

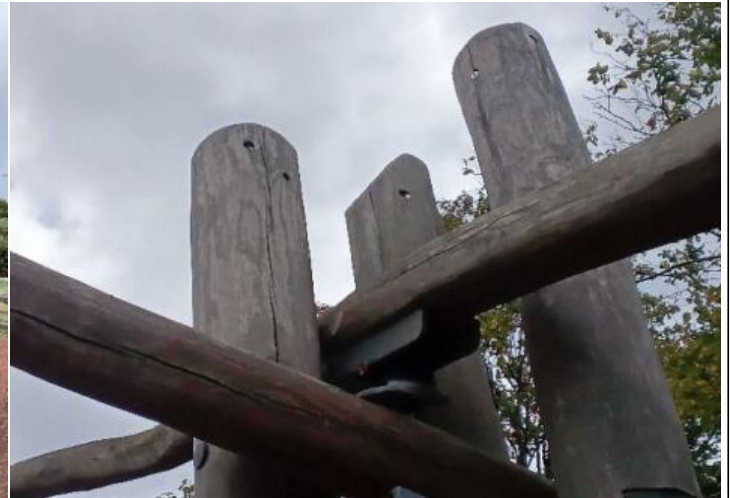
Finding: There is some play within the pivot mechanism

Action: Monitor for any further deterioration and repair as required

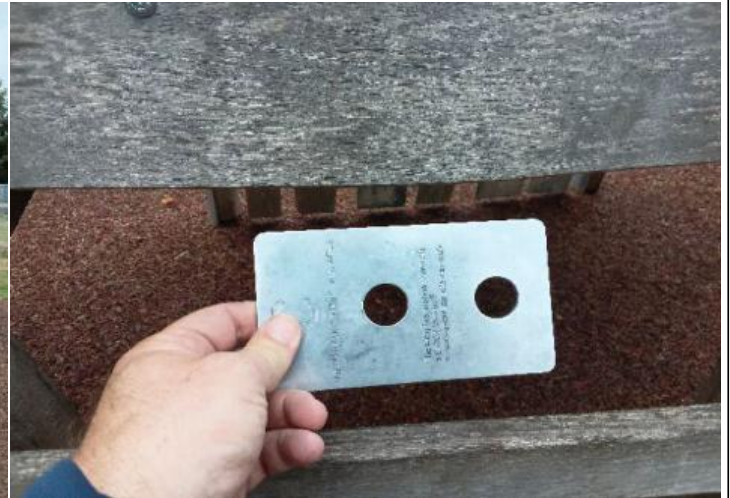
Finding: The item fails to meet the requirements of BS EN 1176 Part 1 4.2.7.2 for head and neck entrapment between the ladder rung and platform

Action: Monitor - No action given the risk assessment

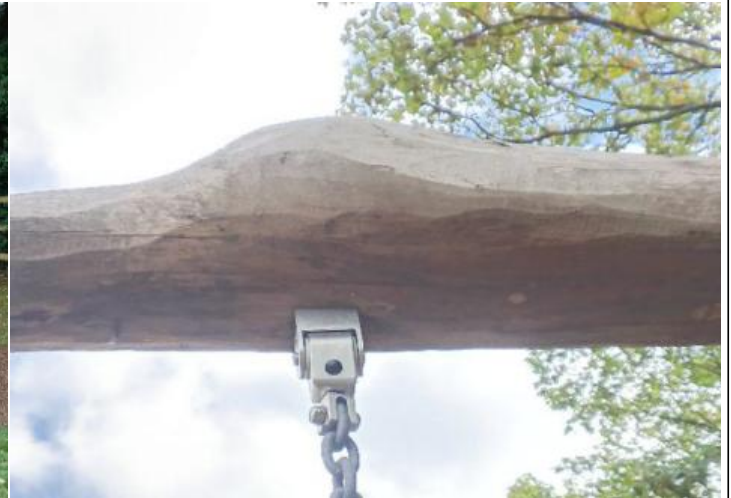
Finding: This design of swing joint has been known to fail on the weld connecting the joint to the threaded stud

Action: We would recommend that the joint be dismantled and checked on a regular basis or consulting with manufacturer on whether a Secondary Safety Device can be fitted

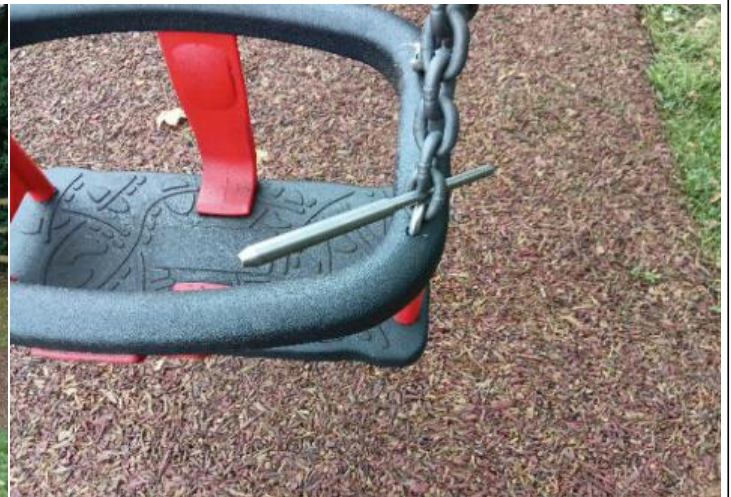
Finding: The chain openings are in excess of the 8.6mm as recommended by BS EN 1176

Action: Monitor - No action given the risk assessment

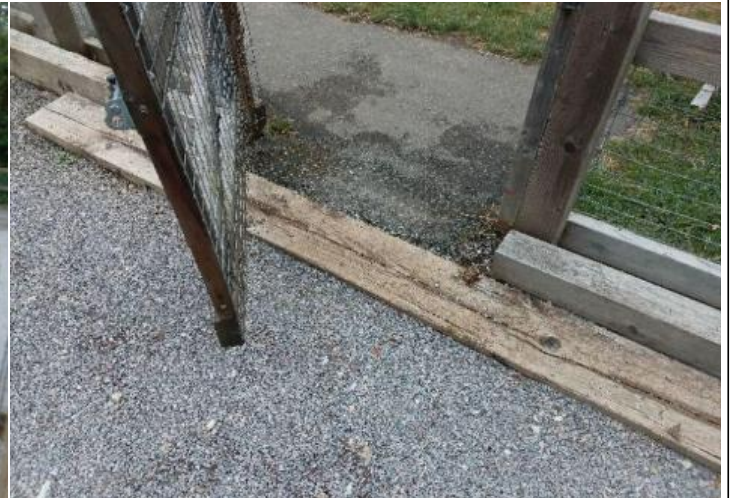
Finding: There are trip hazards at the edges of the surface **Action:** Remove trip hazard

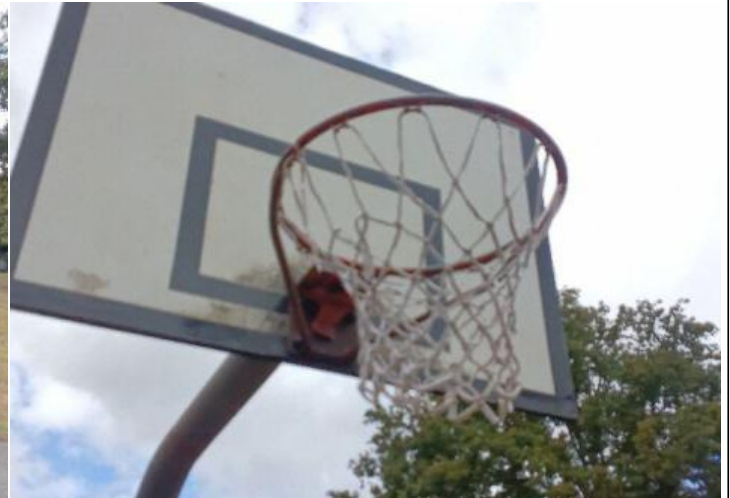
Finding: The net is damaged

Action: Replace / remove net

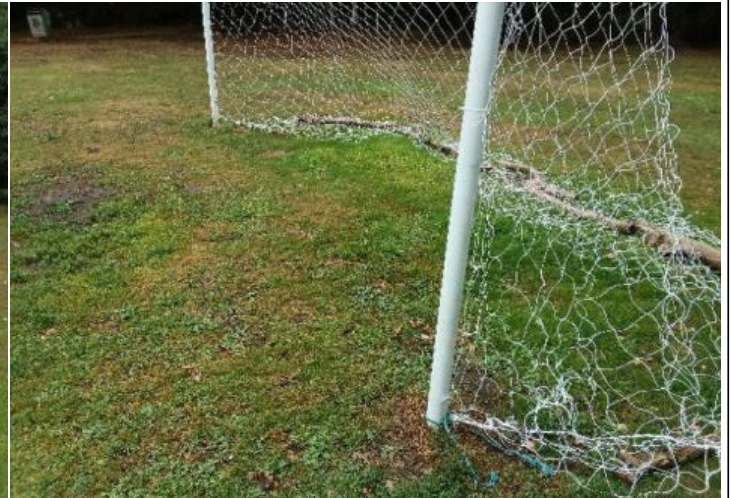
Finding: The posts are slightly loose in the ground

Action: Monitor for any further deterioration and repair as required

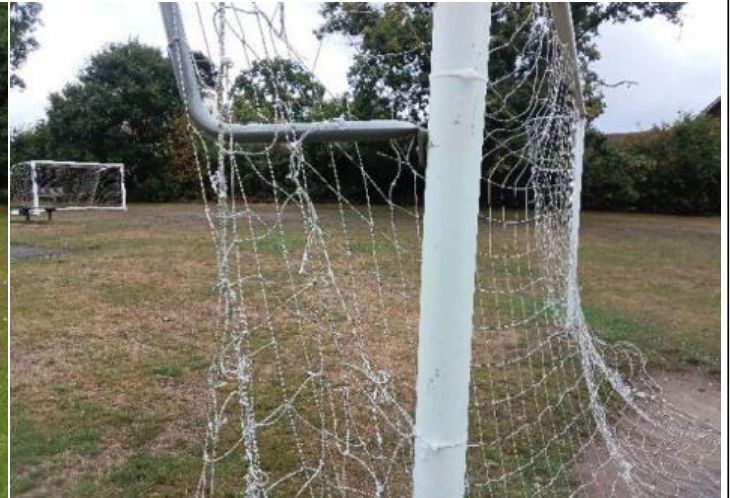
Finding: The nets are damaged

Action: Replace

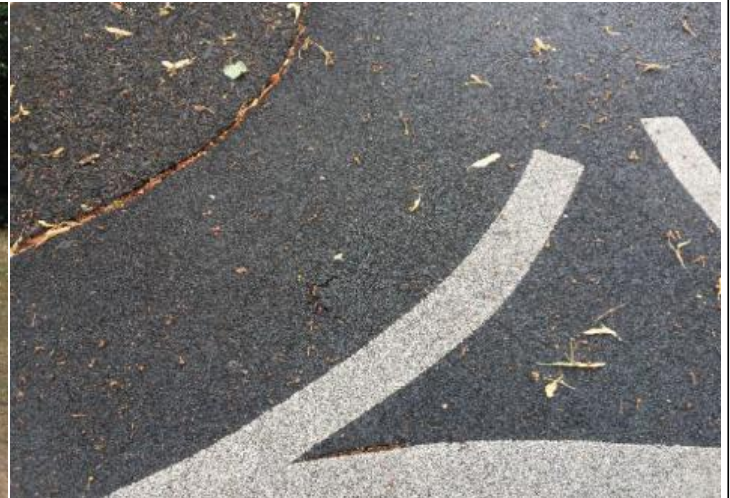
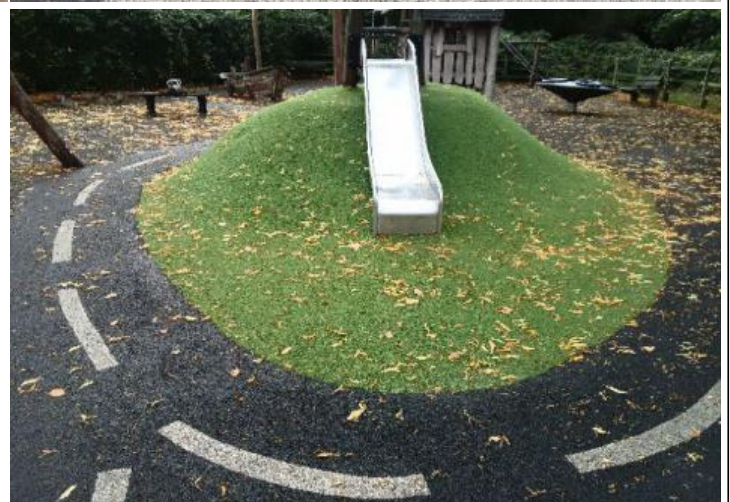
Finding: There is some damage to the wet pour surfacing

Action: Monitor for any further deterioration and repair as required

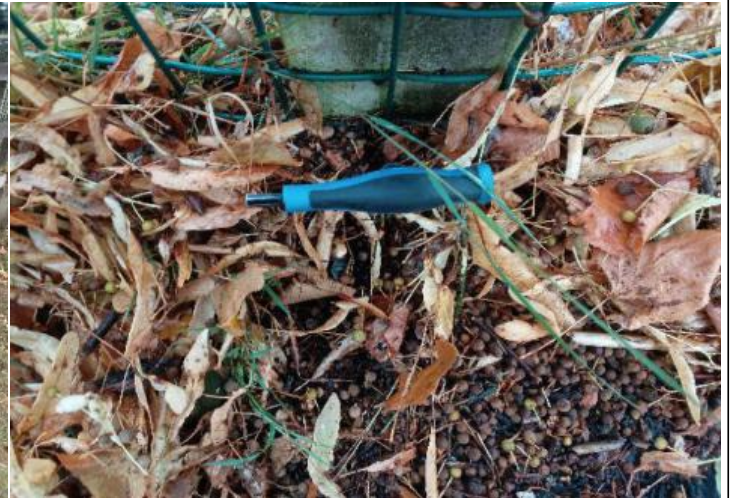
Finding: There is some evidence of rot in the timber

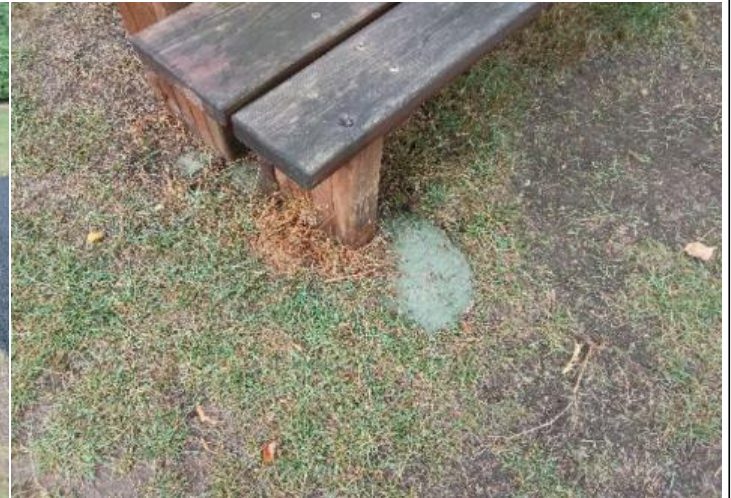
Finding: The surface has eroded and the foundations are exposed

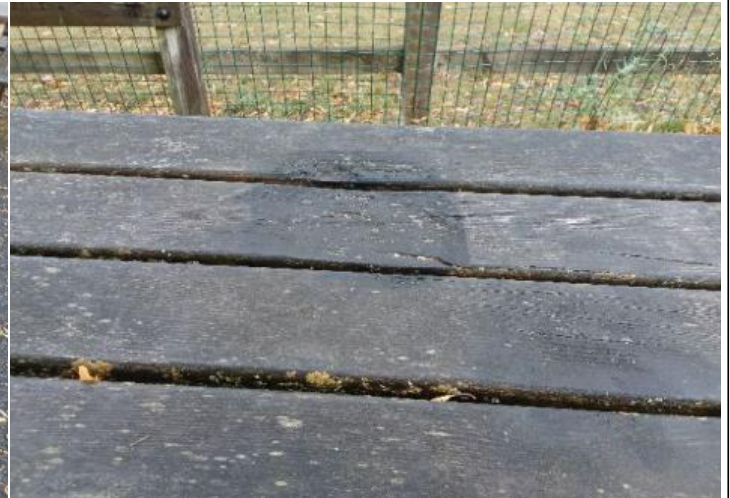
Finding: There is some evidence of fire damage to the item **Action:** Monitor for any further deterioration and repair as required

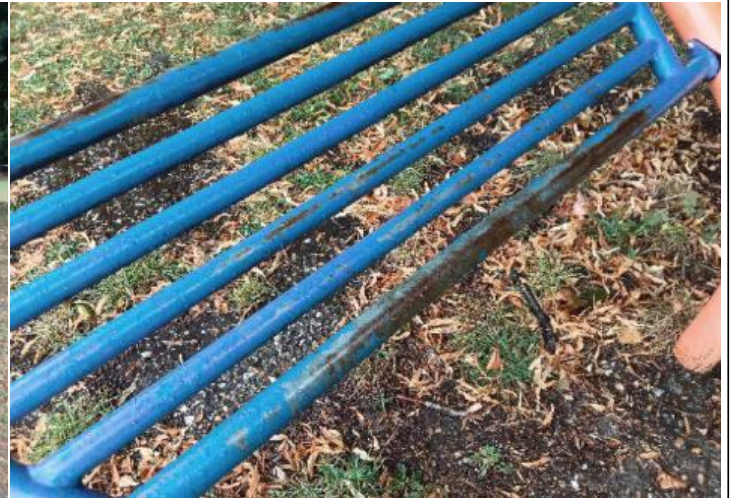
Finding: The paintwork on this item has been damaged or worn exposing the metal underneath which is rusting / corroding

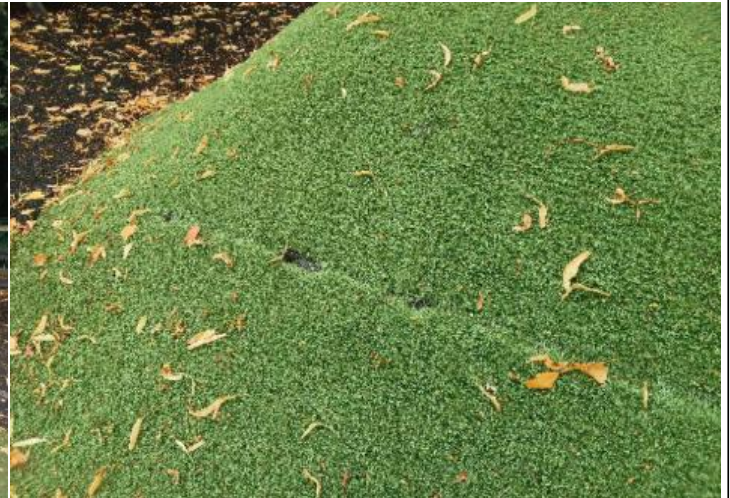
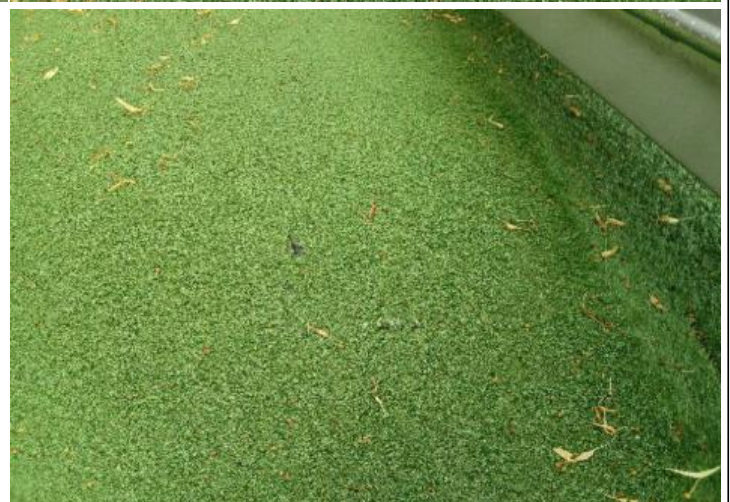
Finding: There is moderate damage to the surface

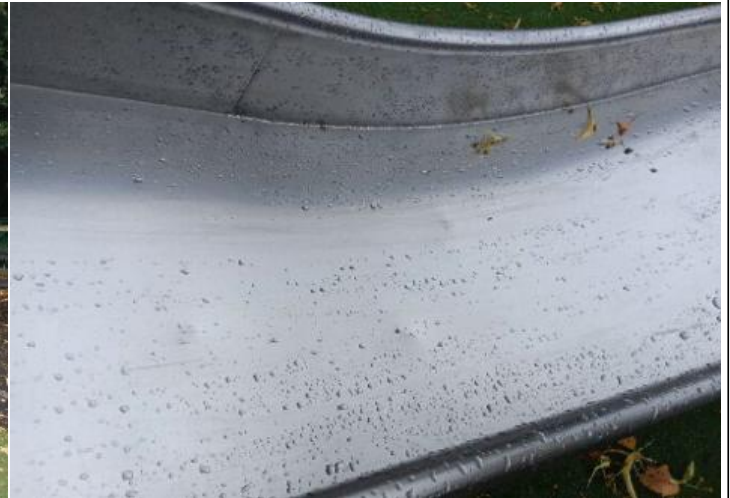
Finding: There are a number of dents in the slide surface

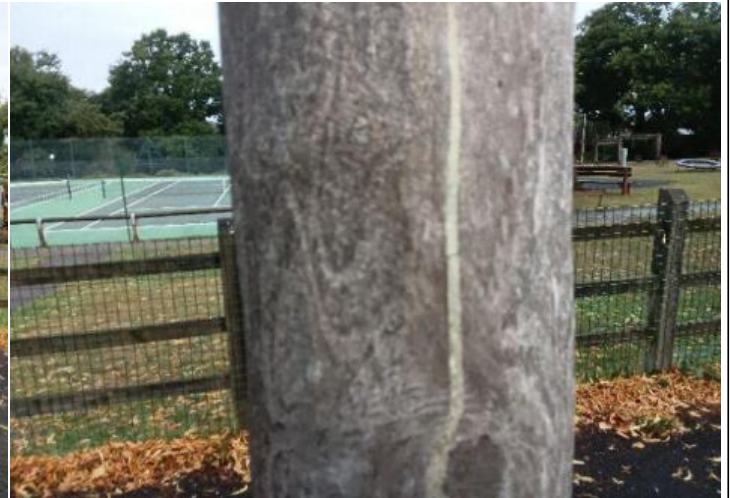
Finding: The use of synthetic fillers in timber is not recommended; timber being a natural material will expand and contract as the moisture content changes and the use of fillers can exacerbate the length and depth of these cracks or shakes in the timber. The only treatment that is normally required is the removal of any rough or sharp edges unless the structural integrity of the item is affected.

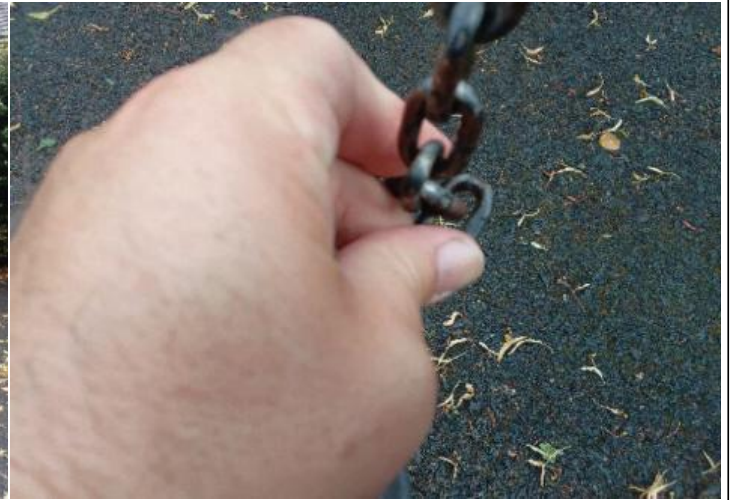
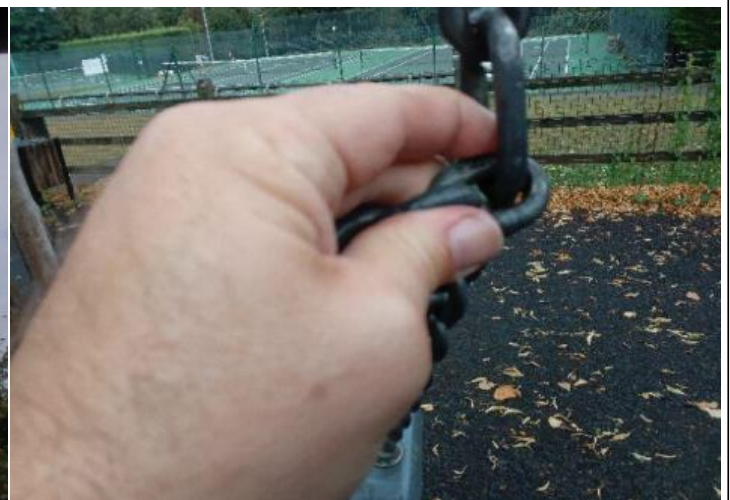
Finding: There is some notable evidence of chain wear

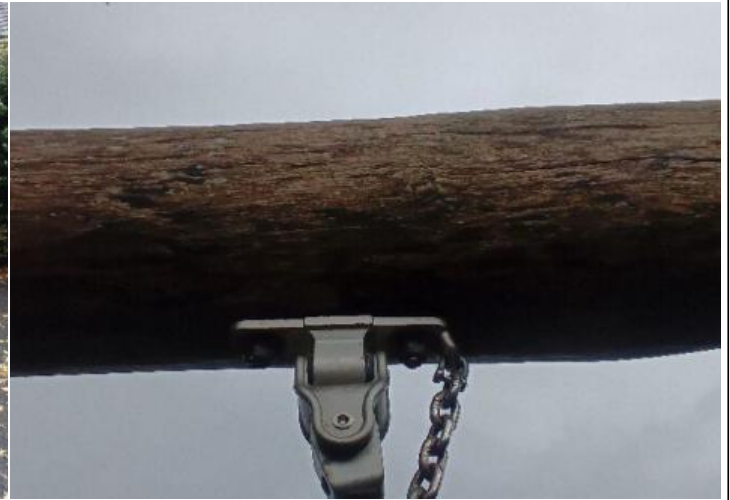
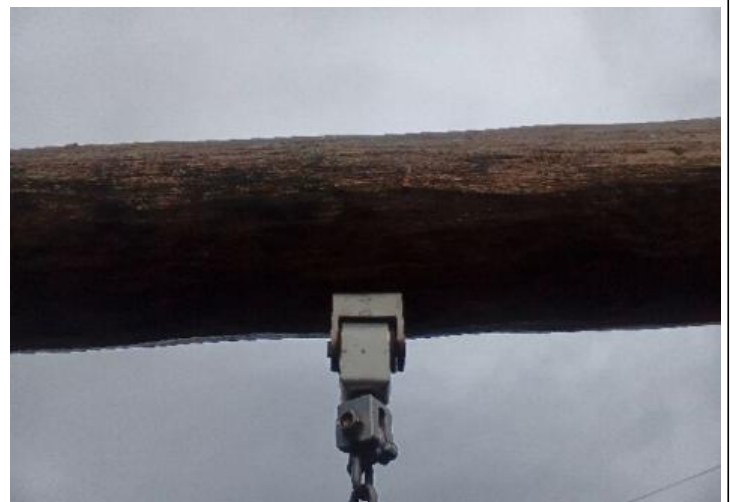
Finding: The bush / bushes is / are showing signs of wear

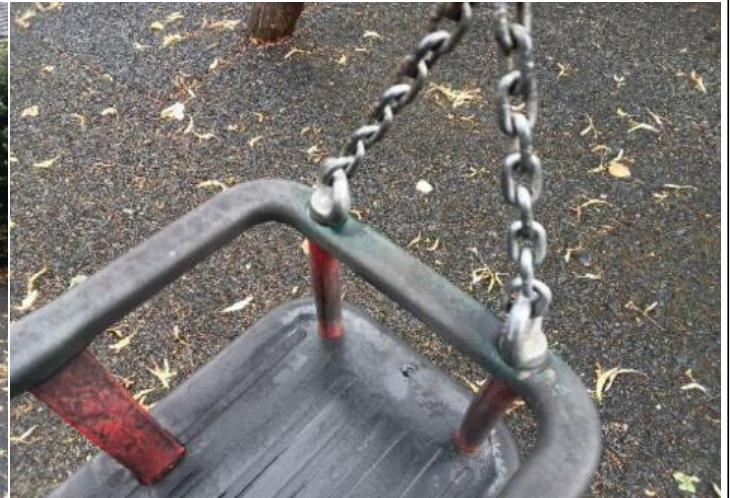
Finding: The swing seat connectors are loose

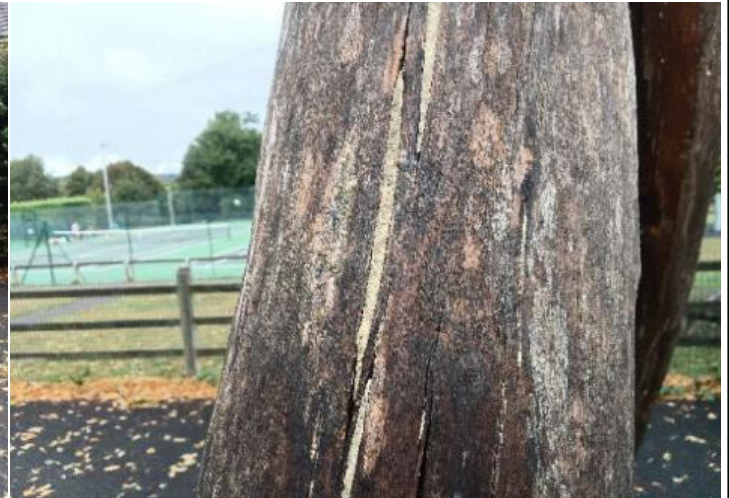
Finding: The use of synthetic fillers in timber is not recommended; timber being a natural material will expand and contract as the moisture content changes and the use of fillers can exacerbate the length and depth of these cracks or shakes in the timber. The only treatment that is normally required is the removal of any rough or sharp edges unless the structural integrity of the item is affected.

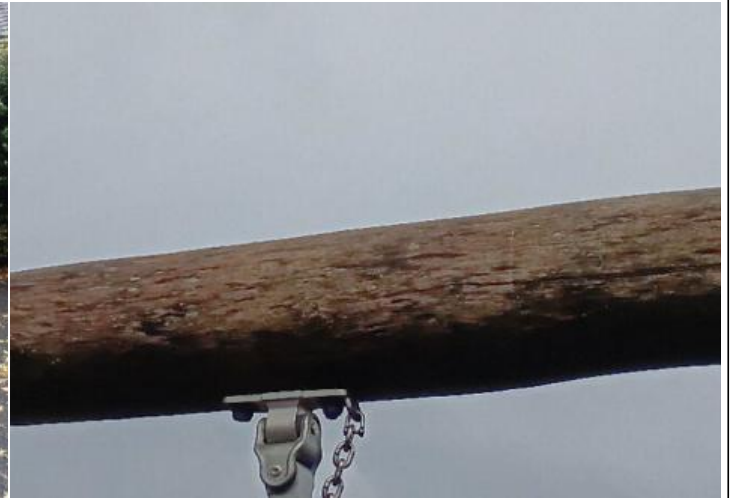
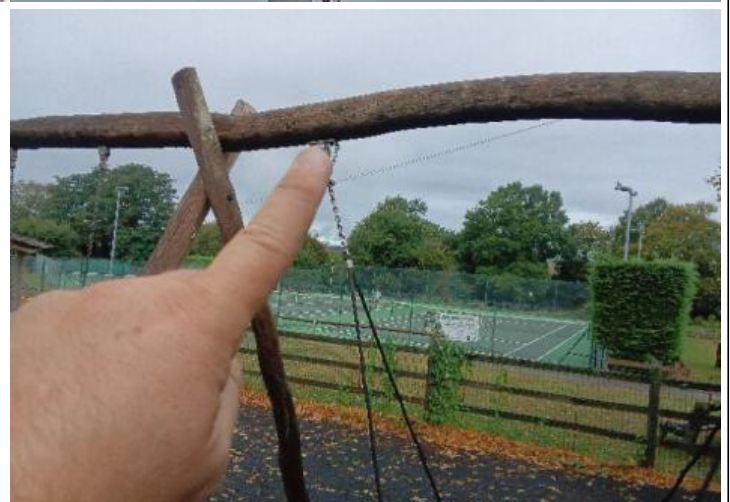
Finding: A number of crossbeam fixing(s) have worked loose

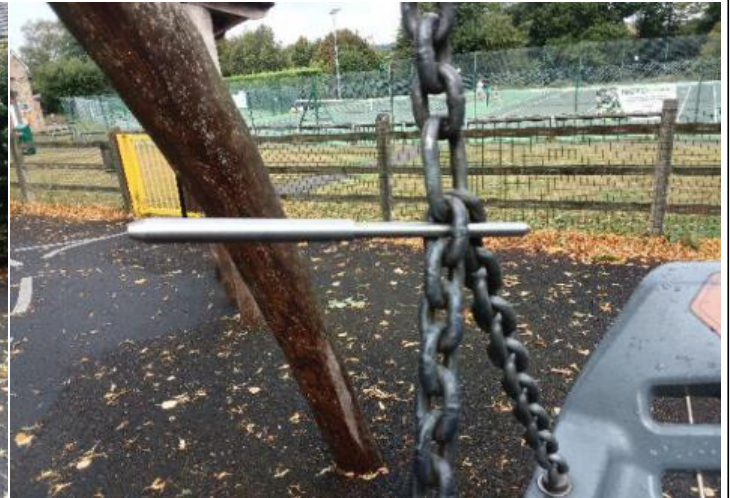
Finding: The chain openings are in excess of the 8.6mm as recommended by BS EN 1176 **Action:** Monitor - No action given the risk assessment

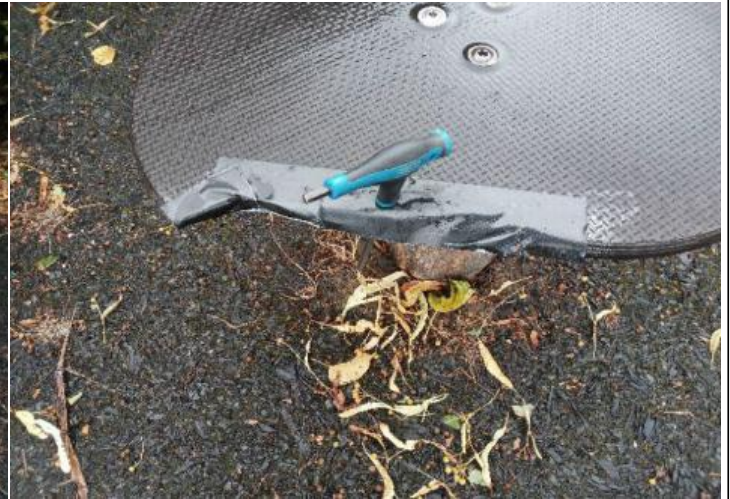
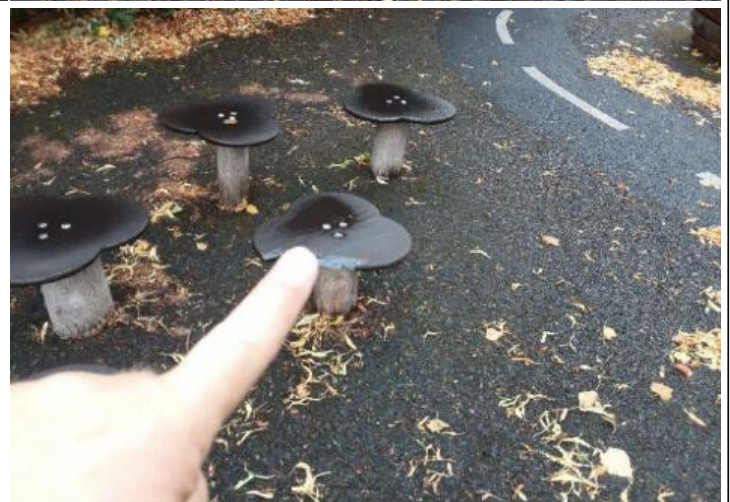
Finding: There are areas or parts of the platforms that have rotted
Action: Replace all affected timbers

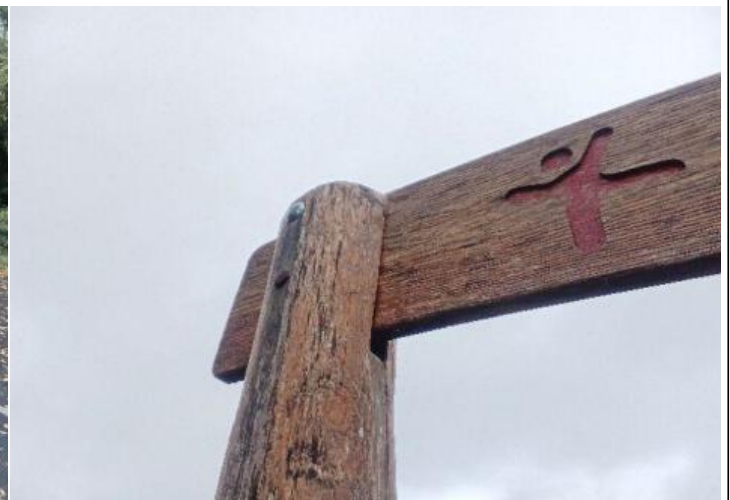
Finding: A number of mast fixing(s) have worked loose

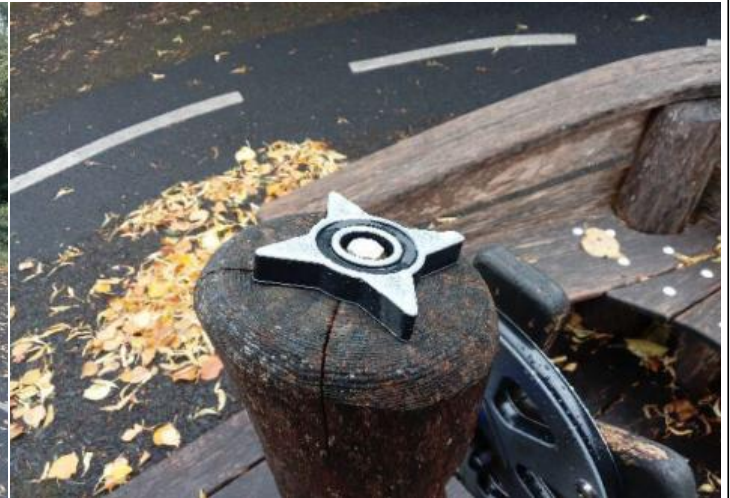
Finding: There is/are bolt cap covers missing or damaged on the item

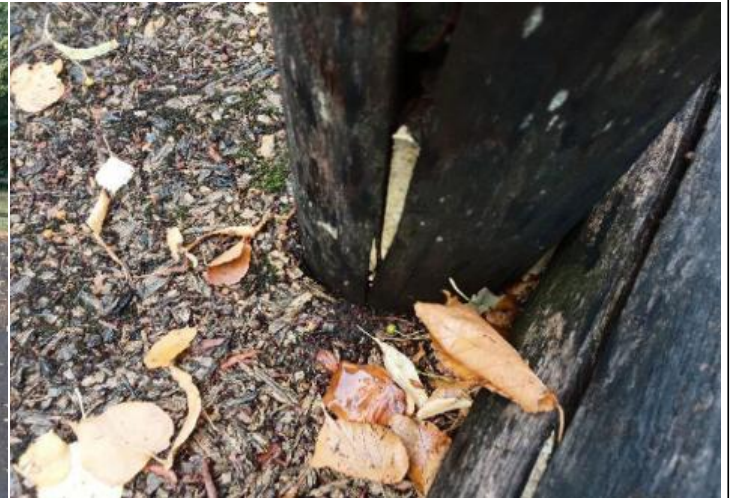
Finding: The use of synthetic fillers in timber is not recommended; timber being a natural material will expand and contract as the moisture content changes and the use of fillers can exacerbate the length and depth of these cracks or shakes in the timber. The only treatment that is normally required is the removal of any rough or sharp edges unless the structural integrity of the item is affected.

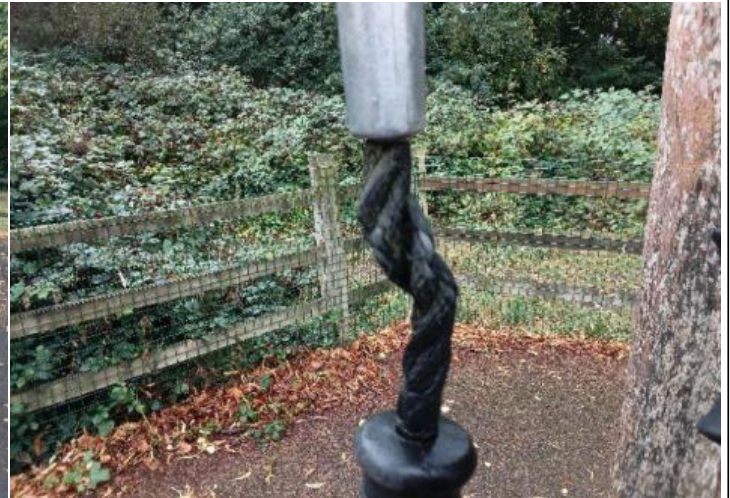
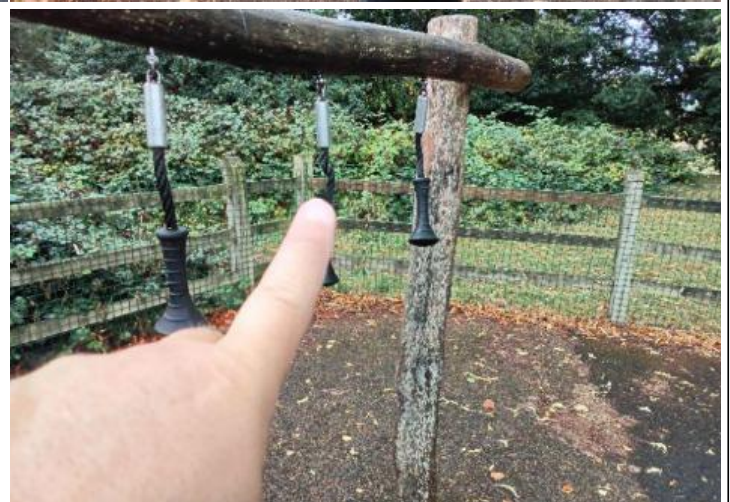
Finding: The handgrip has worn and wire strands are exposed

Action: Replace

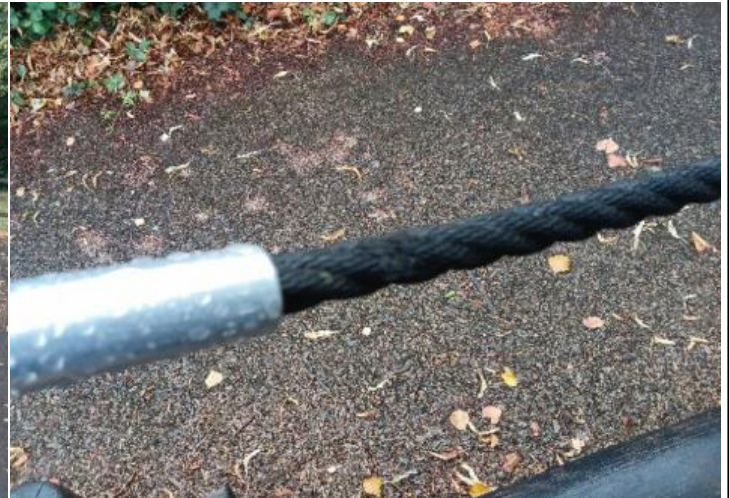
Finding: The ropes/nets are worn/damaged in places

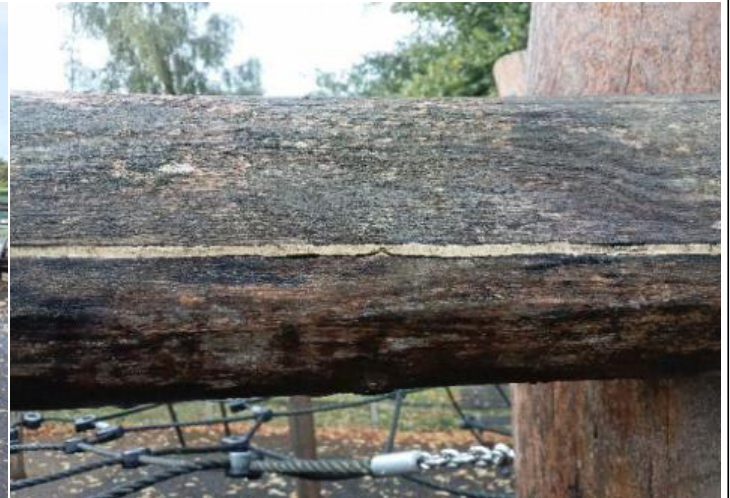
Finding: The use of synthetic fillers in timber is not recommended; timber being a natural material will expand and contract as the moisture content changes and the use of fillers can exacerbate the length and depth of these cracks or shakes in the timber. The only treatment that is normally required is the removal of any rough or sharp edges unless the structural integrity of the item is affected.

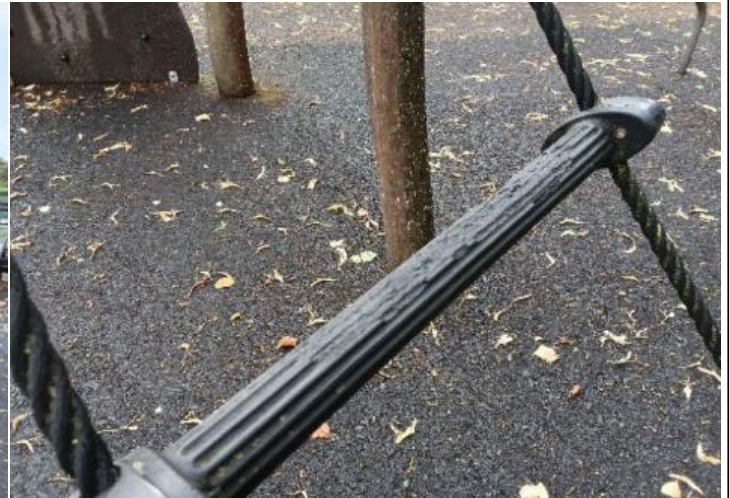
Finding: The rope ladder tread has been damaged
