LISS PARISH COUNCIL

Minutes of the meeting of the Facilities Committee held on 14th July 2025, 7pm,
Village Hall

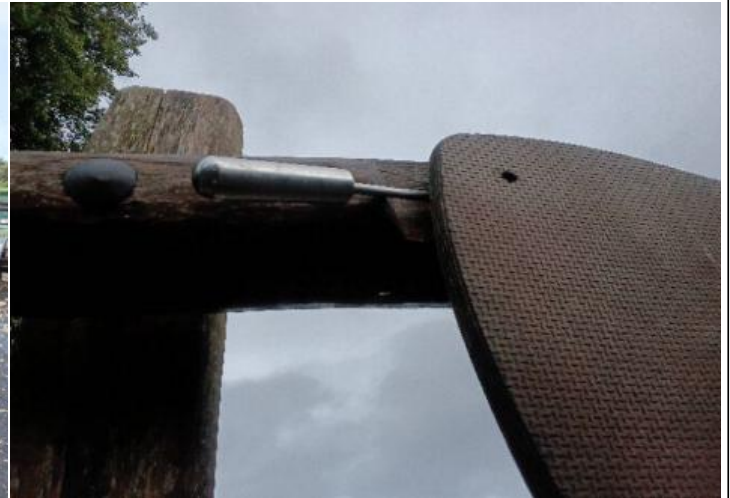
Finding: There is/are finger entrapment/s in the climbing panel and the item fails to meet the requirements of BS EN 1176 Part 1 4.2.7.6 Entrapment of fingers

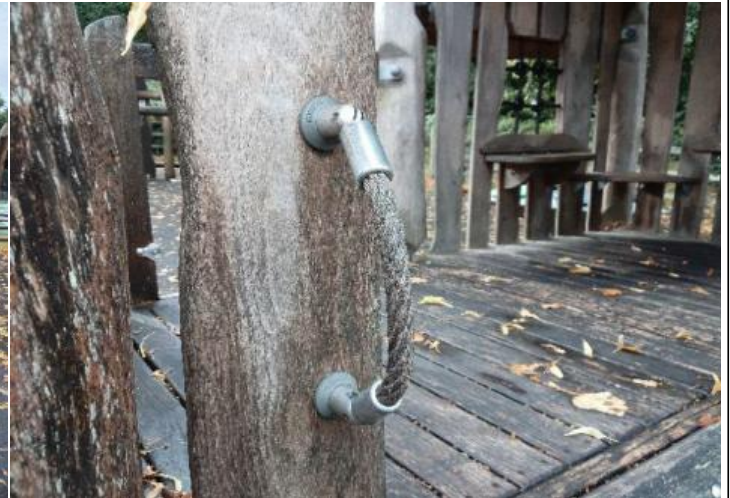
Finding: A number of handgrip fixing(s) have worked loose **Action:** Secure all loose fixings

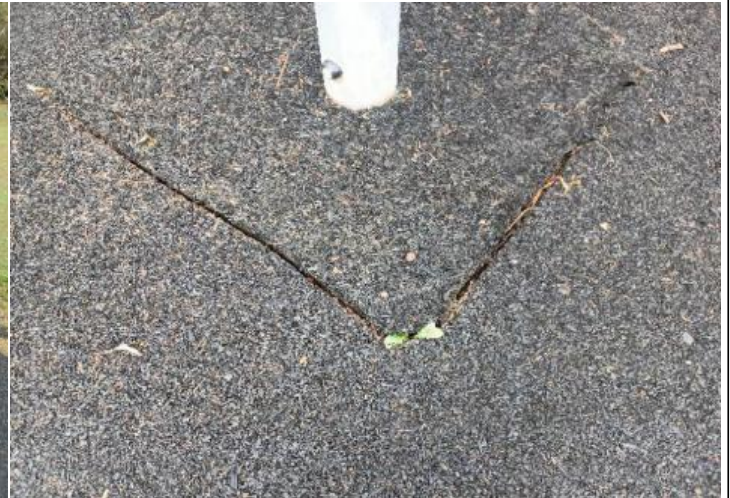
Finding: There are gaps opening between the surfacing and the edging surround or between the joints in the surfacing **Action:** Monitor for any further deterioration and repair as required

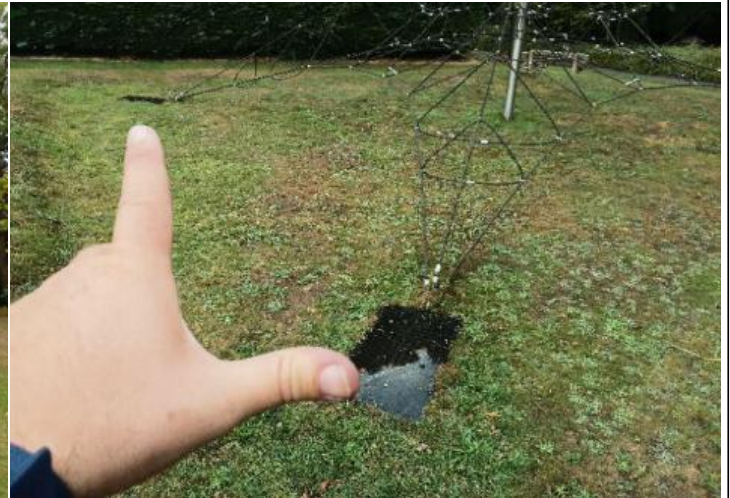
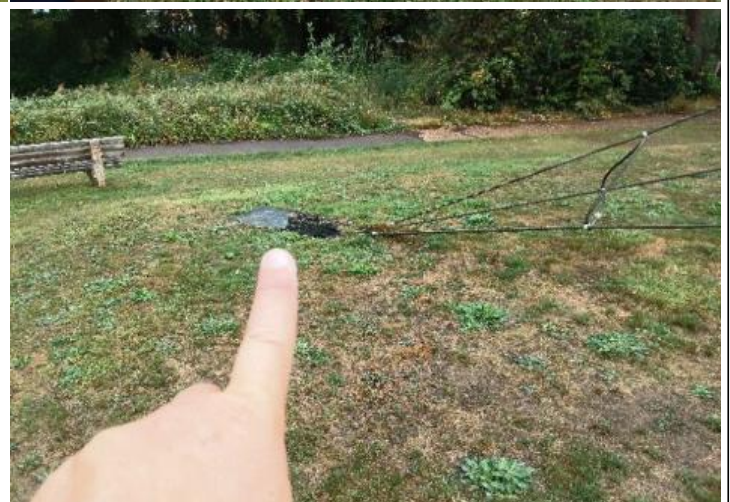
Finding: There is moderate damage to the surface

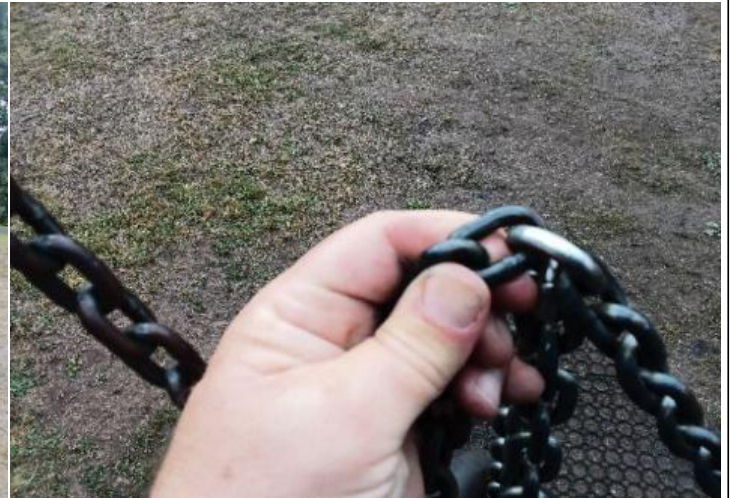
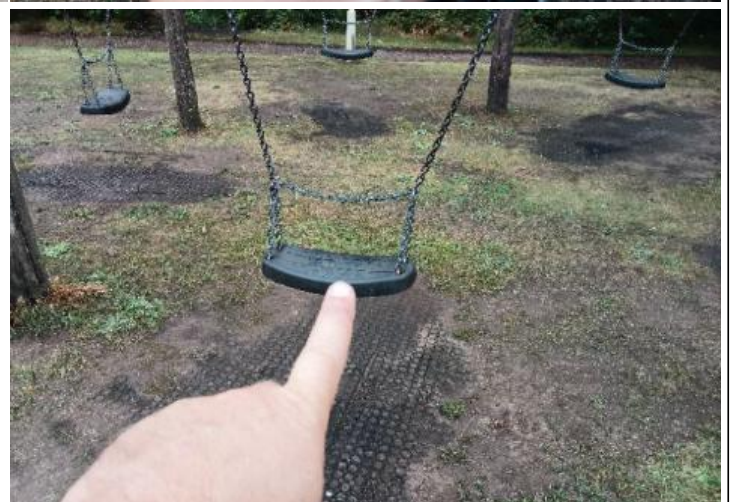
Finding: The chain links are worn excessively (50%) and require renewing

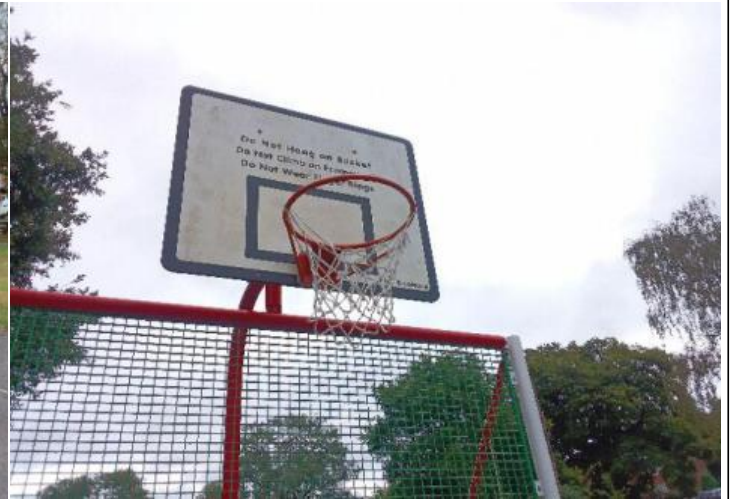
Finding: The net is loose

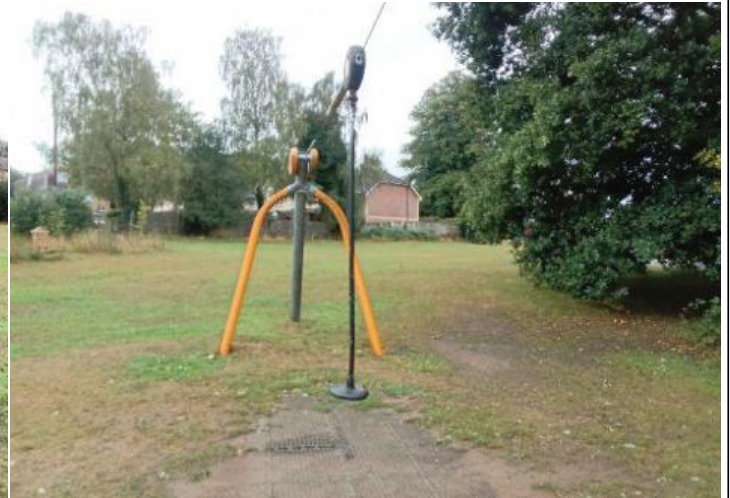
Finding: We have completed a visual inspection of the suspension links, cable and fixing points from ground level, however it is not possible to fully inspect these areas without either hiring equipment to gain access or removing the cable and suspension and inspecting at ground level. We recommend that the main cable and fixing security is thoroughly inspected at least in accordance with the manufacturers recommendations to check for wear, damage, security or internal rusting; this will help to ensure the continued safe use of the equipment

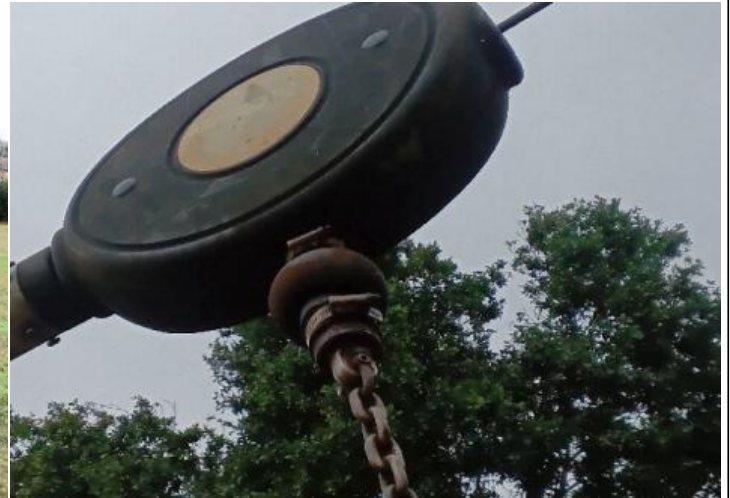
Finding: There is some notable evidence of chain wear

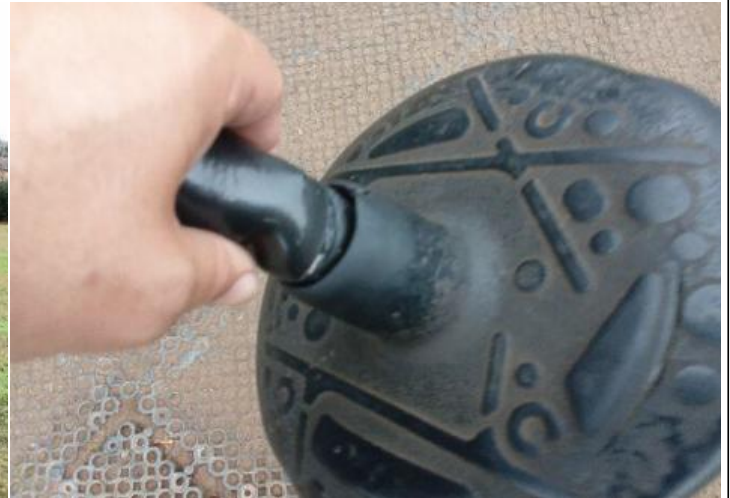
Finding: The seat suspension cover has been damaged

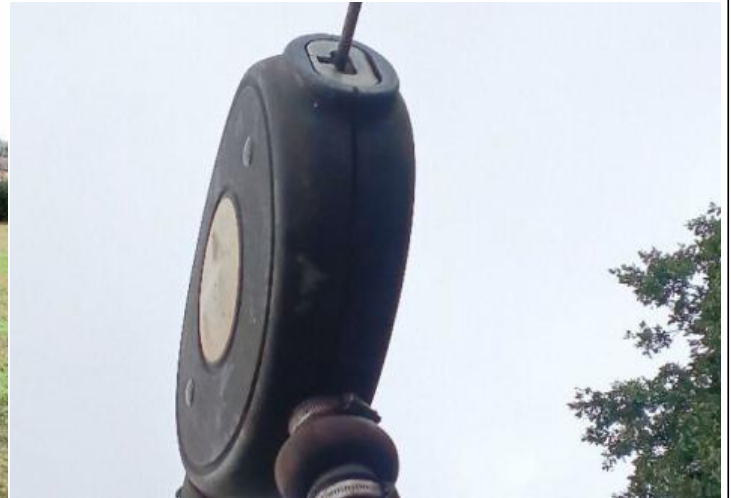
Finding: The traveller casing is beginning to separate

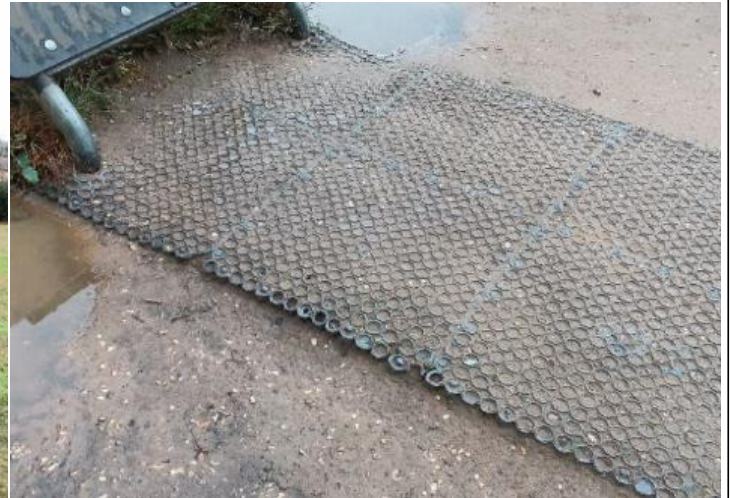
Finding: The surface is lifting at the edges and creating trip points
Action: Repair perimeter of surfacing to remove trip points
