LISS PARISH COUNCIL

Minutes of the meeting of the Facilities Committee held on 14th July 2025, 7pm,
Village Hall

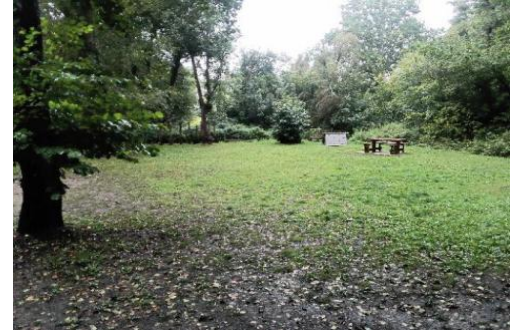
Item: Site General
Manufacturer: Owner/Operator
Surface Type: N/A
Item Quantity: 1
Equipment Compliance: N/A
Surface Area Compliance: N/A

NOTE - There is a body of water or a water basin in close proximity to the playground. Risk assessment of this is a specialist field and outside the scope of our inspection. - Contact our official water safety partner the RLSS (Royal Life Saving Society) at www.rlss.org.uk and / or ensure that the appropriate risk assessment is in place

The surface has eroded in some areas and may be slippery in wet conditions - Reinstate the surface

The play equipment is located within a natural environment and as such there are a number of natural hazards in close proximity. This includes loose logs / felled trees and overgrown / overhanging foliage. There is one log in particular that is likely to encourage climbing, the log is rotting, slippery and has sharp protrusions - Ensure a suitable and sufficient risk assessment is in place and all control measures are implemented, we would recommend the area is formalised to extent to remove the worst of the current hazards

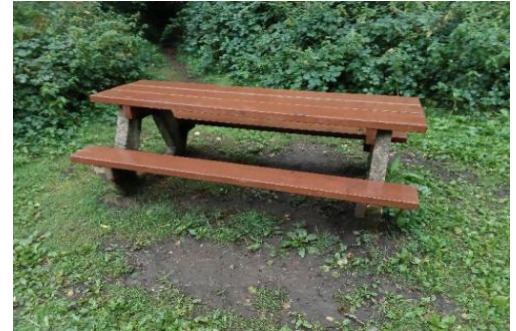
Item: Picnic Table
Manufacturer: Not Identified
Surface Type: Grass
Item Quantity: 1
Equipment Compliance: N/A
Surface Area Compliance: N/A

The area around the item has eroded and may become slippery - Reinststate eroded area

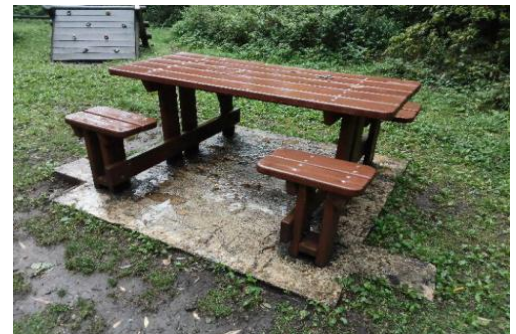
Item: Picnic Table
Manufacturer: Not Identified
Surface Type: Concrete
Item Quantity: 1
Equipment Compliance: N/A
Surface Area Compliance: N/A

There are trip hazards at the edges of the surface - Remove trip hazard

There is some evidence of fire damage to the item - Monitor for any further deterioration and repair as required

There are holes in the surface that may cause users to trip or roll ankles - Infill to provide a sound reasonably level surface.

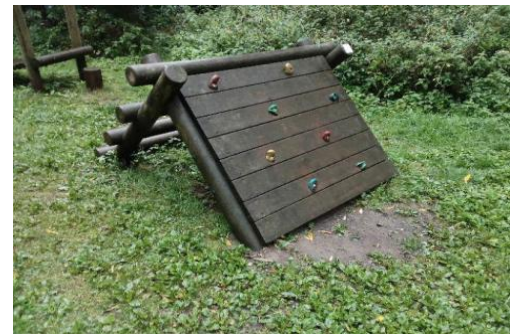
Item: A Frame Climber
Manufacturer: Sovereign Leisure
Surface Type: Grass
Item Quantity: 1
Equipment Compliance: Yes
Surface Area Compliance: Yes

The grass has eroded within the impact area of the equipment and may not provide the necessary impact attenuating properties for the equipment fall height; the surface may also be slippery in wet weather - Reinstate the grass or provide an all weather surface

There is algae or moss on the surface of the equipment resulting in slippery conditions - Clean and treat appropriately

There is some evidence of rot in the timber - Monitor for any further deterioration and replace as required

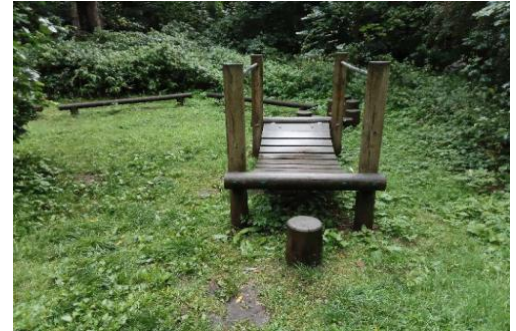
Item: Activity Trail
Manufacturer: Sovereign Leisure
Surface Type: Grass
Item Quantity: 1
Equipment Compliance: No
Surface Area Compliance: Yes

The adjacent foliage is encroaching into the falling space of the equipment - Cut back and maintain to a distance of 1500mm

There is some evidence of rot in the timber - Monitor for any further deterioration and replace as required

There is algae or moss on the surface of the equipment resulting in slippery conditions - Clean and treat appropriately

There are loose handgrips / footrests - Secure

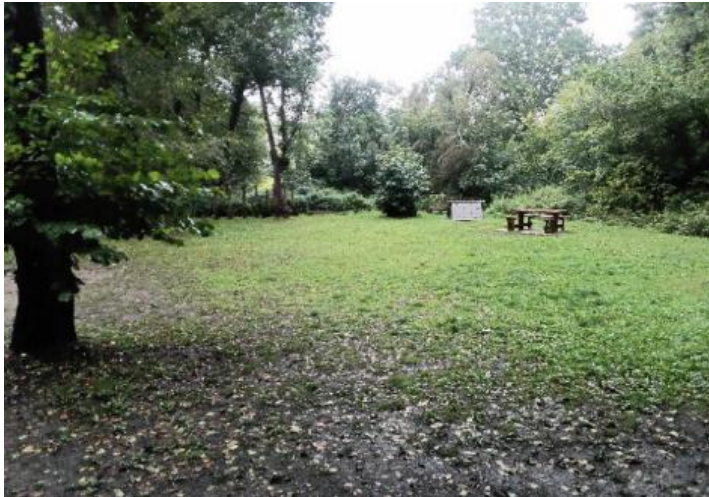
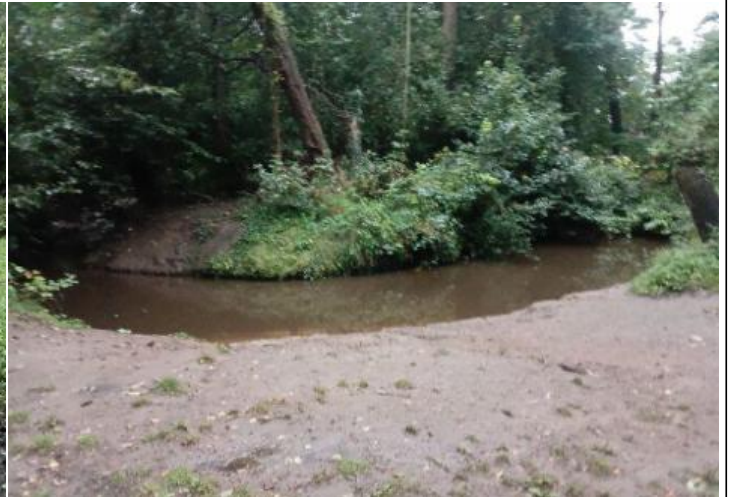
Item: Ancillary Items - Site General
Manufacturer: Owner/Operator

Finding: NOTE - There is a body of water or a water basin in close proximity to the playground. Risk assessment of this is a specialist field and outside the scope of our inspection.

Action: Contact our official water safety partner the RLSS (Royal Life Saving Society) at www.rlss.org.uk and / or ensure that the appropriate risk assessment is in place

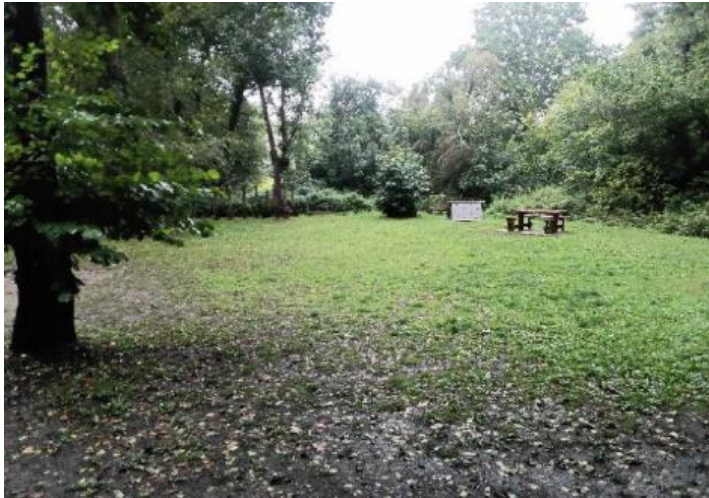
Item: Ancillary Items - Site General
Manufacturer: Owner/Operator

Finding: The surface has eroded in some areas and may be slippery in wet conditions
Action: Reinstate the surface

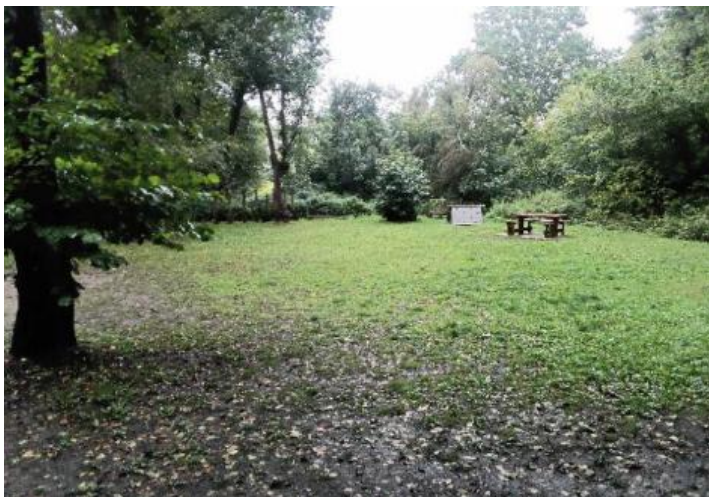
Item: Ancillary Items - Site General
Manufacturer: Owner/Operator

Finding: The play equipment is located within a natural environment and as such there are a number of natural hazards in close proximity. This includes loose logs / felled trees and overgrown / overhanging foliage. There is one log in particular that is likely to encourage climbing, the log is rotting, slippery and has sharp protrusions
Action: Ensure a suitable and sufficient risk assessment is in place and all control measures are implemented, we would recommend the area is formalised to extent to remove the worst of the current hazards

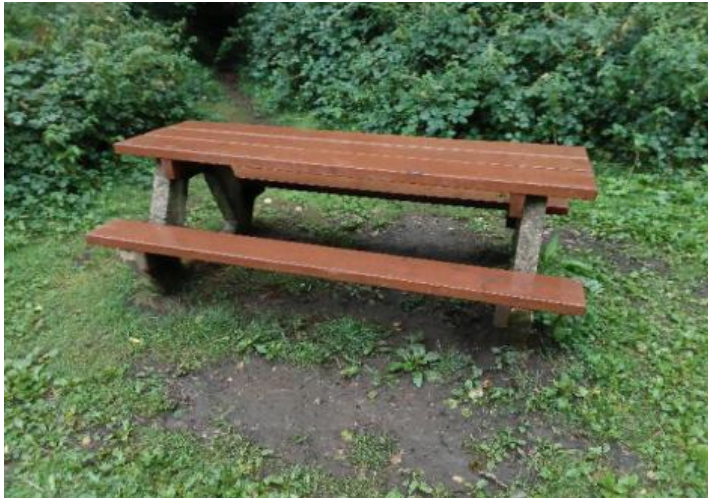
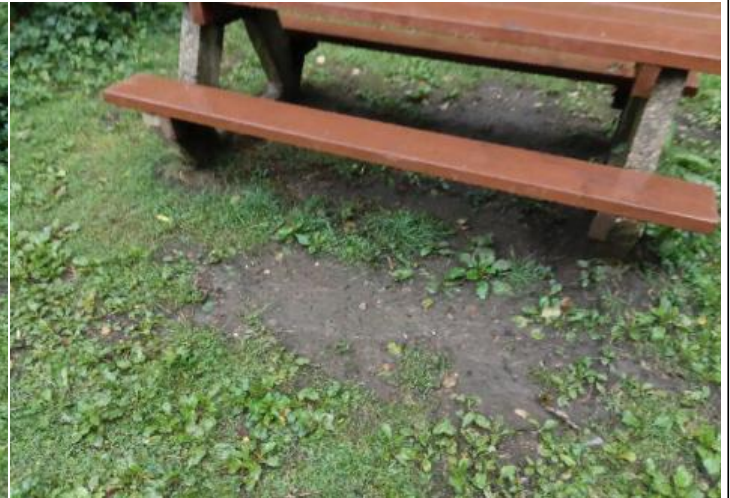
Item: Ancillary Items - Picnic Table
Manufacturer: Not Identified

Finding: The area around the item has eroded and may become slippery

Action: Reinststate eroded area

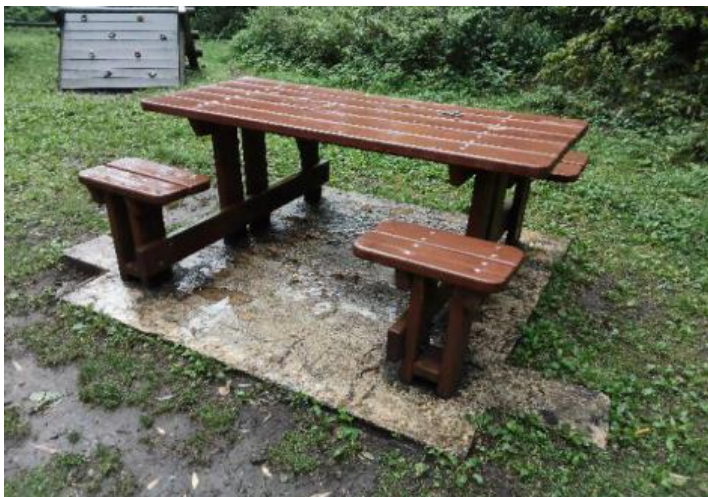
Item: Ancillary Items - Picnic Table
Manufacturer: Not Identified

Finding: There are trip hazards at the edges of the surface

Action: Remove trip hazard

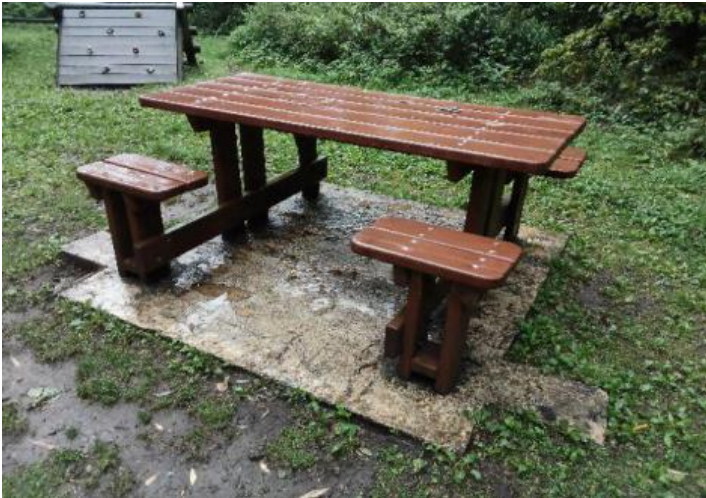
Item: Ancillary Items - Picnic Table
Manufacturer: Not Identified

Finding: There are holes in the surface that may cause users to trip or roll ankles

Action: Infill to provide a sound reasonably level surface.

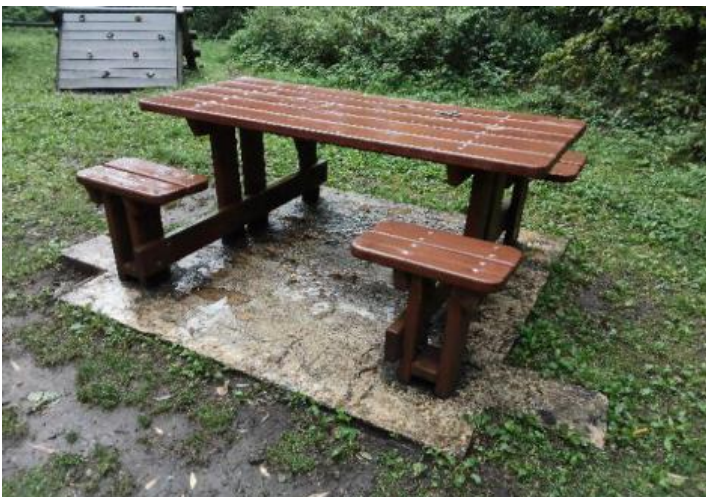
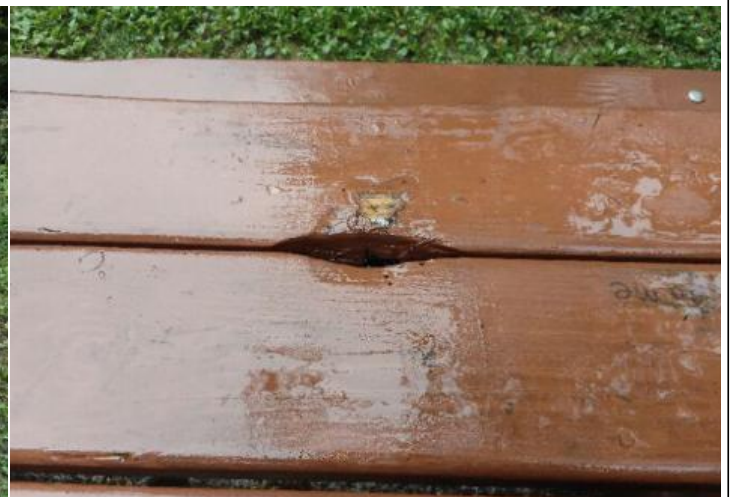
Item: Ancillary Items - Picnic Table
Manufacturer: Not Identified

Finding: There is some evidence of fire damage to the item

Action: Monitor for any further deterioration and repair as required

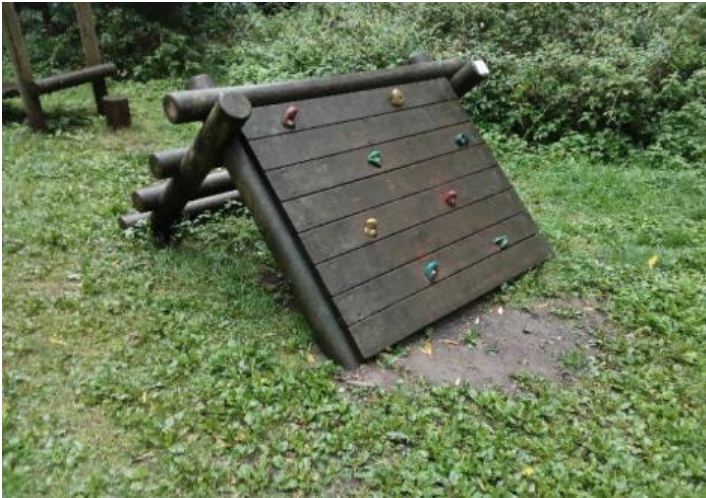
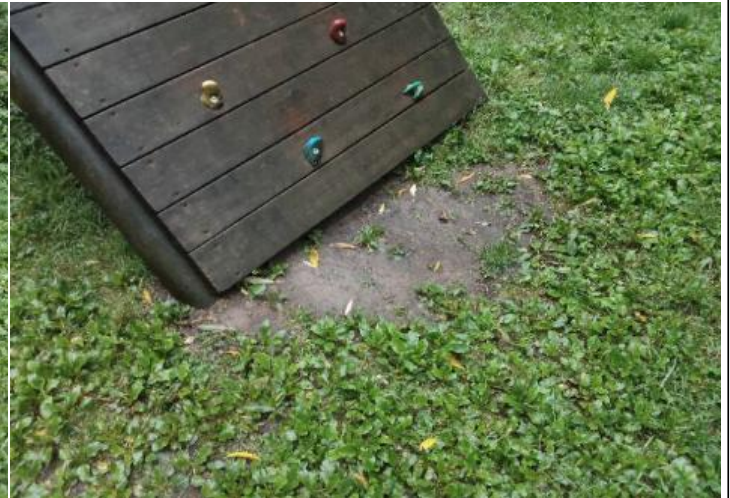
Item: Activity Equipment - A Frame Climber
Manufacturer: Sovereign Leisure

Finding: The grass has eroded within the impact area of the equipment and may not provide the necessary impact attenuating properties for the equipment fall height; the surface may also be slippery in wet weather
Action: Reinstate the grass or provide an all weather surface

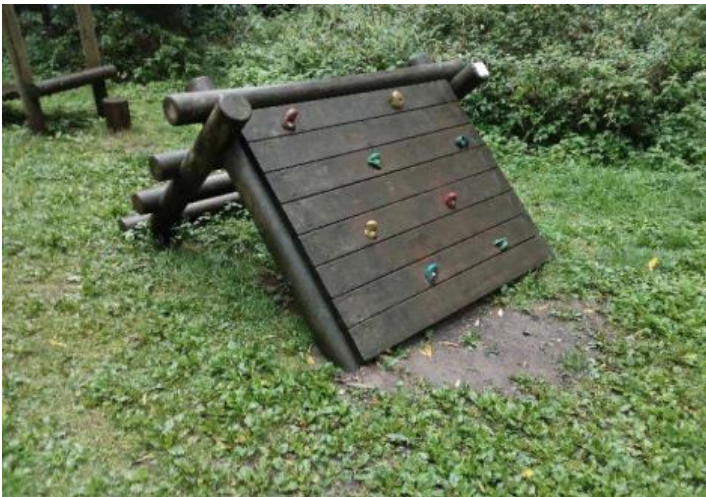
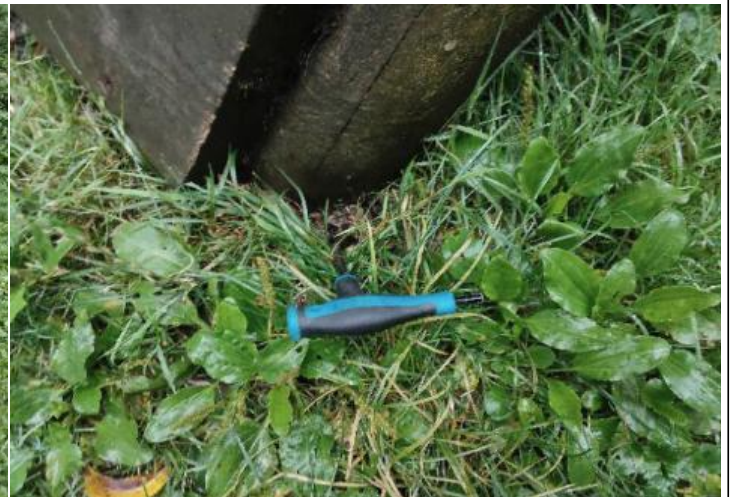
Item: Activity Equipment - A Frame Climber
Manufacturer: Sovereign Leisure

Finding: There is some evidence of rot in the timber
Action: Monitor for any further deterioration and replace as required

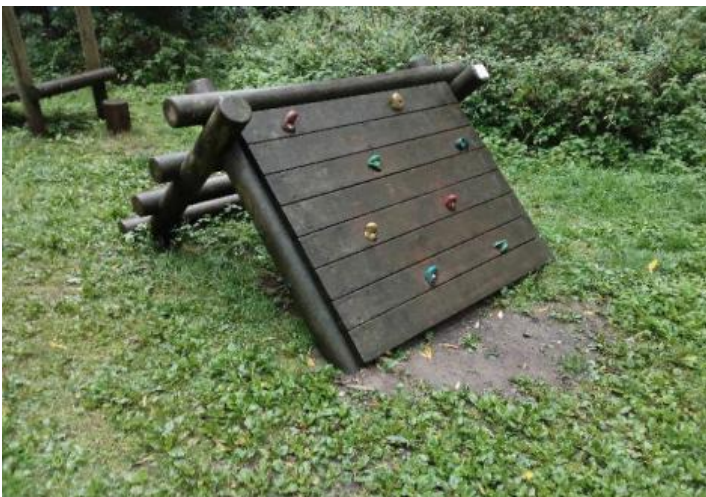
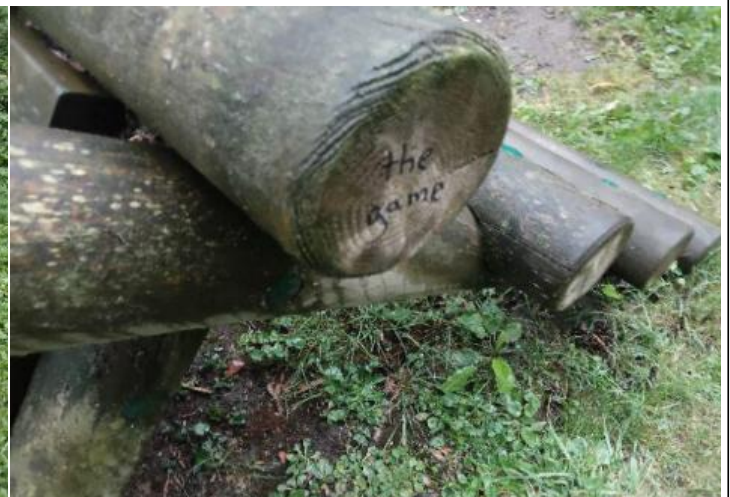
Item: Activity Equipment - A Frame Climber
Manufacturer: Sovereign Leisure

Finding: There is some graffiti present

Action: Remove the graffiti

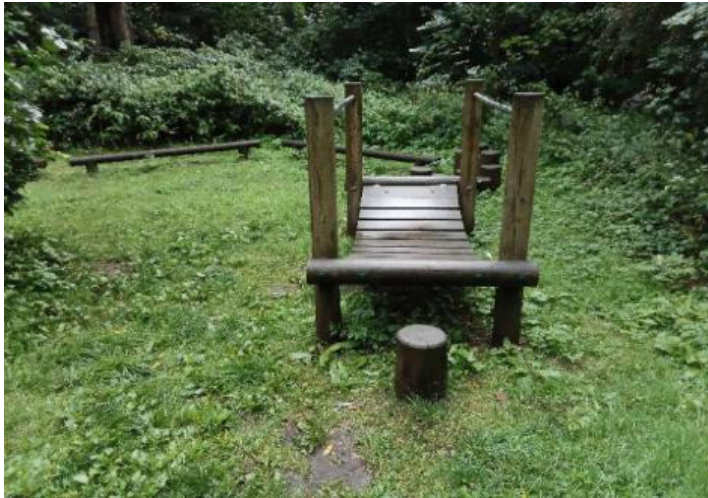
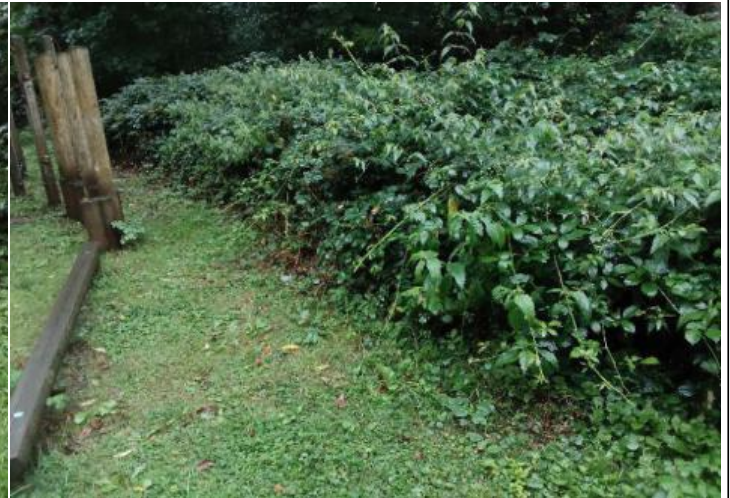
Item: Activity Equipment - Activity Trail
Manufacturer: Sovereign Leisure

Finding: The adjacent foliage is encroaching into the falling space of the equipment
Action: Cut back and maintain to a distance of 1500mm

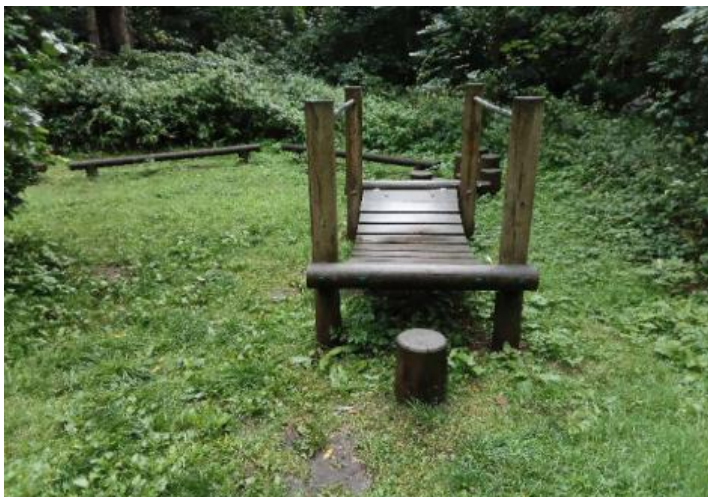
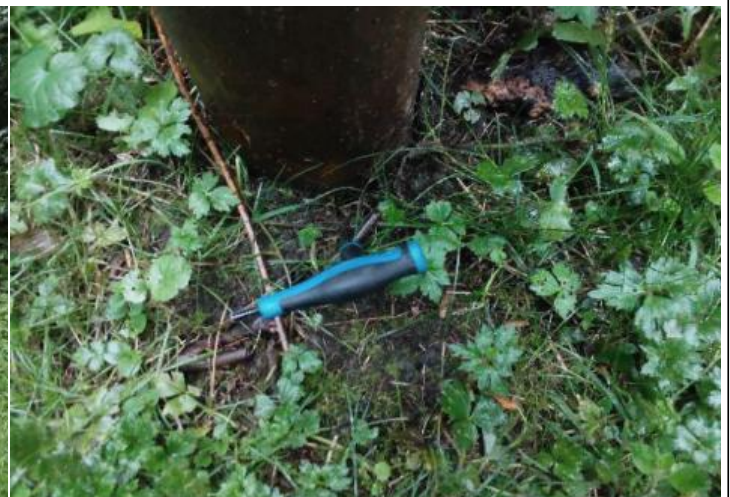
Item: Activity Equipment - Activity Trail
Manufacturer: Sovereign Leisure

Finding: There is some evidence of rot in the timber
Action: Monitor for any further deterioration and replace as required

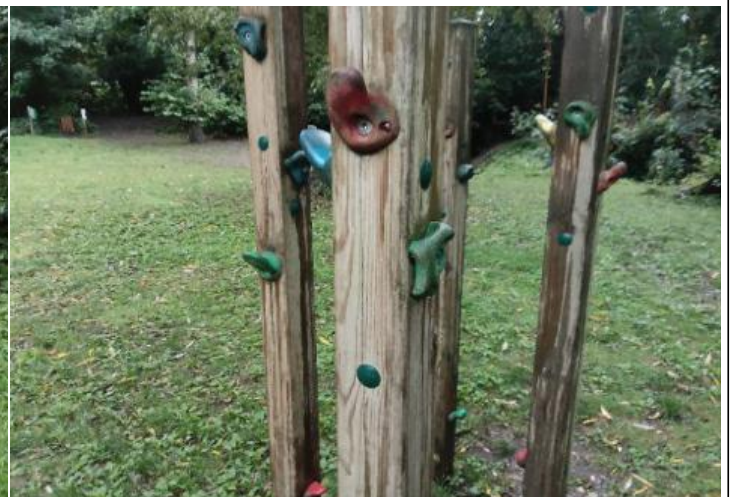
Item: Activity Equipment - Activity Trail
Manufacturer: Sovereign Leisure

Finding: There are loose handgrips / footrests

Action: Secure

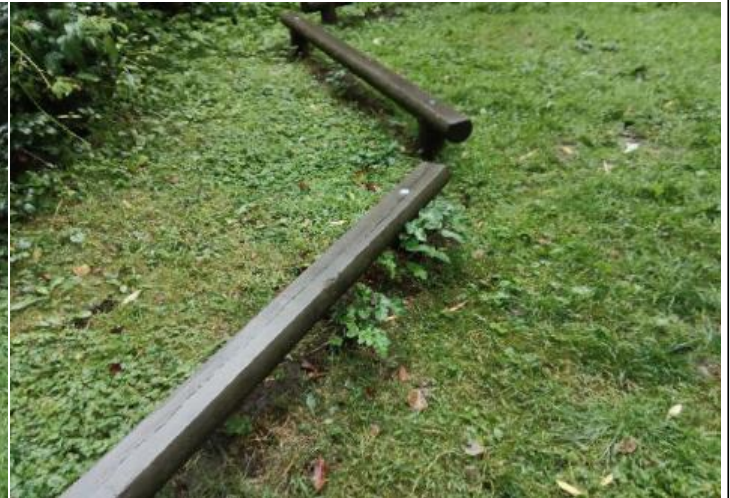
Item: Activity Equipment - Activity Trail
Manufacturer: Sovereign Leisure

Finding: There is weed / vegetation growth within the surface

Action: Remove weed / vegetation growth

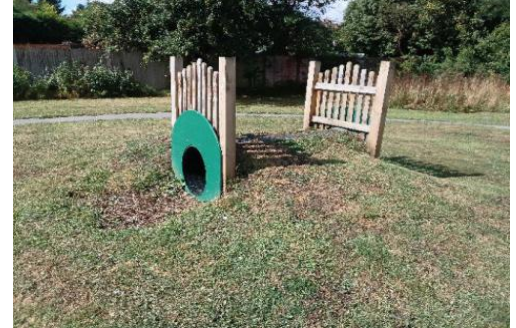
Item: Tunnel Mound
Manufacturer: Not Identified
Surface Type: Mixed Surface
Item Quantity: 1
Equipment Compliance: No
Surface Area Compliance: Yes

The item fails to meet the requirements of BS EN 1176 Part 1 4.2.7.2 for head and neck entrapment in the barriers - Monitor - No action given the risk assessment

The surface has eroded in some areas and may be slippery in wet conditions - Reinststate the surface

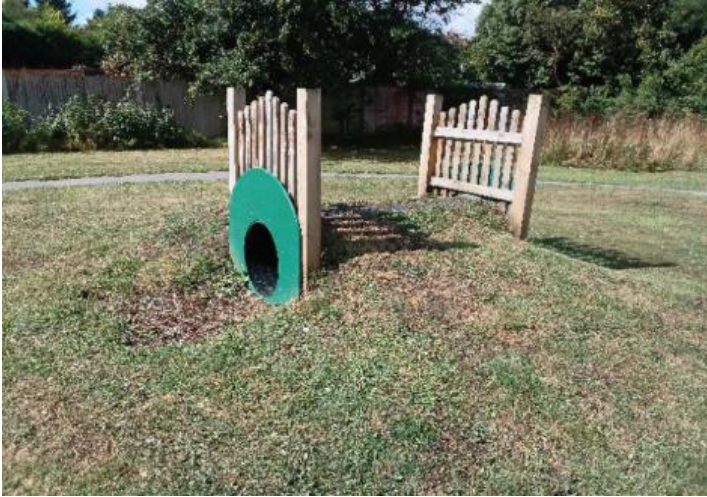
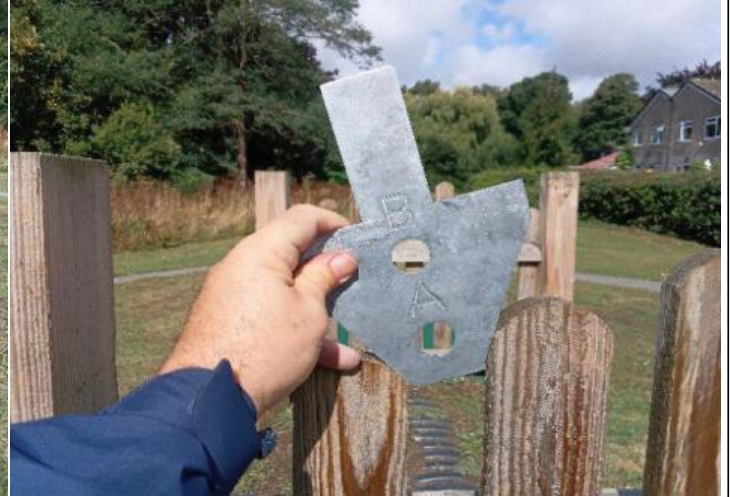
Item: Other - Tunnel Mound
Manufacturer: Not Identified

Finding: The item fails to meet the requirements of BS EN 1176 Part 1 4.2.7.2 for head and neck entrapment in the barriers

Action: Monitor - No action given the risk assessment

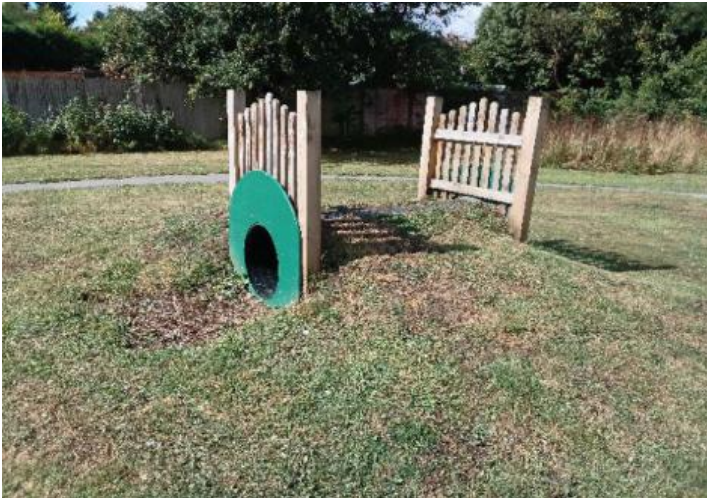
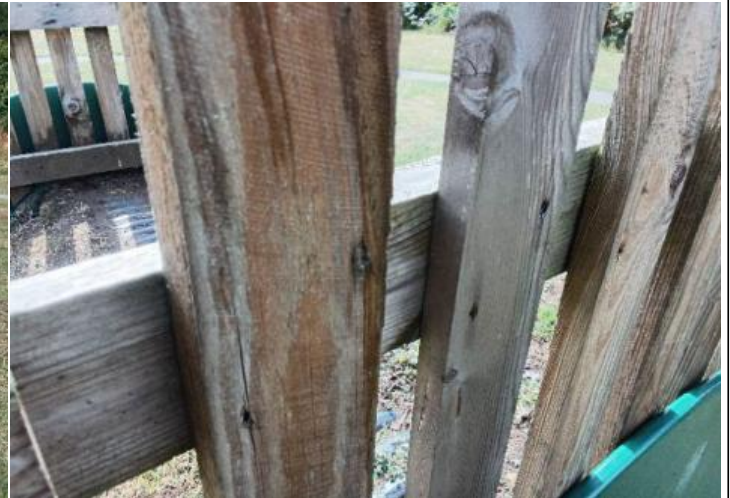
Item: Other - Tunnel Mound
Manufacturer: Not Identified

Finding: Parts of the timber are rough or splintered

Action: Remove all rough or sharp edges

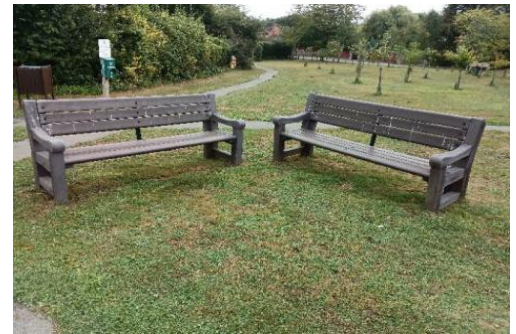
There is bird excrement on the bench - Clean and maintain area

There is/are bolt cap covers missing or damaged on the item - Replace missing or damaged bolt cap covers

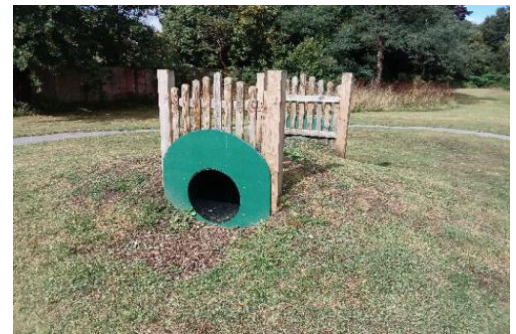
Parts of the timber are rough or splintered - Remove all rough or sharp edges

The item fails to meet the requirements of BS EN 1176 Part 1 4.2.7.2 for head and neck entrapment in the barriers - Monitor - No action given the risk assessment

There is some damage to the barrier timbers - Monitor for any further deterioration and repair as required

The surface has eroded in some areas and may be slippery in wet conditions - Reinstate the surface

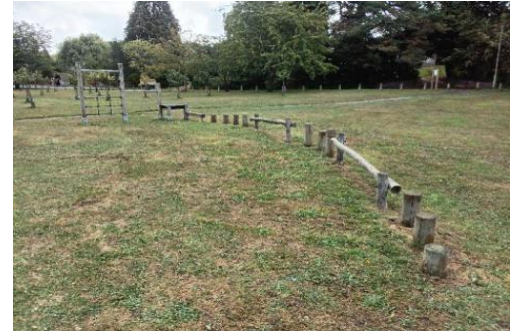
There is some strimmer / machinery damage apparent on the posts, this can penetrate the preservative applied to the timber and accelerate the rotting process - Monitor for any deterioration (rot) and replace as required

A number of fixing(s) have worked loose - Secure all loose fixings

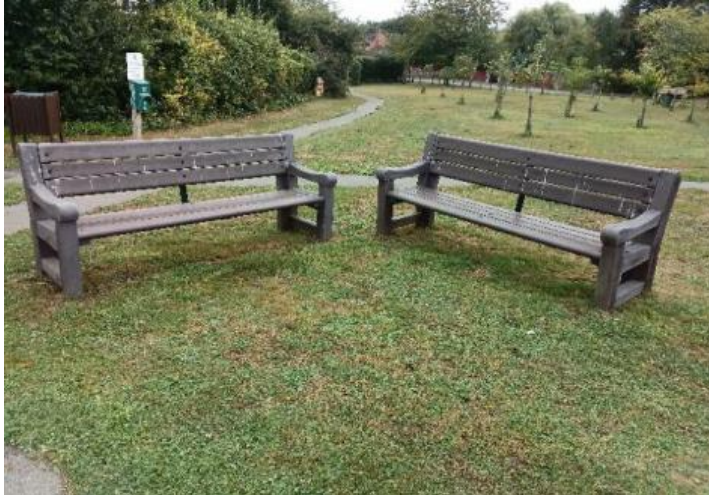
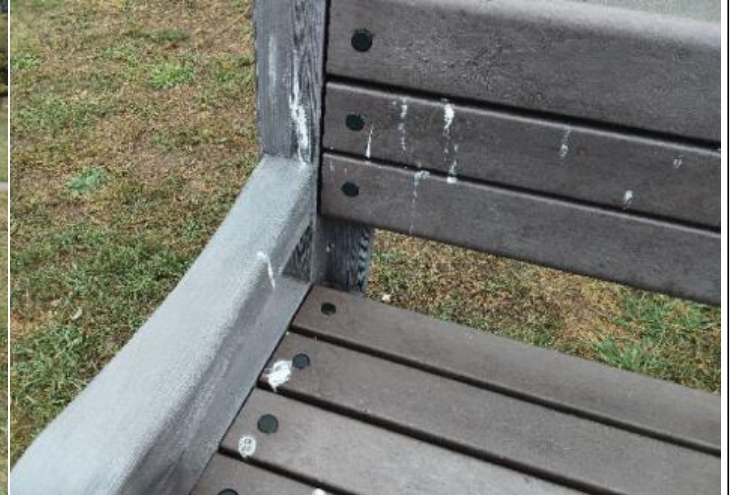
Finding: There is bird excrement on the bench

Action: Clean and maintain area

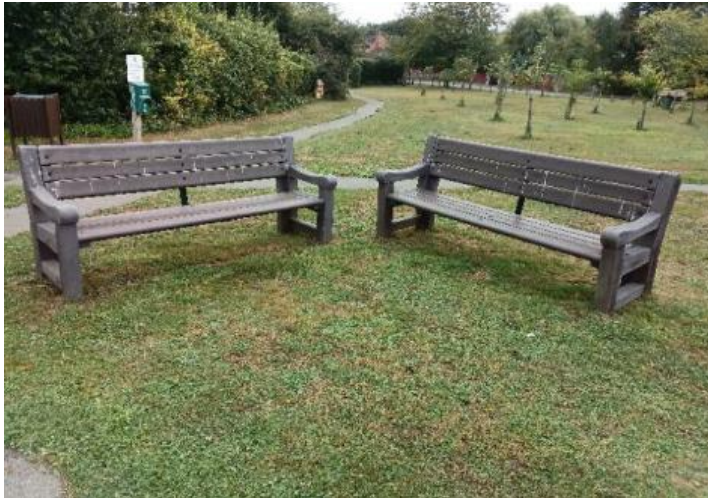
Finding: There is/are bolt cap covers missing or damaged on the item

Action: Replace missing or damaged bolt cap covers

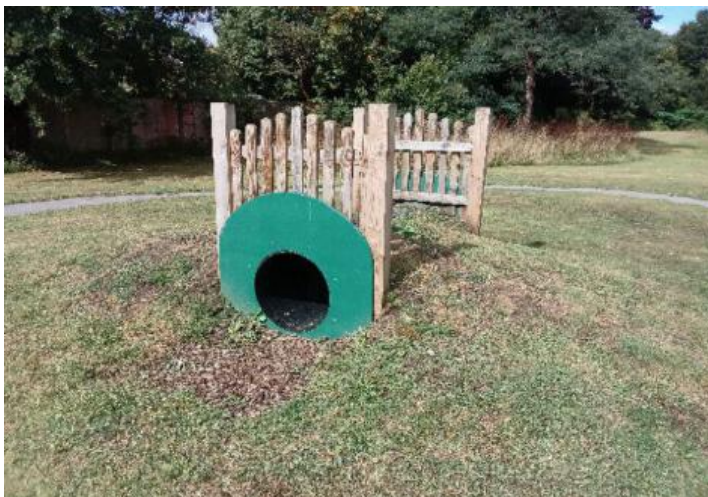
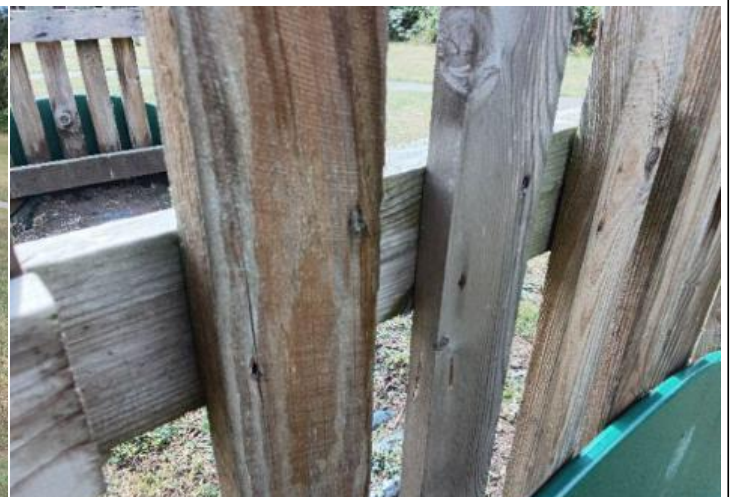
Finding: Parts of the timber are rough or splintered

Action: Remove all rough or sharp edges

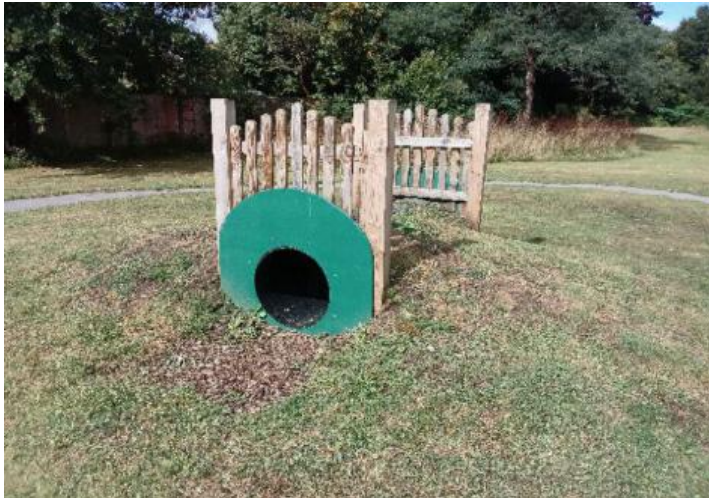
Finding: There is some damage to the barrier timbers

Action: Monitor for any further deterioration and repair as required

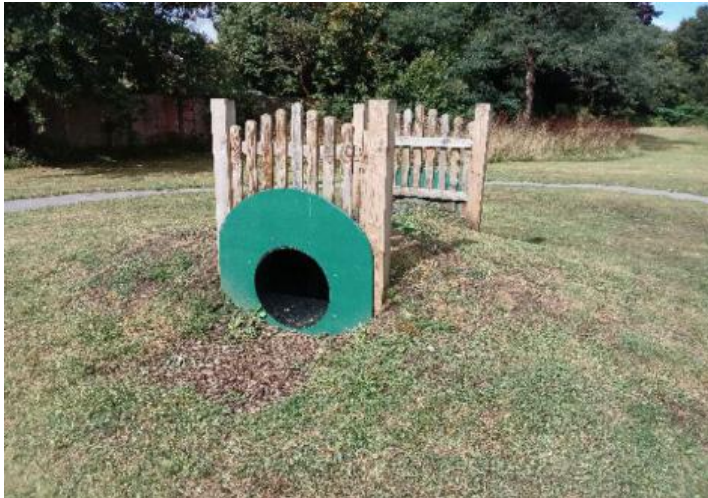
Finding: The item fails to meet the requirements of BS EN 1176 Part 1 4.2.7.2 for head and neck entrapment in the barriers

Action: Monitor - No action given the risk assessment

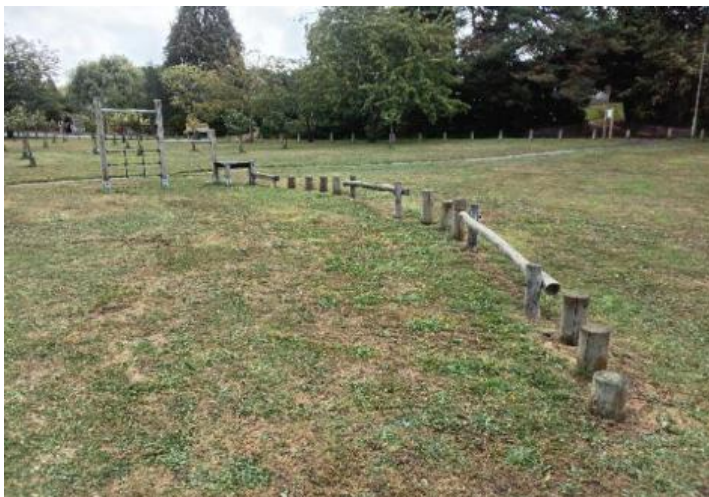
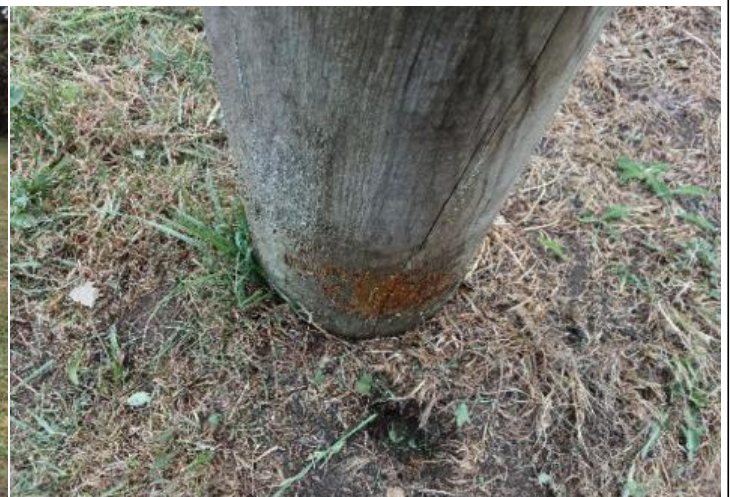
Finding: There is some strimmer / machinery damage apparent on the posts, this can penetrate the preservative applied to the timber and accelerate the rotting process
Action: Monitor for any deterioration (rot) and replace as required

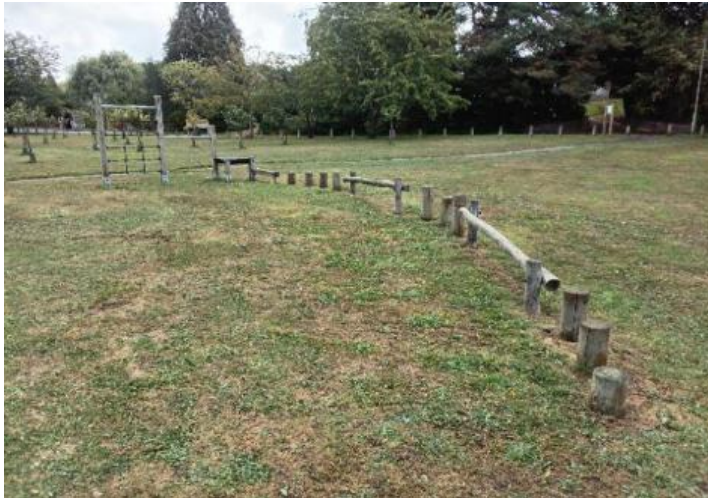
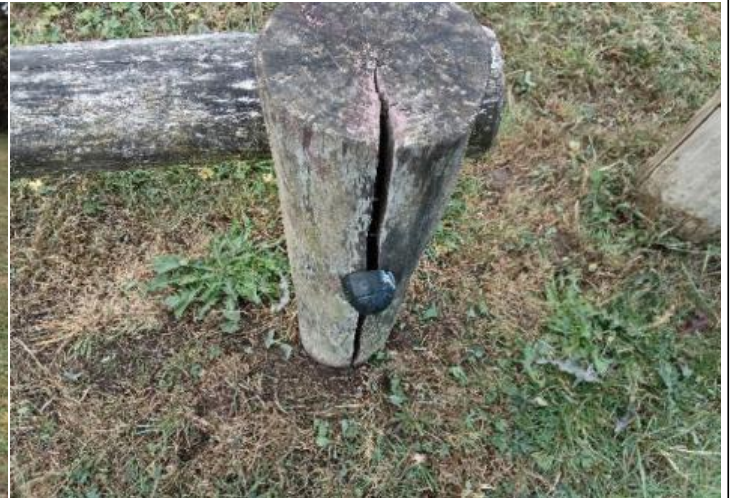
Finding: There are splits running through the timber

Action: Monitor and ensure any rough or splintering edges are sanded down

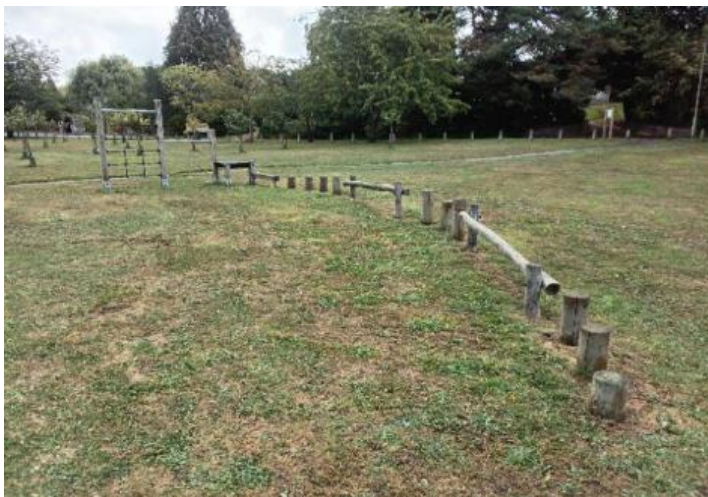
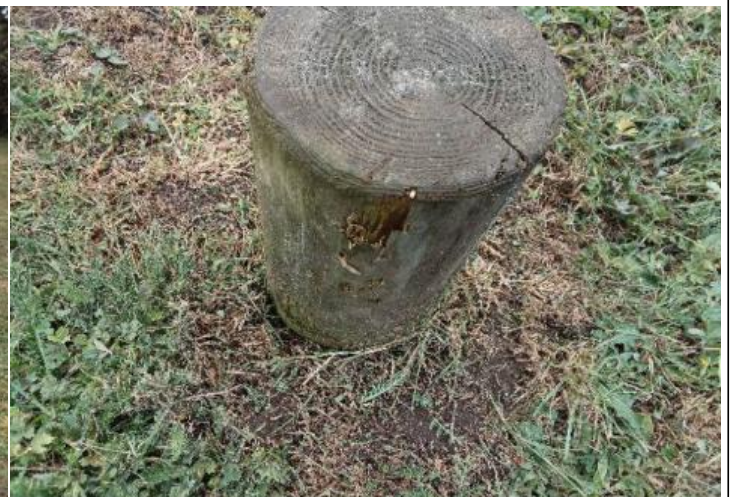
Finding: Parts of the timber are rough or splintered

Action: Remove all rough or sharp edges

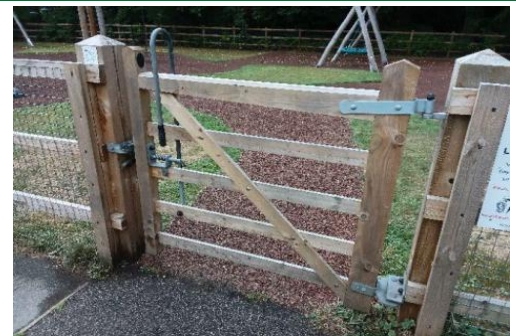
There are openings that are less than 12mm that could trap or crush fingers - Provide a 12mm gap throughout full range of motion at both sides of gate

The timber has a number of splits/shakes or air cracks and this may affect the stability or allow water ingress which will accelerate the rotting process. Timber splits may also create rough / splintering edges. - Monitor, sand down any rough edges and ensure the splits do not cross through fixing points of the structure and/or cause any instability

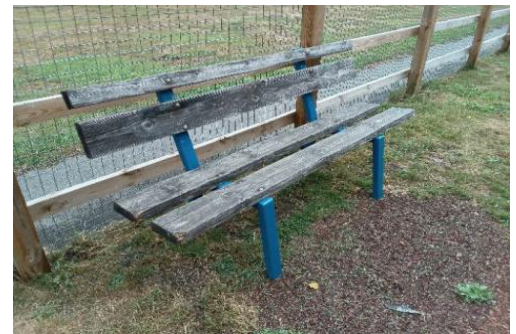
Parts of the timber are rough or splintered - Remove all rough or sharp edges

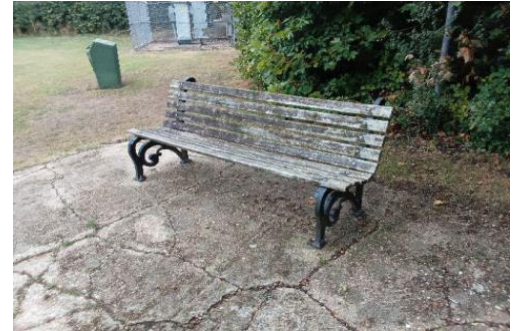
There is moderate damage to the concrete pad - Repair the damaged areas of surfacing

There is/are a number of missing or damaged slats. - Repair or Replace as required

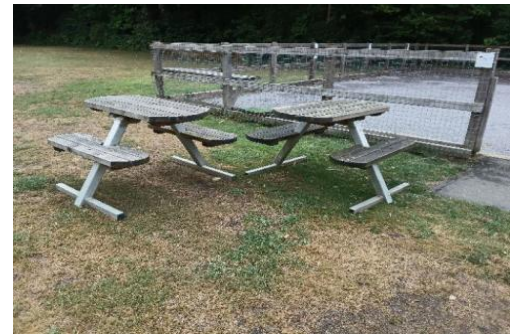
The table/s is/are not secured to the ground and there is some potential for the item/s to be moved within falling spaces of equipment - Secure to the ground

There are missing end caps - Replace

There are missing timbers - Replace

There is some evidence of rot in the timber - Monitor for any further deterioration and replace as required

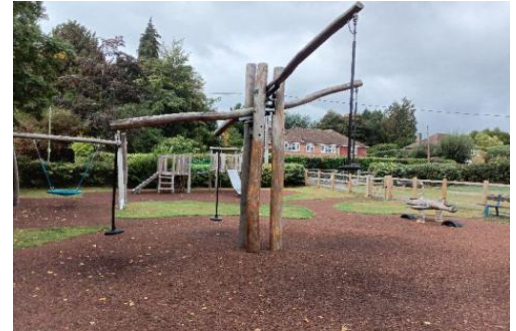
NOTE - The fixings or components for this item were in excess of 2.5m above the standing surface and could not be fully accessed by the inspector. We have completed a visual inspection of the fixings from ground level but a maintenance inspection should be undertaken to assess the condition, security and wear of the components at intervals in accordance with the manufacturers recommendations. - Inspect in accordance with the manufacturers recommendations

There is some notable evidence of chain wear - Monitor for any further deterioration and replace when 40% worn

The chain openings are in excess of the 8.6mm as recommended by BS EN 1176 - Monitor - No action given the risk assessment

The seat connection cannot be inspected without dismantling the seat - Dismantle the seat to inspect the seat connection for wear

There is some play within the pivot mechanism - Monitor for any further deterioration and repair as required

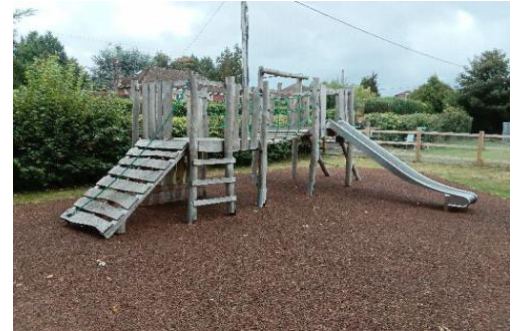
There is some evidence of rot in the timber - Monitor for any further deterioration and replace as required

The item fails to meet the requirements of BS EN 1176 Part 1 4.2.7.2 for head and neck entrapment between the ladder rung and platform - Monitor - No action given the risk assessment

The connecting links are in excess of 8.6mm and less than 12mm and fail the requirements of BS EN 1176 Part 1; clause 4.2.13, Chains - Monitor - No action given the risk assessment

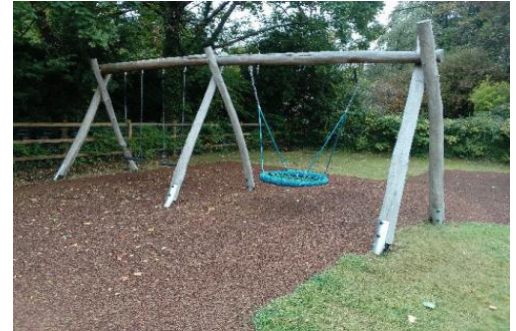
This design of swing joint has been known to fail on the weld connecting the joint to the threaded stud - We would recommend that the joint be dismantled and checked on a regular basis or consulting with manufacturer on whether a Secondary Safety Device can be fitted

The connecting links are in excess of 8.6mm and less than 12mm and fail the requirements of BS EN 1176 Part 1; clause 4.2.13, Chains - Monitor - No action given the risk assessment

The bush / bushes is / are showing signs of wear - Monitor for any further deterioration and replace as required

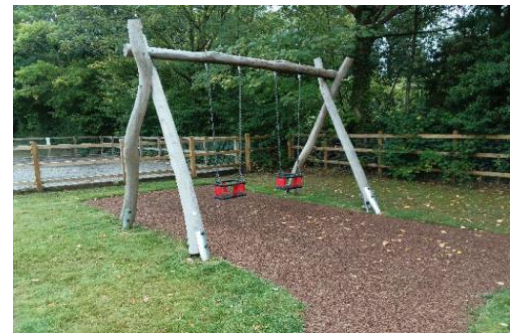
This design of swing joint has been known to fail on the weld connecting the joint to the threaded stud - We would recommend that the joint be dismantled and checked on a regular basis or consulting with manufacturer on whether a Secondary Safety Device can be fitted

The chain openings are in excess of the 8.6mm as recommended by BS EN 1176 - Monitor - No action given the risk assessment

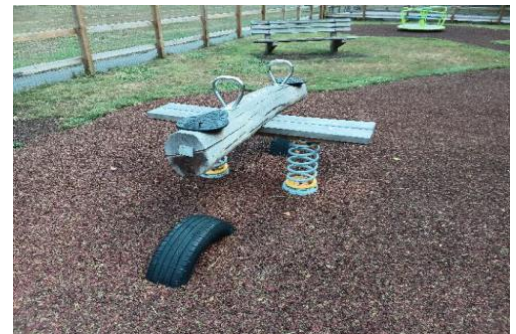
There are splits running through the timber - Monitor and ensure any rough or splintering edges are sanded down

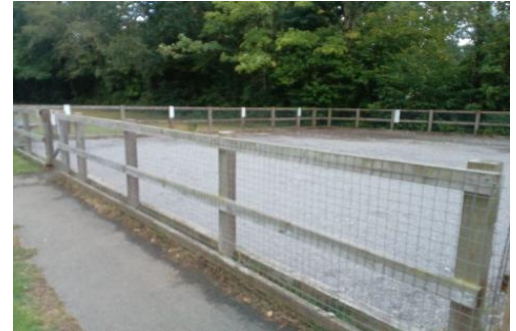
There are gate openings that are less than 12mm that could trap or crush fingers - Provide a 12mm gap throughout full range of motion at both sides of gate

A number of gate hinge fixing(s) have worked loose - Secure all loose fixings

There are trip hazards at the edges of the surface - Remove trip hazard

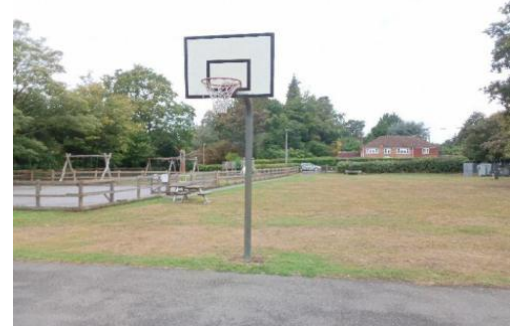
The net is damaged - Replace / remove net

The paintwork on this item has been damaged or worn exposing the metal underneath which is rusting / corroding - Treat affected areas and repaint

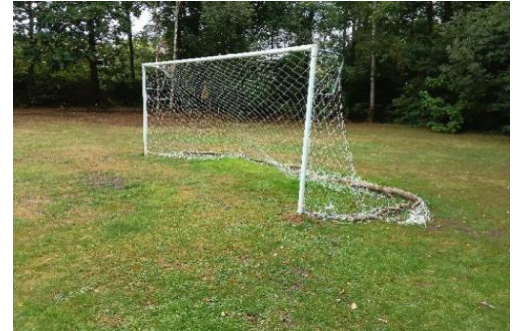
NB: We have undertaken a maintenance inspection only of the football goal(s); full load testing falls outside the scope of our inspection. - Implement load testing as required

The posts are slightly loose in the ground - Monitor for any further deterioration and repair as required

The nets are damaged - Replace

The net is loose and has been secured by tree branches - Remove branches and secure net

The paintwork on this item has been damaged or worn exposing the metal underneath which is rusting / corroding - Treat affected areas and repaint

There are missing net connectors - Replace

The surface has eroded in some areas and may be slippery in wet conditions - Reinstate the surface

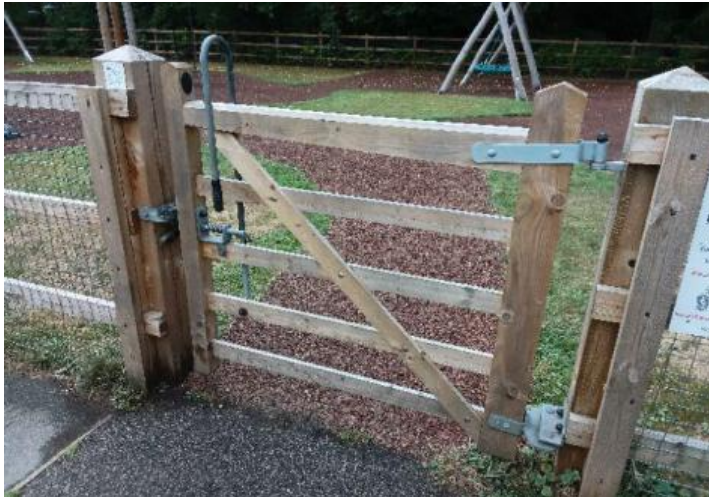
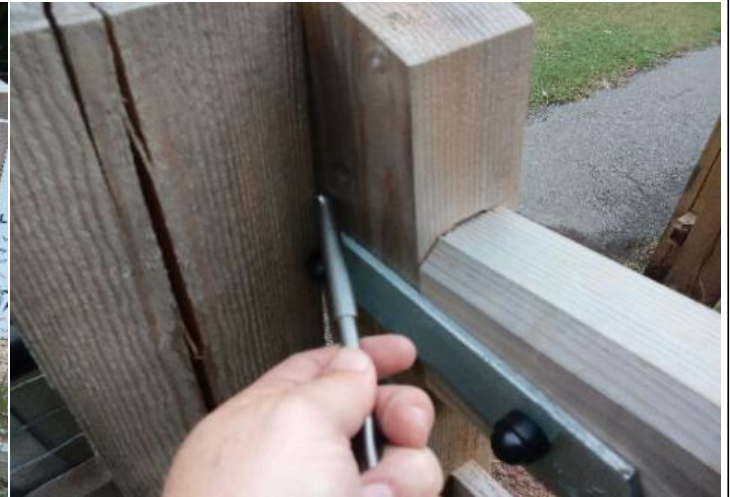
Finding: There are openings that are less than 12mm that could trap or crush fingers

Finding: The timber has a number of splits/shakes or air cracks and this may affect the stability or allow water ingress which will accelerate the rotting process. Timber splits may also create rough / splintering edges.

Action: Provide a 12mm gap throughout full range of motion at both sides of gate

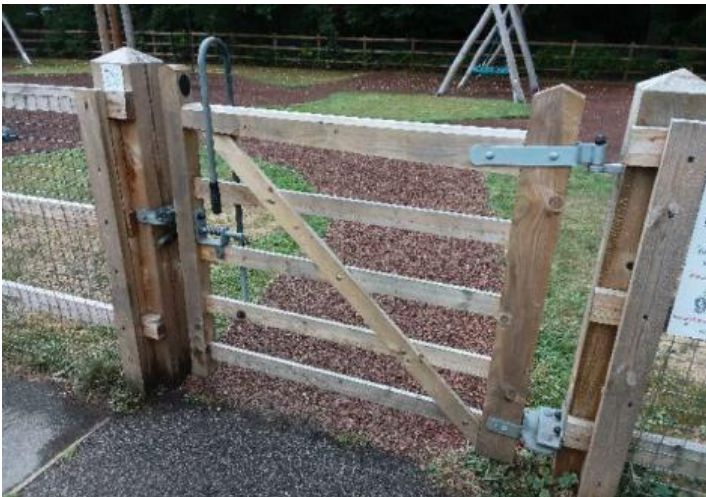
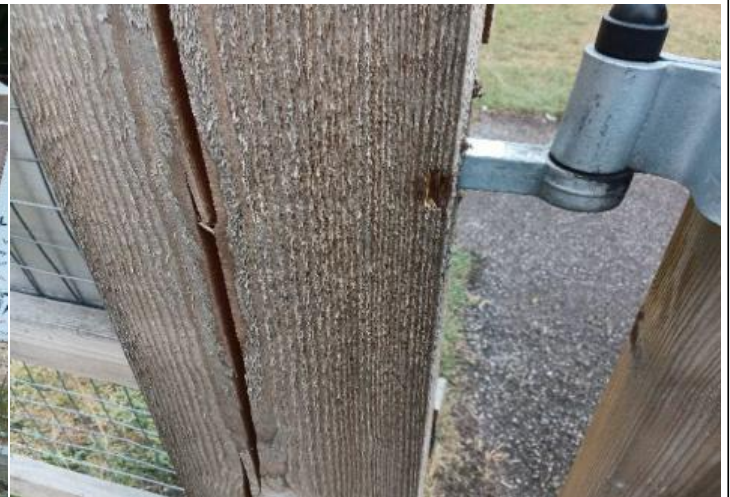
Item: Gates - Gate
Manufacturer: Not Identified

Finding: Parts of the timber are rough or splintered

Action: Remove all rough or sharp edges
