LISS PARISH COUNCIL

Minutes of the meeting of the Facilities Committee held on 14th July 2025, 7pm,
Village Hall

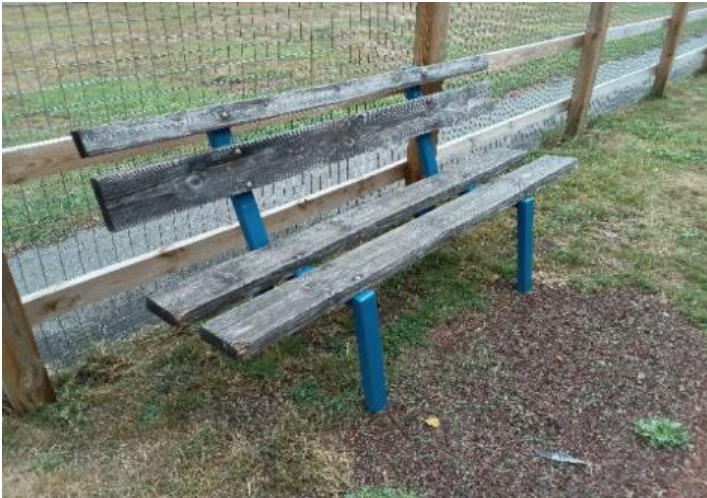
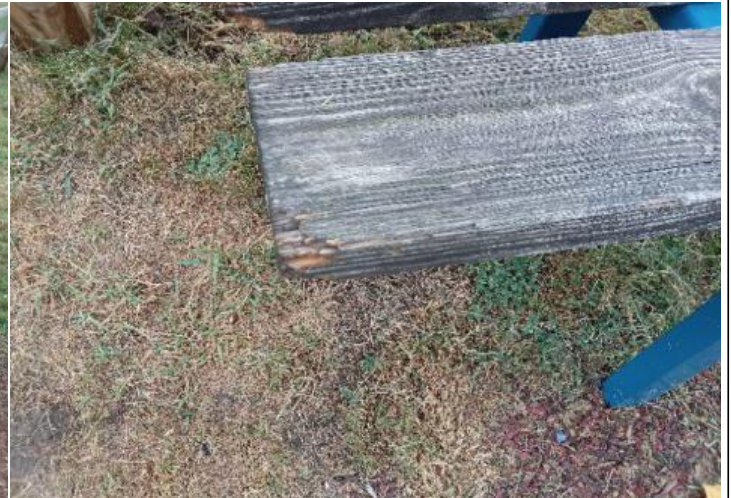
Item: Ancillary Items - Bench
Manufacturer: Not Identified

Finding: Parts of the timber are rough or splintered

Action: Remove all rough or sharp edges

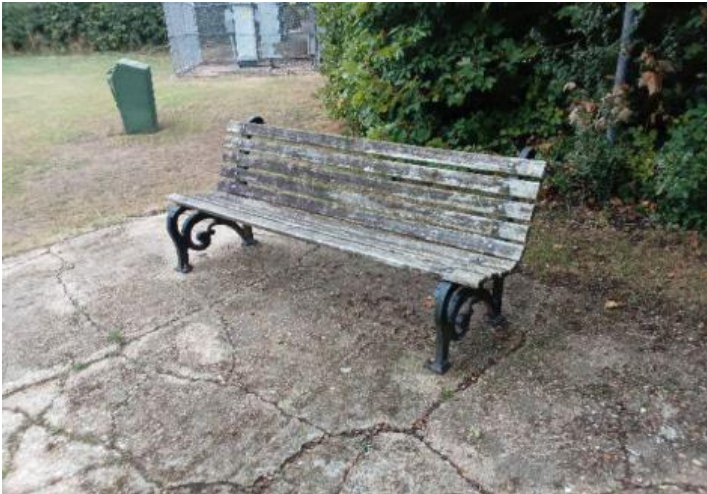
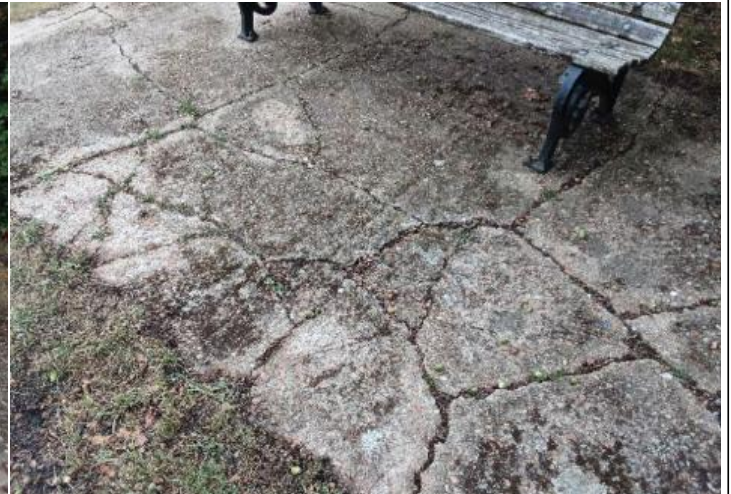
Item: Ancillary Items - Bench
Manufacturer: Not Identified

There is moderate damage to the concrete pad - Repair the damaged areas of surfacing

Finding: There is moderate damage to the concrete pad

Action: Repair the damaged areas of surfacing

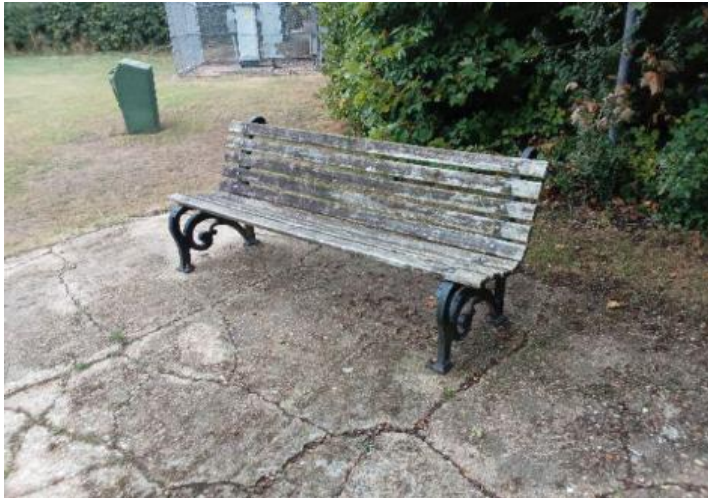
Item: Ancillary Items - Bench
Manufacturer: Not Identified

There is/are a number of missing or damaged slats. - Repair or Replace as required

Finding: There is/are a number of missing or damaged slats.

Action: Repair or Replace as required

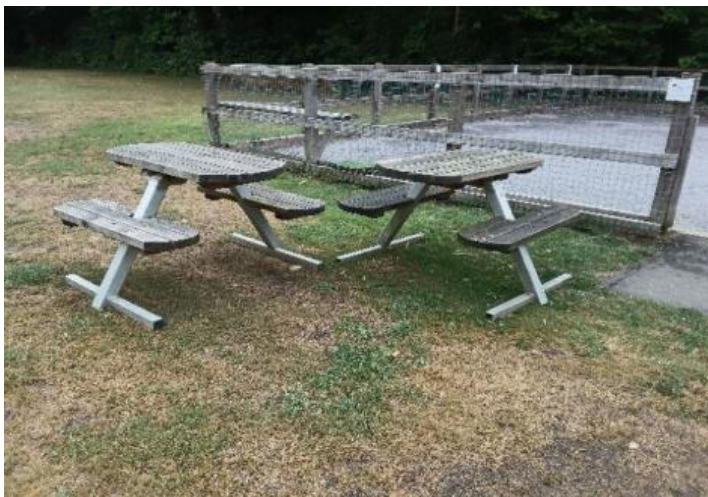
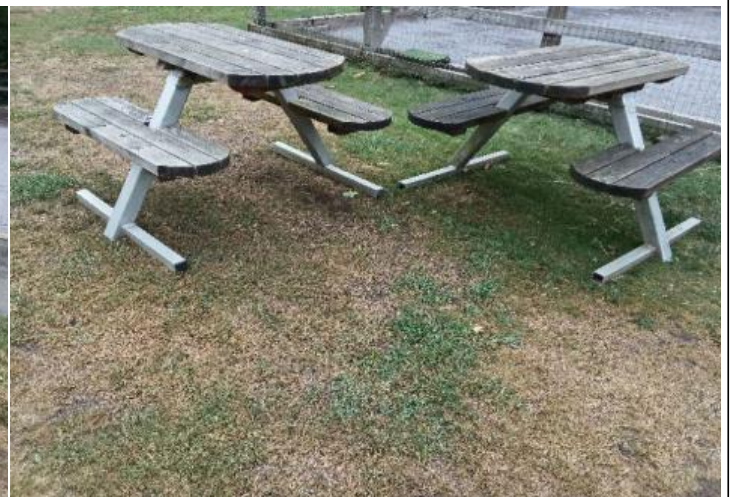
Item: Ancillary Items - Picnic Table
Manufacturer: Not Identified

Finding: The table/s is/are not secured to the ground and there is some potential for the item/s to be moved within falling spaces of equipment

Action: Secure to the ground

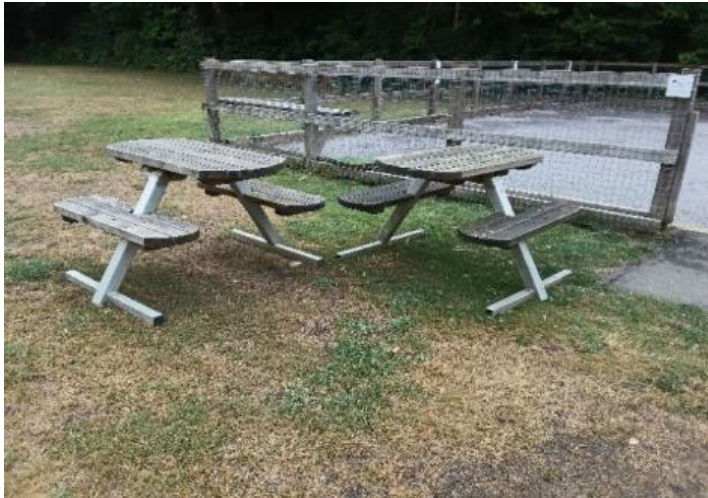
Item: Ancillary Items - Picnic Table
Manufacturer: Not Identified

There are missing end caps - Replace

Finding: There are missing end caps

Action: Replace

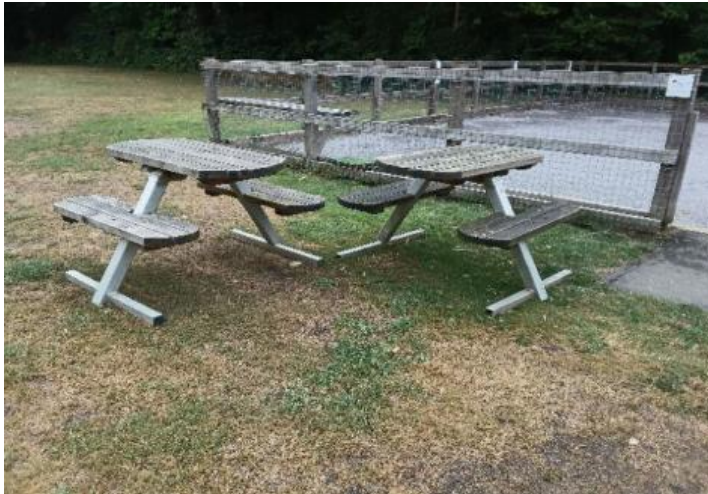
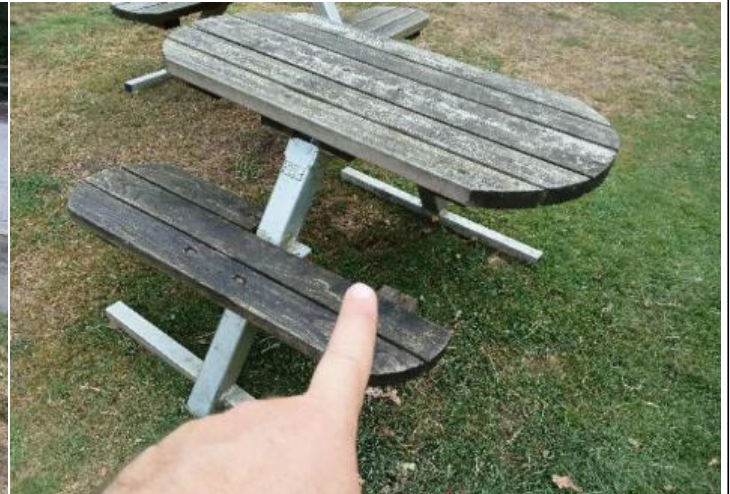
Item: Ancillary Items - Picnic Table
Manufacturer: Not Identified

There are missing timbers - Replace

Finding: There are missing timbers

Action: Replace

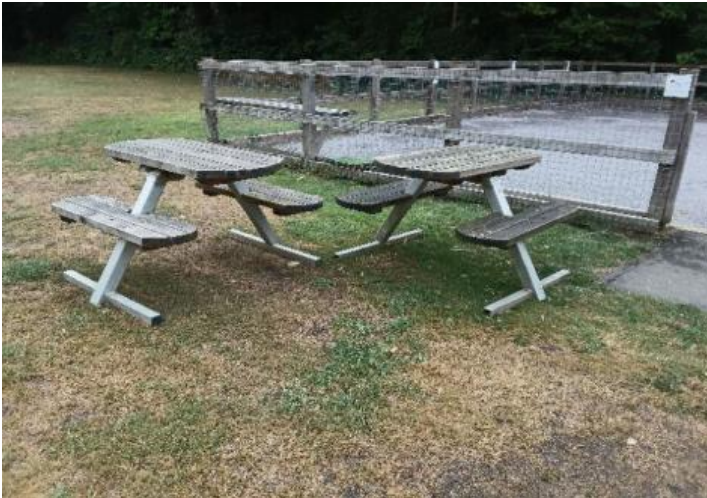
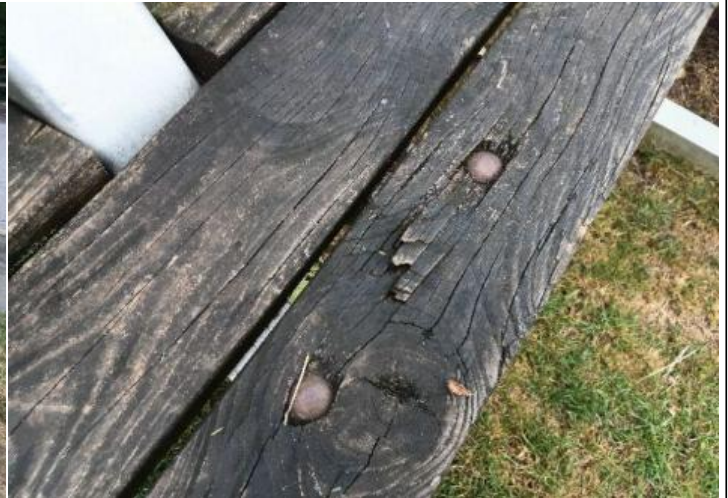
Item: Ancillary Items - Picnic Table
Manufacturer: Not Identified

Finding: Parts of the timber are rough or splintered

Action: Remove all rough or sharp edges

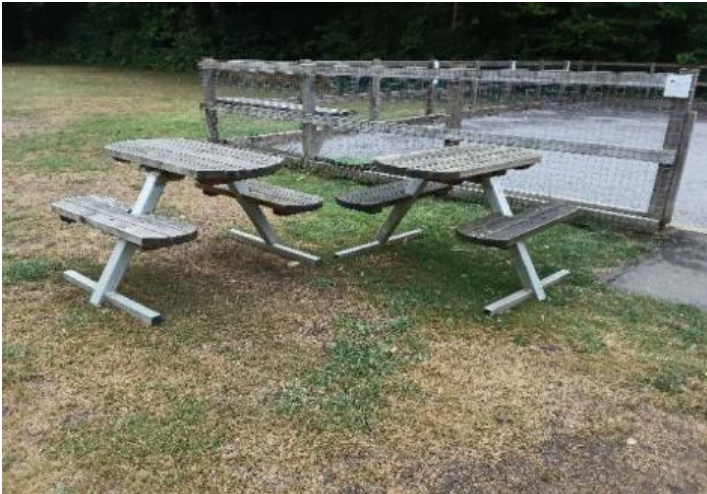
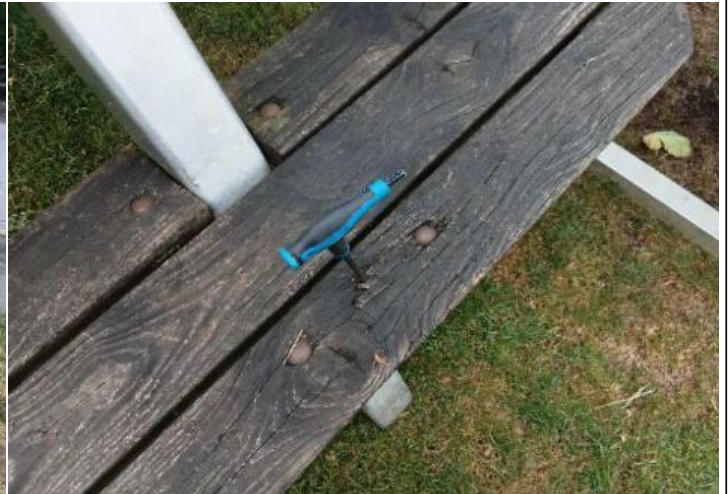
Item: Ancillary Items - Picnic Table
Manufacturer: Not Identified

There is some evidence of rot in the timber - Monitor for any further deterioration and replace as required

Finding: There is some evidence of rot in the timber

Action: Monitor for any further deterioration and replace as required

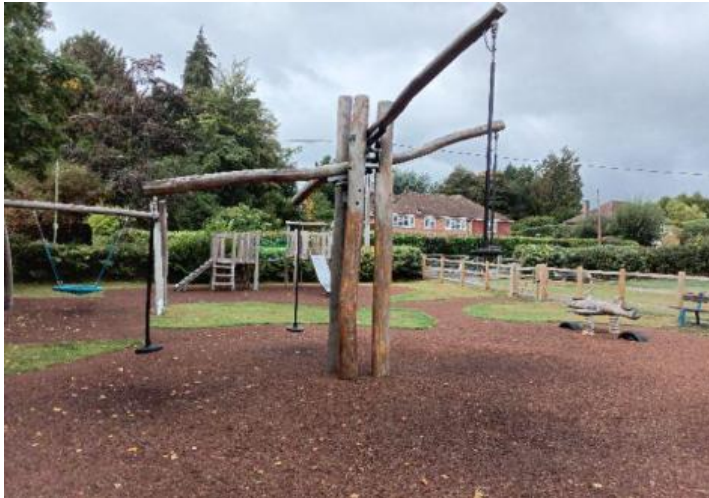
Item: Rocking Equipment - Overhead See Saw
Manufacturer: Playsafe Playgrounds

NOTE - The fixings or components for this item were in excess of 2.5m above the standing surface and could not be fully accessed by the inspector. We have completed a visual inspection of the fixings from ground level but a maintenance inspection should be undertaken to assess the condition, security and wear of the components at intervals in accordance with the manufacturers recommendations. - Inspect in accordance with the manufacturers recommendations

Finding: NOTE - The fixings or components for this item were in excess of 2.5m above the standing surface and could not be fully accessed by the inspector. We have completed a visual inspection of the fixings from ground level but a maintenance inspection should be undertaken to assess the condition, security and wear of the components at intervals in accordance with the manufacturers recommendations.

Action: Inspect in accordance with the manufacturers recommendations

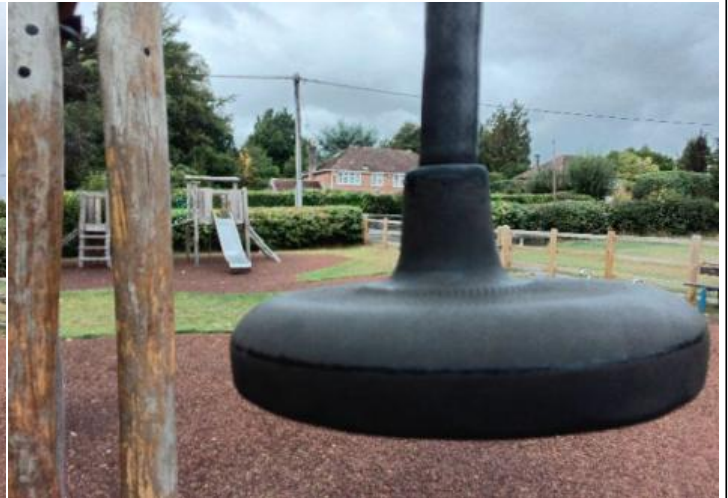
Item: Rocking Equipment - Overhead See Saw
Manufacturer: Playsafe Playgrounds

The seat connection cannot be inspected without dismantling the seat - Dismantle the seat to inspect the seat connection for wear

Finding: The seat connection cannot be inspected without dismantling the seat

Action: Dismantle the seat to inspect the seat connection for wear

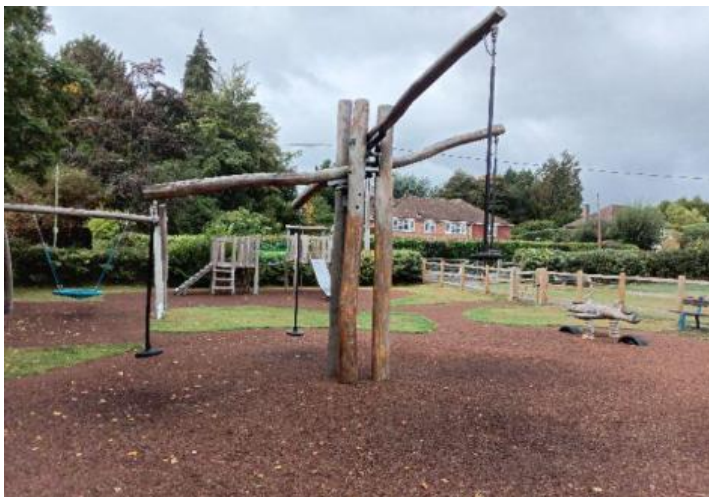
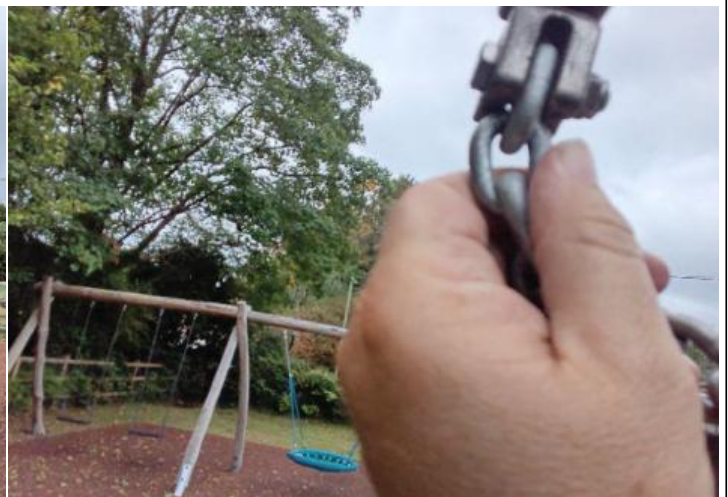
Item: Rocking Equipment - Overhead See Saw
Manufacturer: Playsafe Playgrounds

There is some notable evidence of chain wear - Monitor for any further deterioration and replace when 40% worn

Finding: There is some notable evidence of chain wear

Action: Monitor for any further deterioration and replace when 40% worn

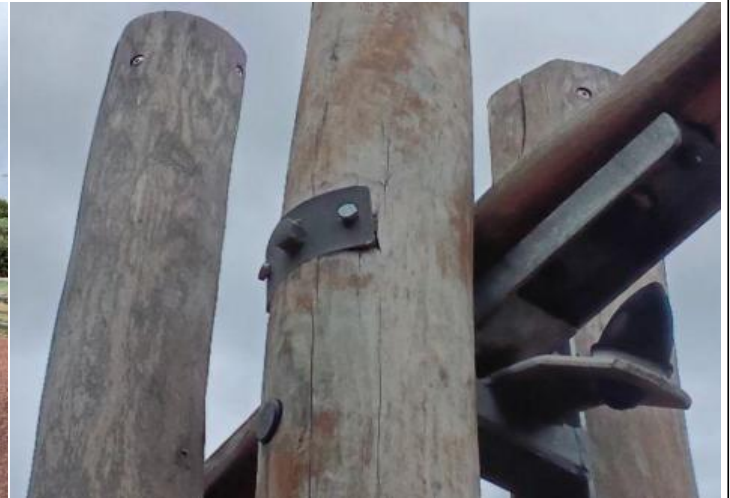
Item: Rocking Equipment - Overhead See Saw
Manufacturer: Playsafe Playgrounds

Finding: The fixings are not flush with the fixing plate

Action: Realign fixings

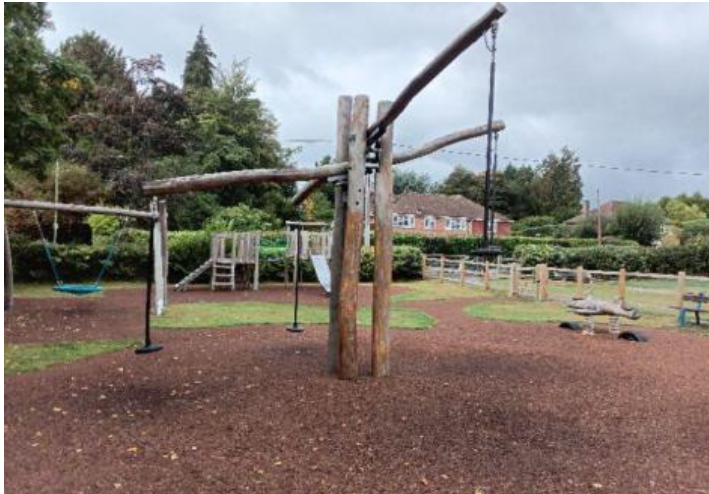
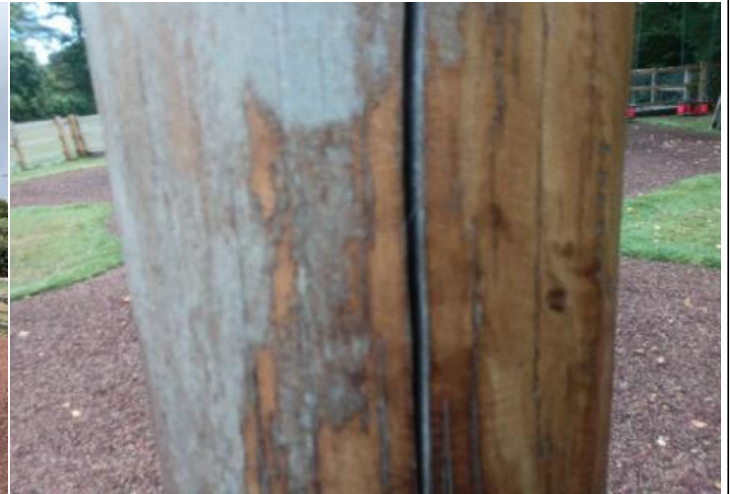
Item: Rocking Equipment - Overhead See Saw
Manufacturer: Playsafe Playgrounds

Finding: There are splits running through the timber

Action: Monitor and ensure any rough or splintering edges are sanded down

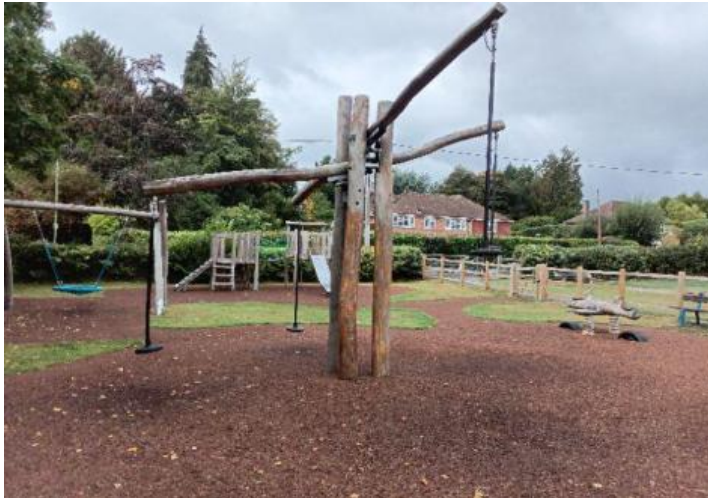
Item: Rocking Equipment - Overhead See Saw
Manufacturer: Playsafe Playgrounds

There is some play within the pivot mechanism - Monitor for any further deterioration and repair as required

Finding: There is some play within the pivot mechanism

Action: Monitor for any further deterioration and repair as required

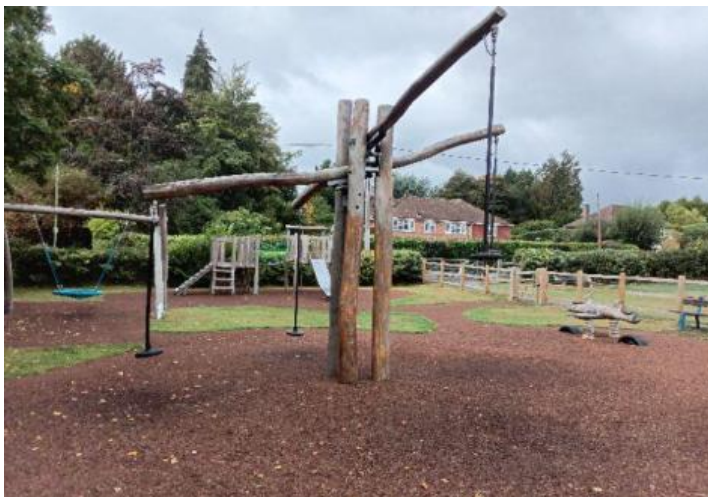
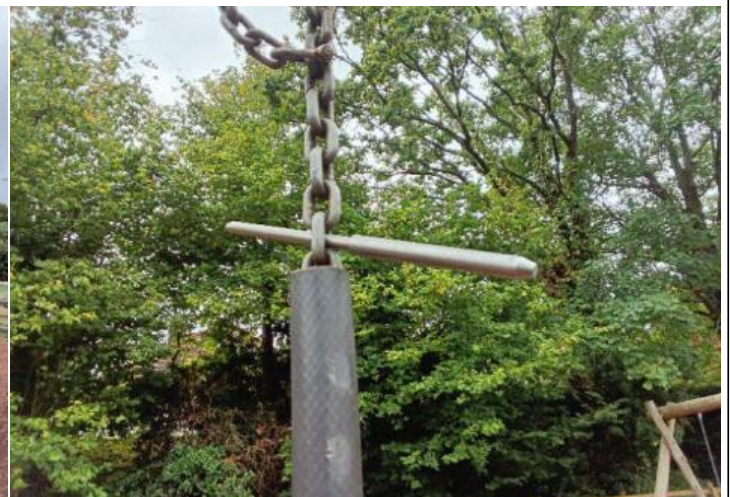
Item: Rocking Equipment - Overhead See Saw
Manufacturer: Playsafe Playgrounds

The chain openings are in excess of the 8.6mm as recommended by BS EN 1176 - Monitor - No action given the risk assessment

Finding: The chain openings are in excess of the 8.6mm as recommended by BS EN 1176

Action: Monitor - No action given the risk assessment

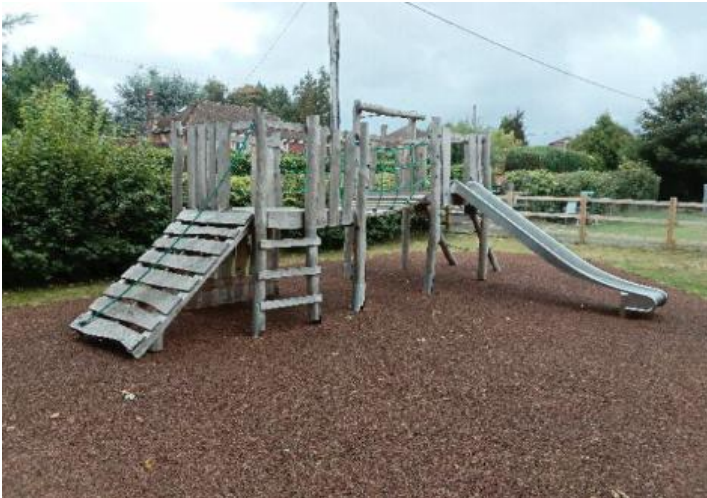
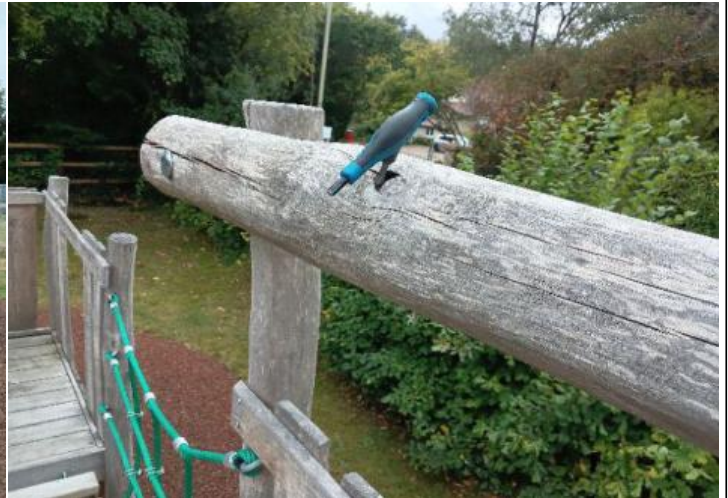
Item: Activity Equipment - Multi Play (Junior)
Manufacturer: Sawscapes Play

There is some evidence of rot in the timber - Monitor for any further deterioration and replace as required

Finding: There is some evidence of rot in the timber

Action: Monitor for any further deterioration and replace as required

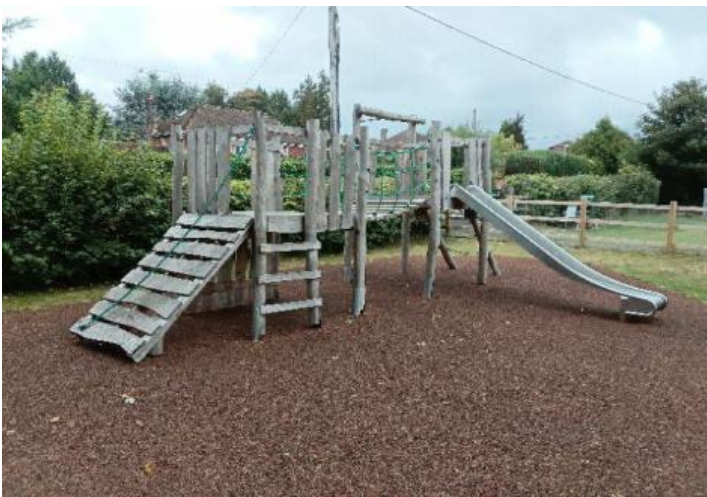
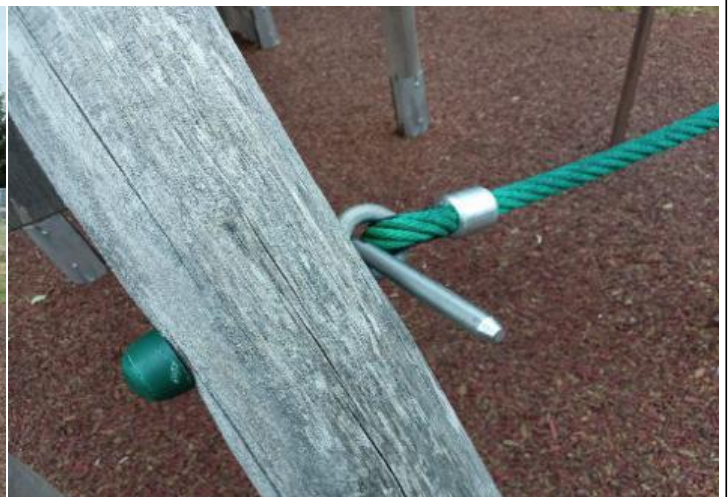
Item: Activity Equipment - Multi Play (Junior)
Manufacturer: Sawscapes Play

The connecting links are in excess of 8.6mm and less than 12mm and fail the requirements of BS EN 1176 Part 1; clause 4.2.13, Chains - Monitor - No action given the risk assessment

Finding: The connecting links are in excess of 8.6mm and less than 12mm and fail the requirements of BS EN 1176 Part 1; clause 4.2.13, Chains

Action: Monitor - No action given the risk assessment

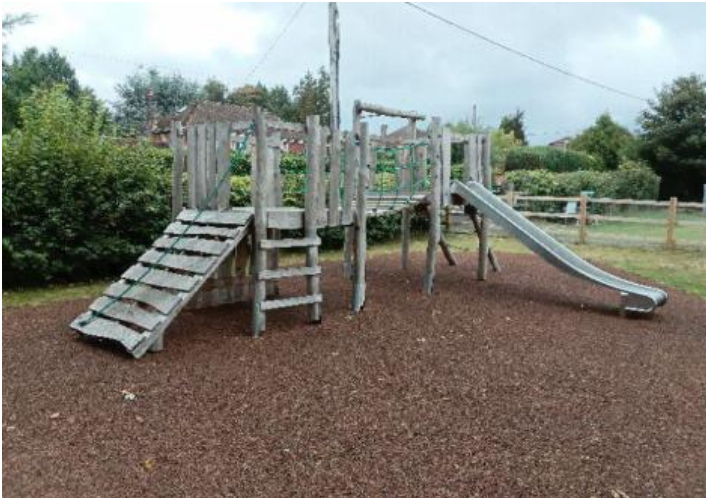
Item: Activity Equipment - Multi Play (Junior)
Manufacturer: Sawscapes Play

The item fails to meet the requirements of BS EN 1176 Part 1 4.2.7.2 for head and neck entrapment between the ladder rung and platform - Monitor - No action given the risk assessment

Finding: The item fails to meet the requirements of BS EN 1176 Part 1 4.2.7.2 for head and neck entrapment between the ladder rung and platform

Action: Monitor - No action given the risk assessment

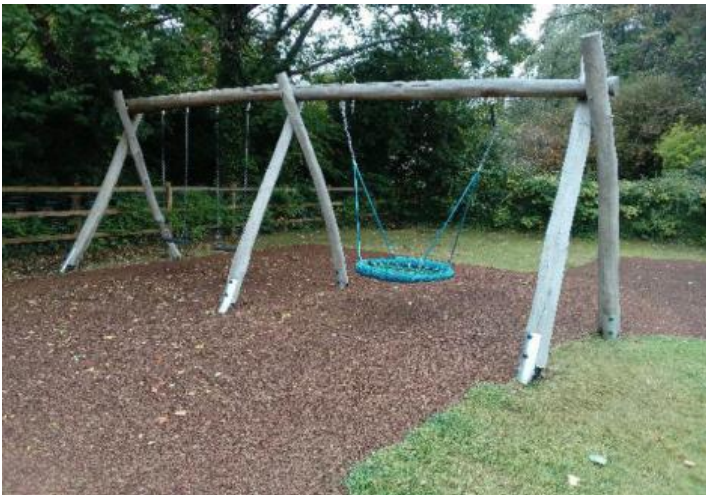
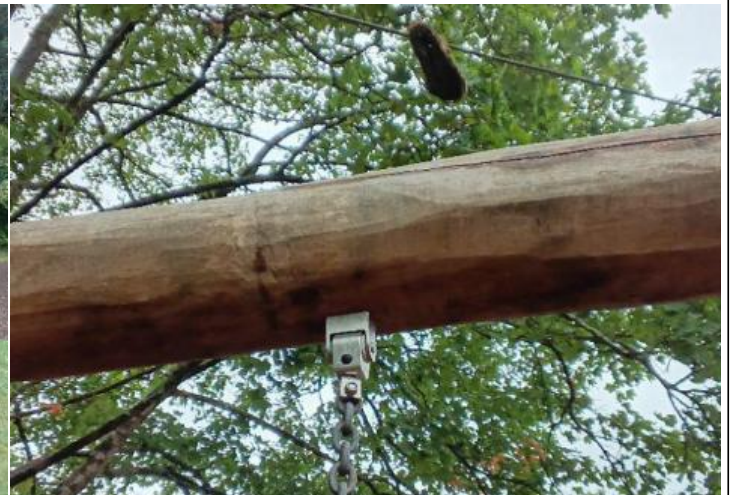
Item: Swings - 2 Bay 2 Flat 1 Basket Seat
Manufacturer: Sawscapes Play

This design of swing joint has been known to fail on the weld connecting the joint to the threaded stud - We would recommend that the joint be dismantled and checked on a regular basis or consulting with manufacturer on whether a Secondary Safety Device can be fitted

Finding: This design of swing joint has been known to fail on the weld connecting the joint to the threaded stud

Action: We would recommend that the joint be dismantled and checked on a regular basis or consulting with manufacturer on whether a Secondary Safety Device can be fitted

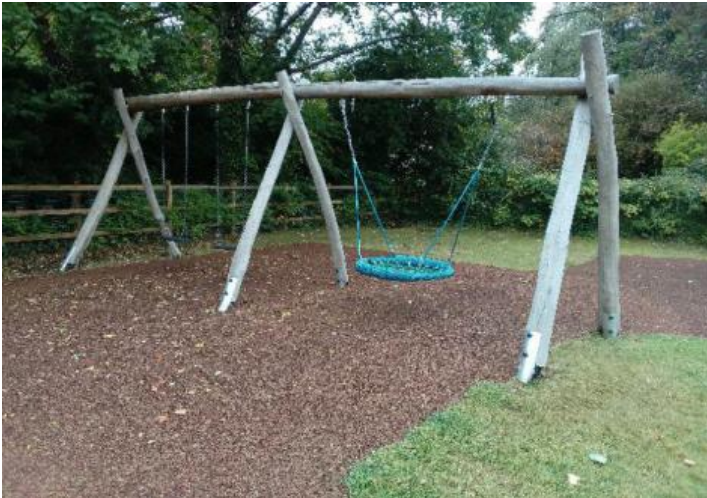
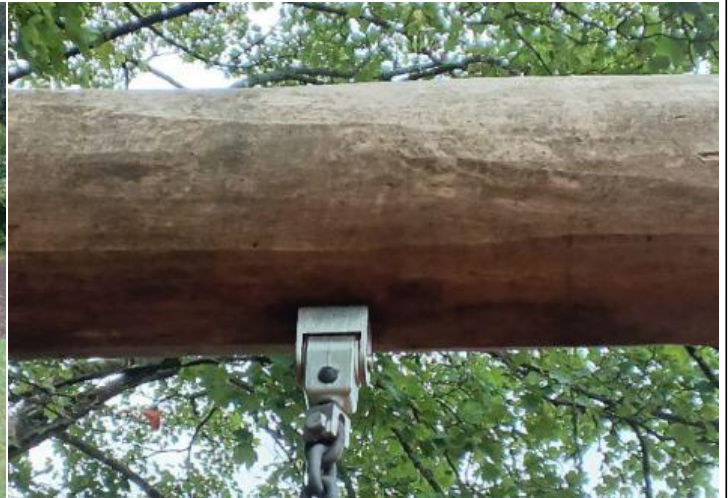
Item: Swings - 2 Bay 2 Flat 1 Basket Seat
Manufacturer: Sawscapes Play

The bush / bushes is / are showing signs of wear - Monitor for any further deterioration and replace as required

Finding: The bush / bushes is / are showing signs of wear

Action: Monitor for any further deterioration and replace as required

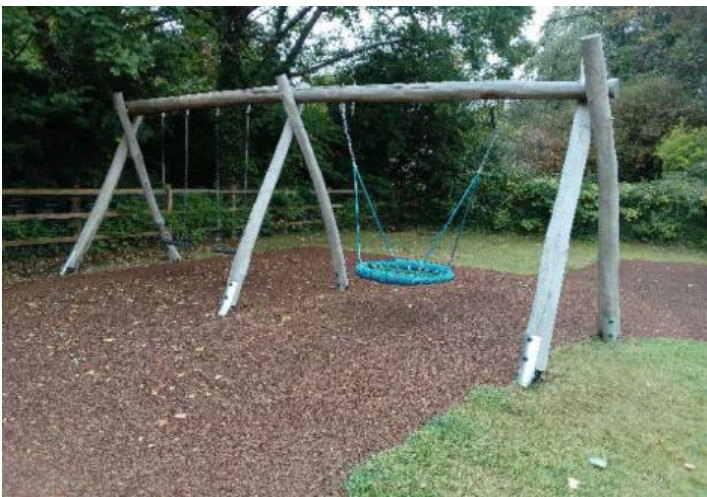
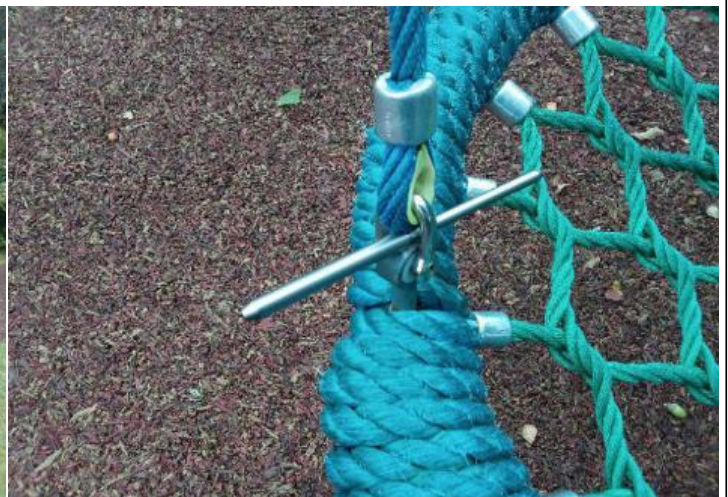
Item: Swings - 2 Bay 2 Flat 1 Basket Seat
Manufacturer: Sawscapes Play

The connecting links are in excess of 8.6mm and less than 12mm and fail the requirements of BS EN 1176 Part 1; clause 4.2.13, Chains - Monitor - No action given the risk assessment

Finding: The connecting links are in excess of 8.6mm and less than 12mm and fail the requirements of BS EN 1176 Part 1; clause 4.2.13, Chains

Action: Monitor - No action given the risk assessment

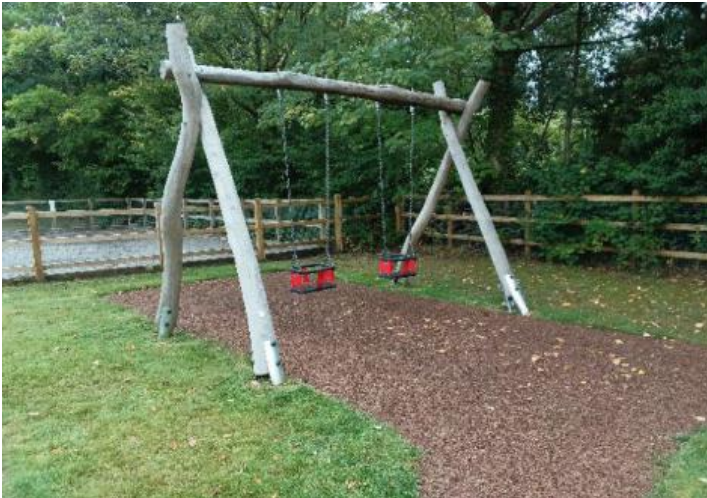
Item: Swings - 1 Bay 2 Seat (Cradle)
Manufacturer: Sawscapes Play

This design of swing joint has been known to fail on the weld connecting the joint to the threaded stud - We would recommend that the joint be dismantled and checked on a regular basis or consulting with manufacturer on whether a Secondary Safety Device can be fitted

Finding: This design of swing joint has been known to fail on the weld connecting the joint to the threaded stud

Action: We would recommend that the joint be dismantled and checked on a regular basis or consulting with manufacturer on whether a Secondary Safety Device can be fitted

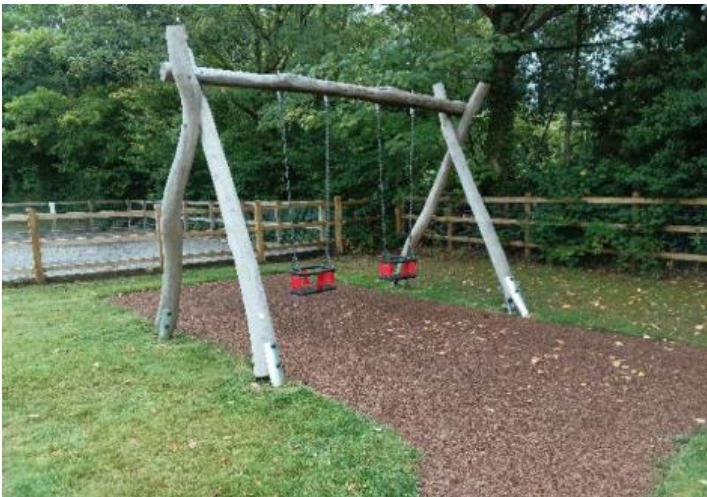
Item: Swings - 1 Bay 2 Seat (Cradle)
Manufacturer: Sawscapes Play

The chain openings are in excess of the 8.6mm as recommended by BS EN 1176 - Monitor - No action given the risk assessment

Finding: The chain openings are in excess of the 8.6mm as recommended by BS EN 1176

Action: Monitor - No action given the risk assessment

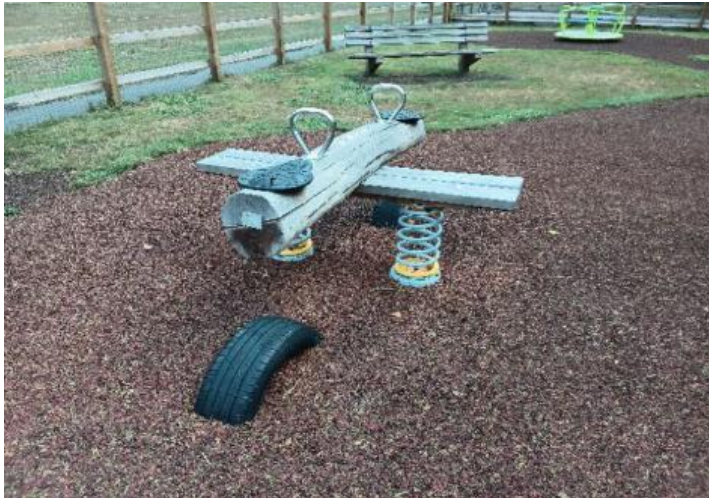
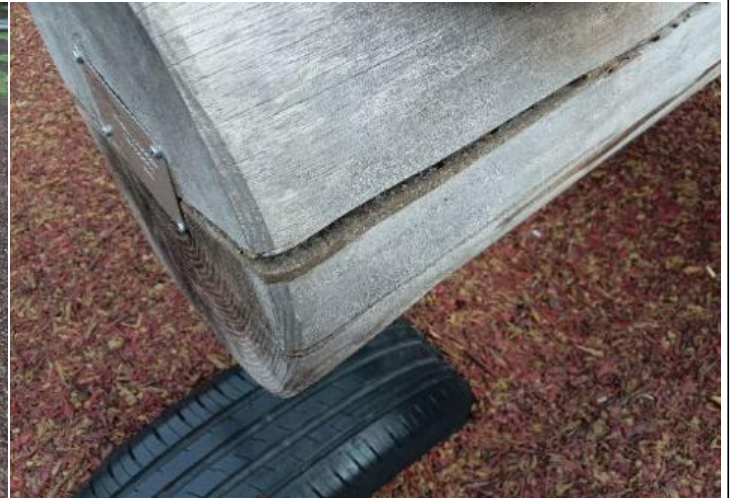
Item: Rocking Equipment - Four Way Springer
Manufacturer: Sawscapes Play

Finding: There are splits running through the timber

Action: Monitor and ensure any rough or splintering edges are sanded down

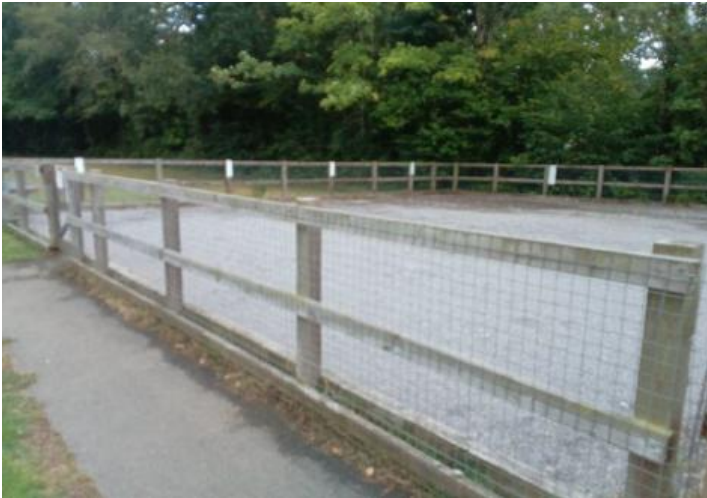
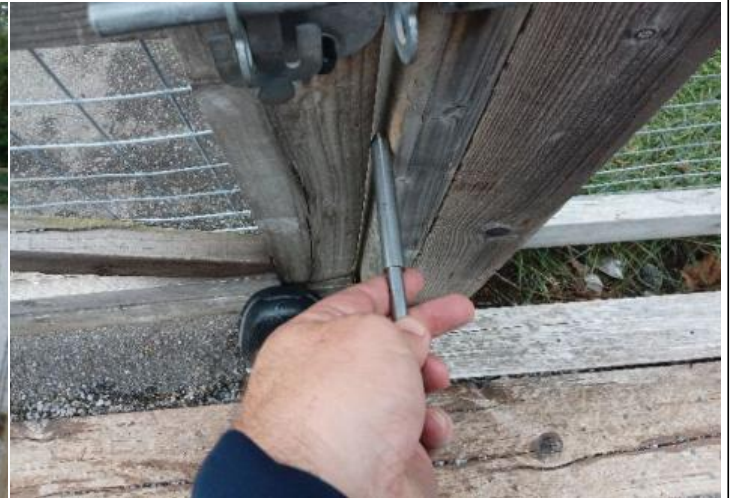
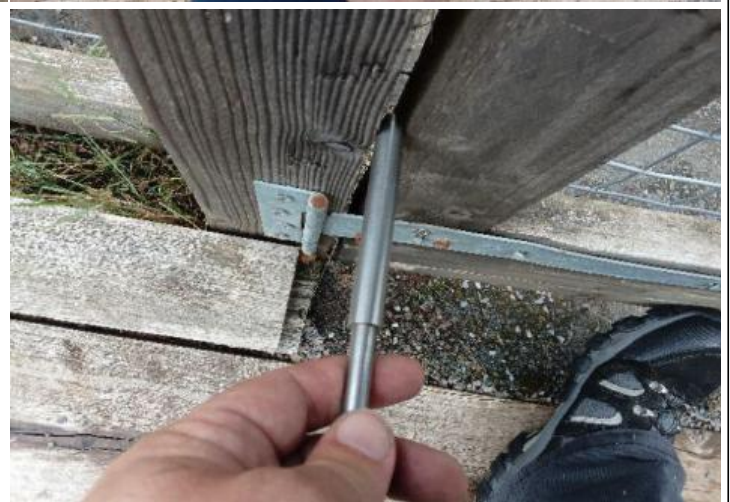
Finding: There are gate openings that are less than 12mm that could trap or crush fingers

Action: Provide a 12mm gap throughout full range of motion at both sides of gate

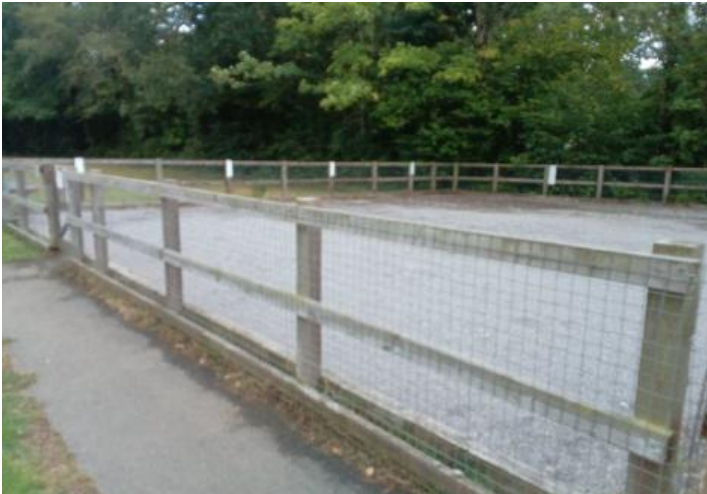
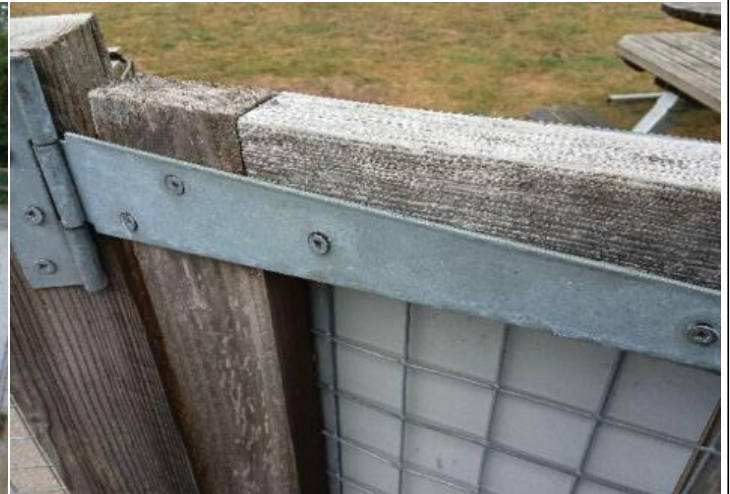
Finding: A number of gate hinge fixing(s) have worked loose **Action:** Secure all loose fixings

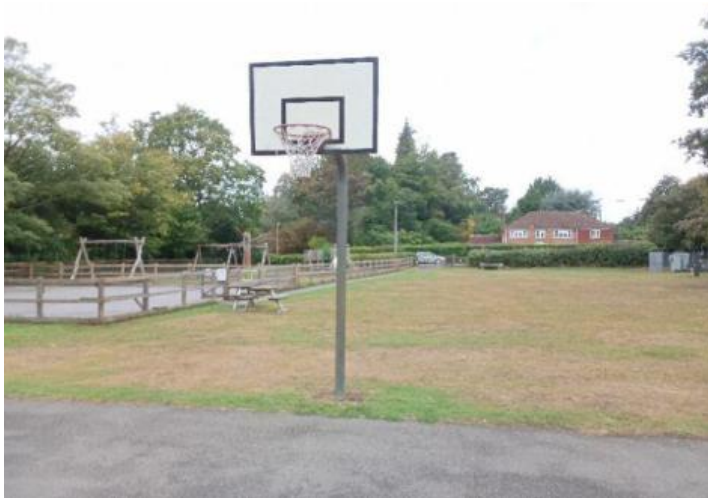
Finding: The net is damaged

Action: Replace / remove net

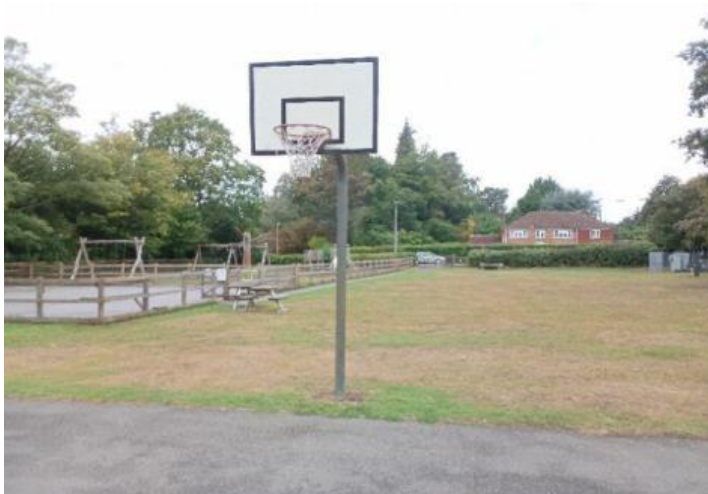
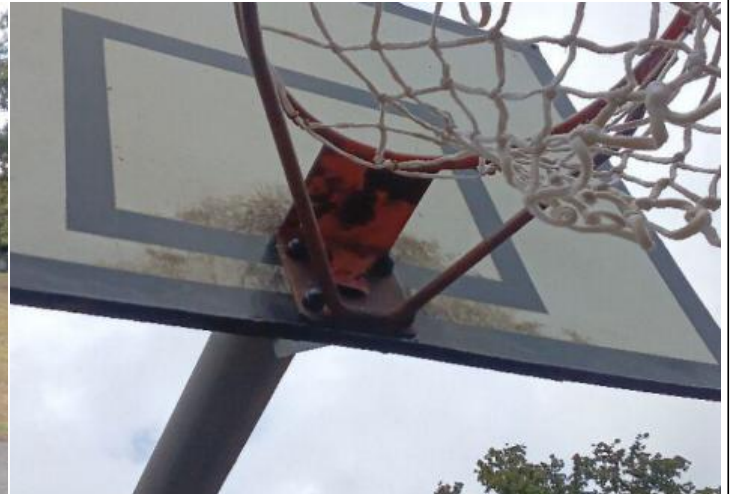
Finding: The paintwork on this item has been damaged or worn exposing the metal underneath which is rusting / corroding

Action: Treat affected areas and repaint

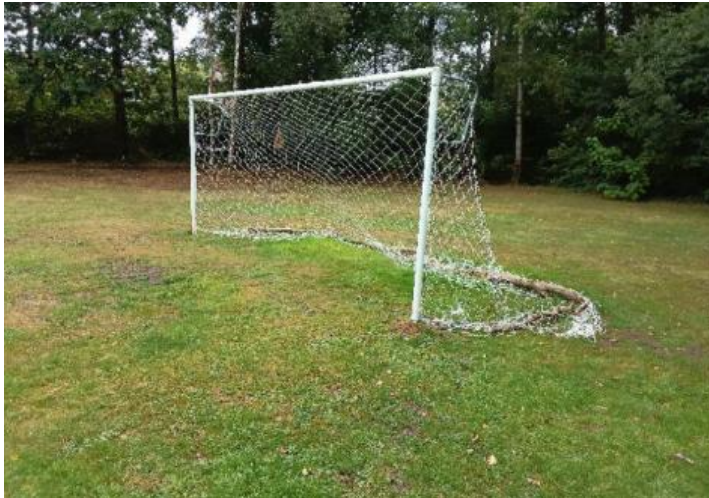
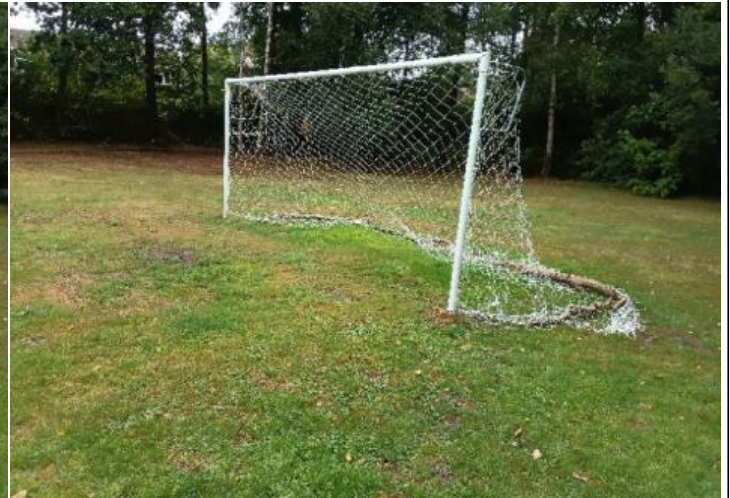
Finding: NB: We have undertaken a maintenance inspection only of the football goal(s); full load testing falls outside the scope of our inspection.

Action: Implement load testing as required

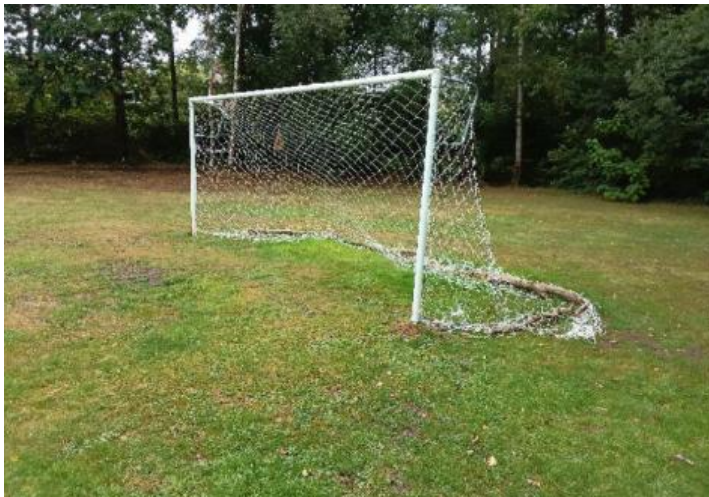
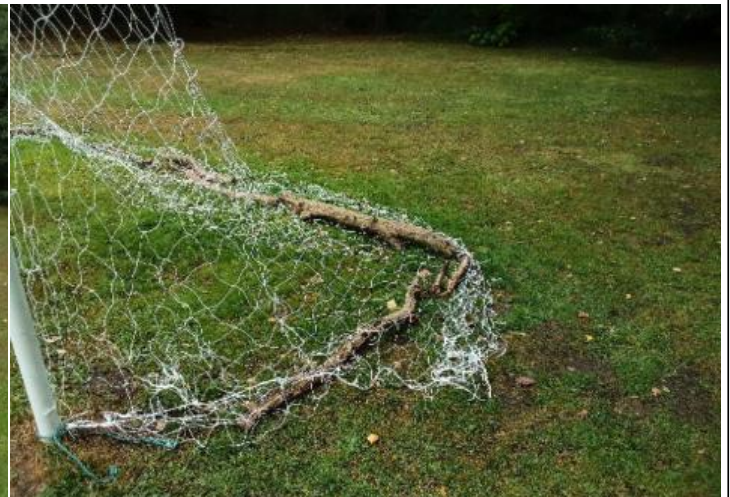
Finding: The net is loose and has been secured by tree branches

Action: Remove branches and secure net

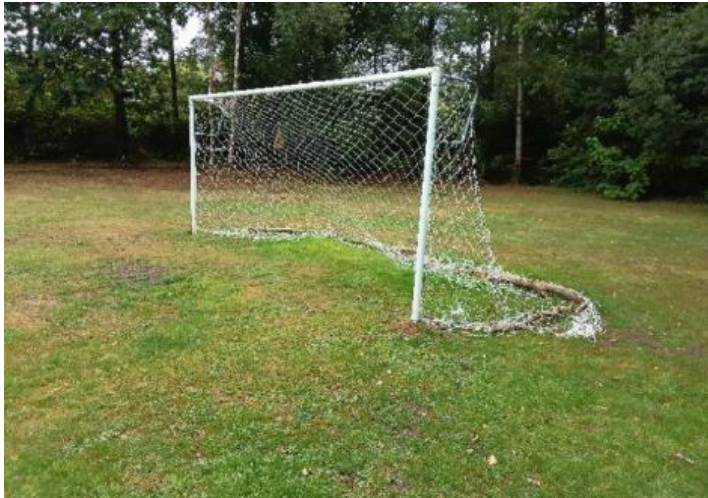
Finding: The posts are slightly loose in the ground

Action: Monitor for any further deterioration and repair as required

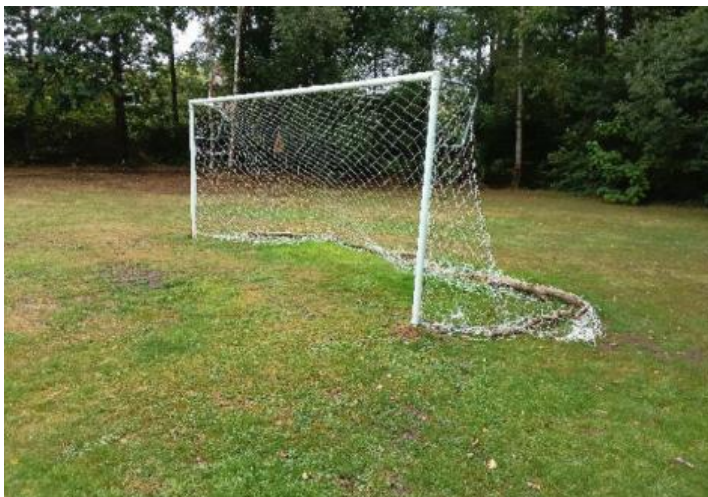
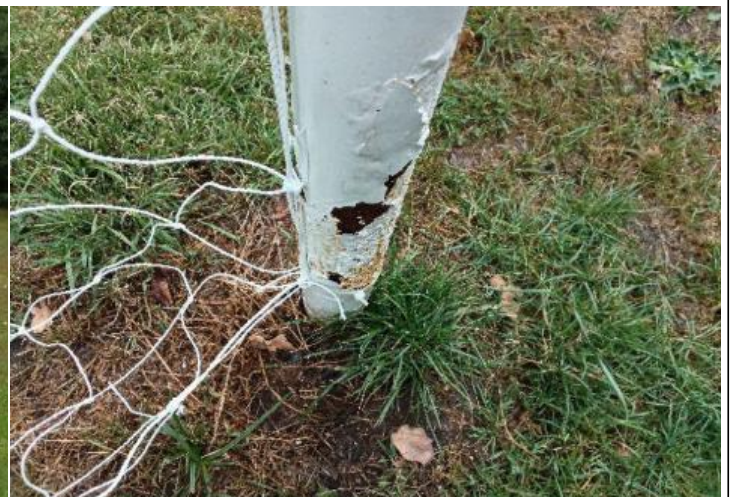
Finding: The paintwork on this item has been damaged or worn exposing the metal underneath which is rusting / corroding

Action: Treat affected areas and repaint

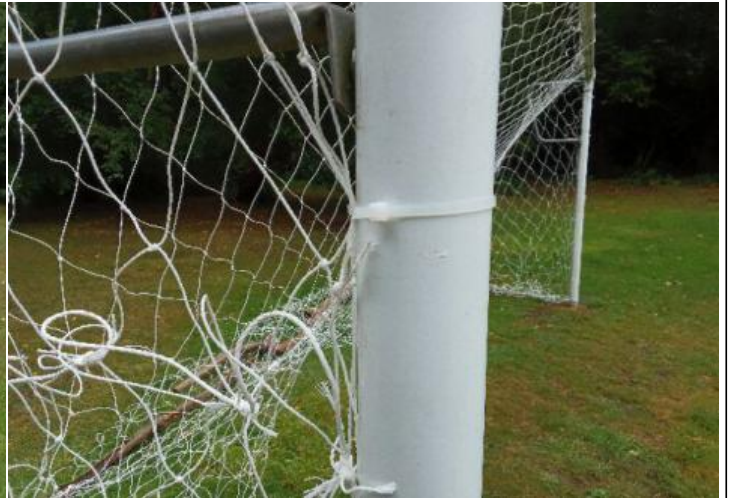
Finding: Cable ties are present and there are sharp projecting ends

Action: Remove

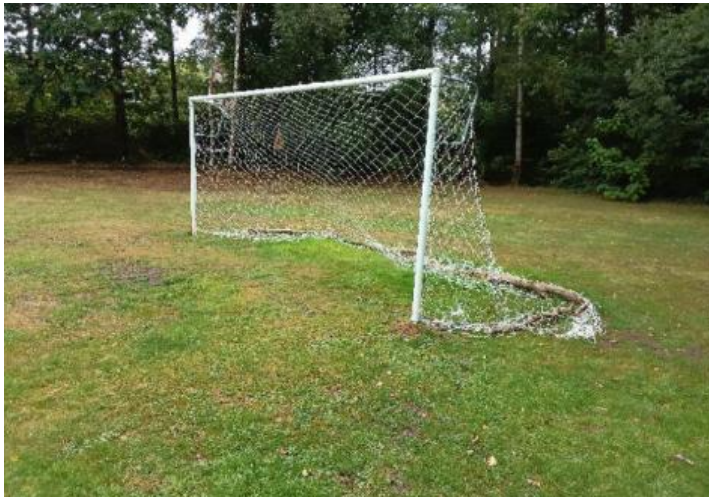
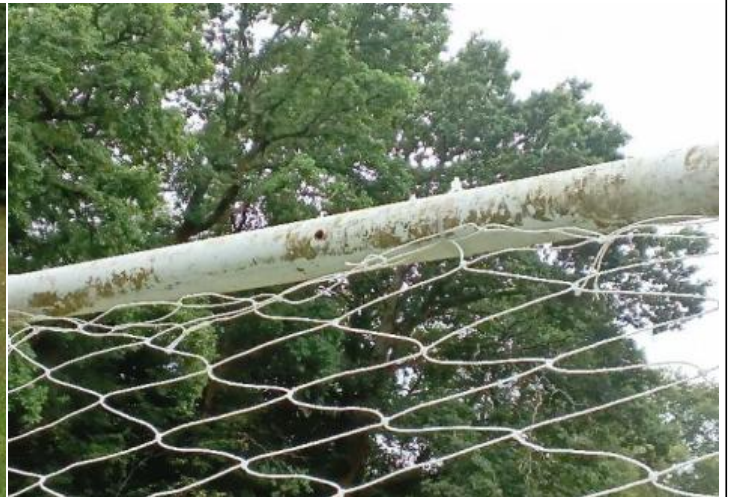
Finding: There are missing net connectors

Action: Replace
