LISS PARISH COUNCIL

Minutes of the meeting of the Facilities Committee held on 14th July 2025, 7pm,
Village Hall

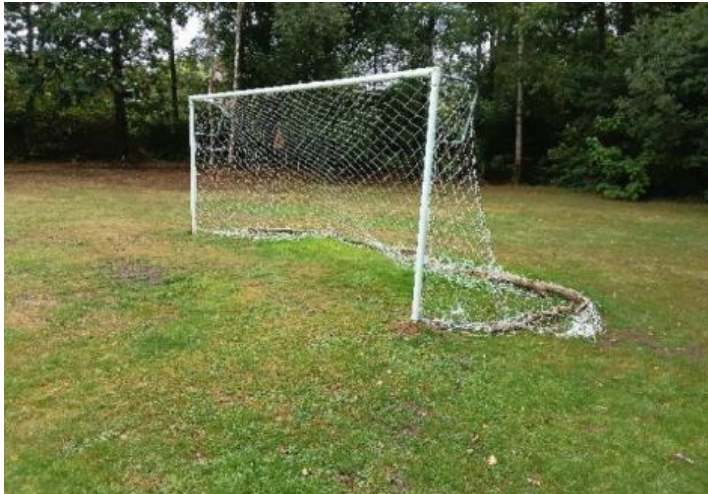
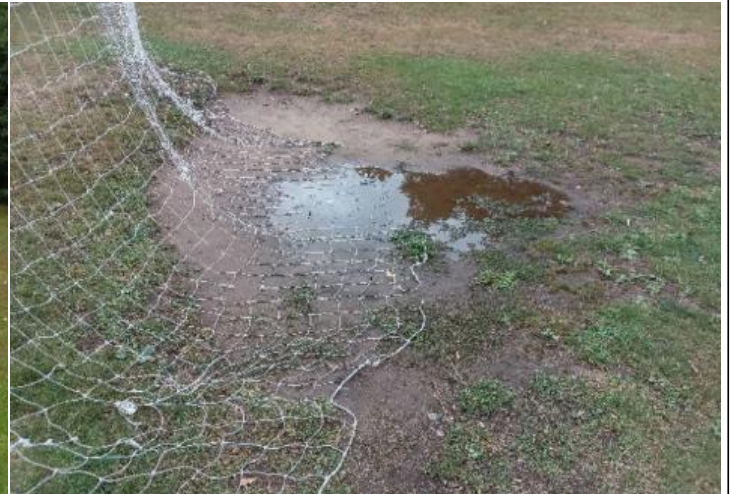
Finding: The surface has eroded in some areas and may be slippery in wet conditions

Action: Reinstate the surface

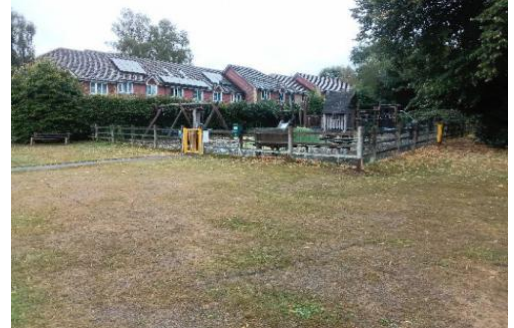
There is some tree debris on the surfacing - Remove and maintain

The surface has subsided in some areas - Monitor for any further deterioration and repair as required

There is some damage to the wet pour surfacing - Monitor for any further deterioration and repair as required

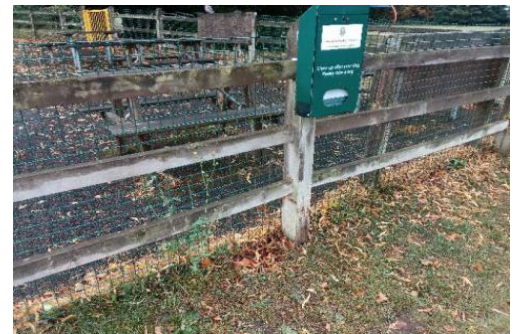
There is some evidence of rot in the timber - Monitor for any further deterioration and replace as required

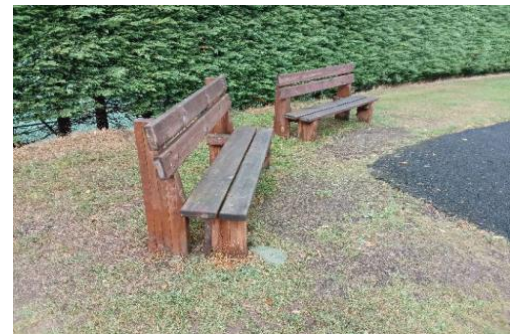
The area around the item has eroded and may become slippery - Reinstate eroded area

There is some strimmer / machinery damage apparent on the posts, this can penetrate the preservative applied to the timber and accelerate the rotting process - Monitor for any deterioration (rot) and replace as required

The surface has eroded and the foundations are exposed - Reinstate surrounding surfaces to cover the foundations

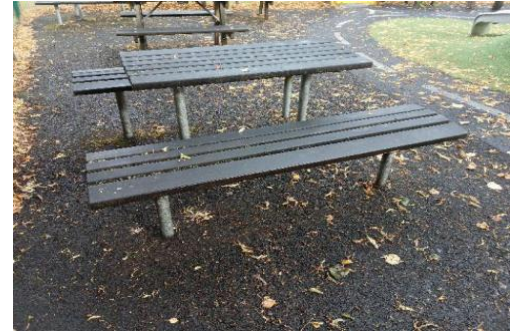
There is algae or moss on the surface of the equipment - Clean and treat appropriately

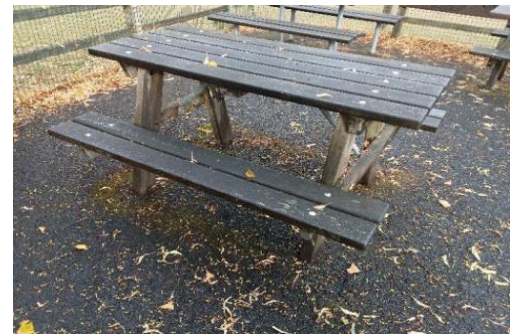
There is some evidence of fire damage to the item - Monitor for any further deterioration and repair as required

A number of fixing(s) have worked loose - Secure all loose fixings

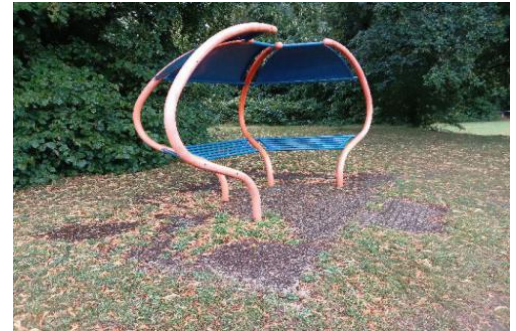
There is weed / vegetation growth within the surface -
Remove weed / vegetation growth

The paintwork on this item has been damaged or worn
exposing the metal underneath which is rusting / corroding -
Treat affected areas and repaint

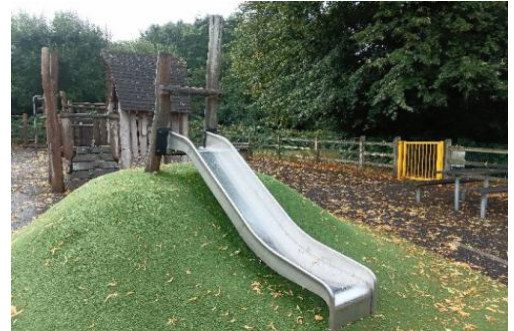
The mound is particularly steep and is likely to present difficulties to users during access - Monitor and consider modifying the design if deemed necessary

There are a number of dents in the slide surface - Monitor for any further deterioration and repair as required

A number of fixing(s) have worked loose - Secure all loose fixings

There is moderate damage to the surface - Repair the damaged areas of surfacing

There is/are bolt cap covers missing or damaged on the item - Replace missing or damaged bolt cap covers

There is some minor damage to the timbers - Monitor for any further deterioration and replace as required

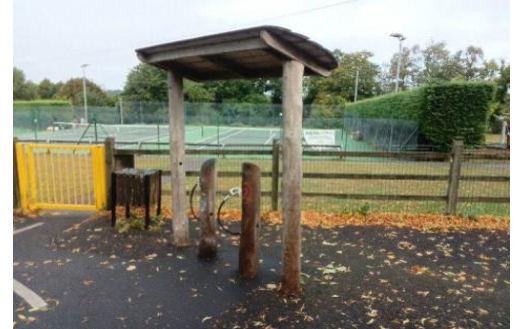
The use of synthetic fillers in timber is not recommended; timber being a natural material will expand and contract as the moisture content changes and the use of fillers can exacerbate the length and depth of these cracks or shakes in the timber. The only treatment that is normally required is the removal of any rough or sharp edges unless the structural integrity of the item is affected. - Remove any rough or sharp edges and monitor timber for any further deterioration

There are gaps opening between the surfacing and the edging surround or between the joints in the surfacing - Monitor for any further deterioration and repair as required

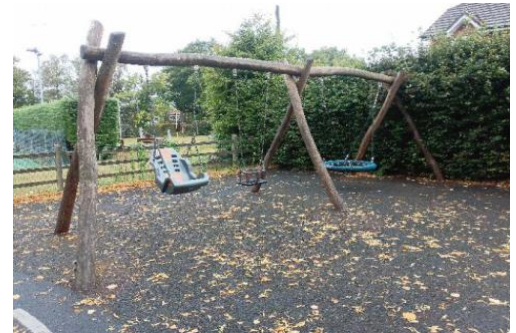
NOTE: The inclusive seat is particularly high at 800mm which may make access and egress difficult for smaller users (We recommend a seat height of 400-500mm) -

There is some notable evidence of chain wear - Monitor for any further deterioration and replace when 40% worn

The swing seat connectors are loose - Tighten to secure

The use of synthetic fillers in timber is not recommended; timber being a natural material will expand and contract as the moisture content changes and the use of fillers can exacerbate the length and depth of these cracks or shakes in the timber. The only treatment that is normally required is the removal of any rough or sharp edges unless the structural integrity of the item is affected. - Remove any rough or sharp edges and monitor timber for any further deterioration

The chain openings are in excess of the 8.6mm as recommended by BS EN 1176 - Monitor - No action given the risk assessment

This design of swing joint has been known to fail on the weld connecting the joint to the threaded stud - We would recommend that the joint be dismantled and checked on a regular basis or consulting with manufacturer on whether a Secondary Safety Device can be fitted

The bush / bushes is / are showing signs of wear - Monitor for any further deterioration and replace as required

A number of crossbeam fixing(s) have worked loose - Secure all loose fixings

There are gaps opening between the surfacing and the edging surround or between the joints in the surfacing - Monitor for any further deterioration and repair as required

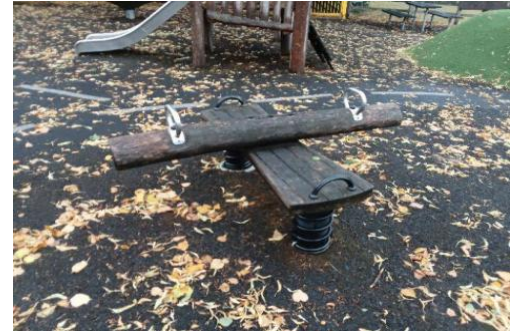
There are splits running through the timber - Monitor and ensure any rough or splintering edges are sanded down

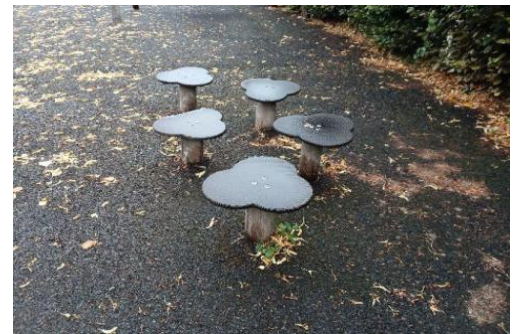
There are areas or parts of the platforms that have rotted - Replace all affected timbers

A number of mast fixing(s) have worked loose - Secure all loose fixings

There is/are bolt cap covers missing or damaged on the item - Replace missing or damaged bolt cap covers

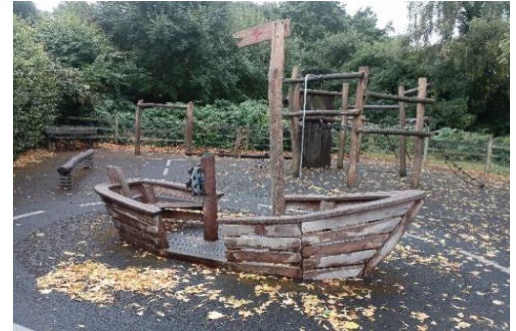
Item: Ship
Manufacturer: Kompan Ltd
Surface Type: Bonded Rubber Mulch
Item Quantity: 1
Equipment Compliance: Yes
Surface Area Compliance: Yes

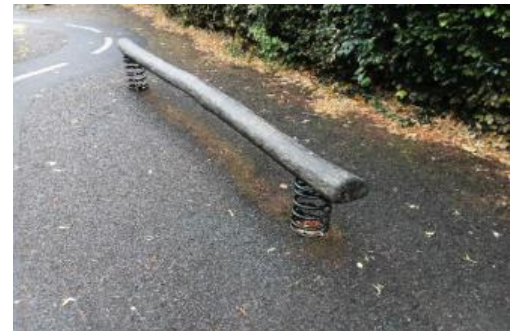
Item: Spring Balance Beam
Manufacturer: Kompan Ltd
Surface Type: Bonded Rubber Mulch
Item Quantity: 1
Equipment Compliance: Yes
Surface Area Compliance: Yes

This item is satisfactory - no work required -

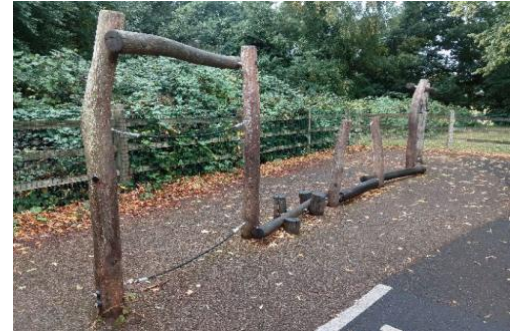
Item: Activity Trail
Manufacturer: Kompan Ltd
Surface Type: Bonded Rubber Mulch
Item Quantity: 1
Equipment Compliance: Yes
Surface Area Compliance: Yes

There are splits running through the timber - Monitor and ensure any rough or splintering edges are sanded down

The use of synthetic fillers in timber is not recommended; timber being a natural material will expand and contract as the moisture content changes and the use of fillers can exacerbate the length and depth of these cracks or shakes in the timber. The only treatment that is normally required is the removal of any rough or sharp edges unless the structural integrity of the item is affected. - Remove any rough or sharp edges and monitor timber for any further deterioration

The handgrip has worn and wire strands are exposed - Replace

The ropes/nets are worn/damaged in places - Monitor for any further deterioration and repair or replace as required

There is or are fixings missing on the rotating beam - Replace all missing fixings

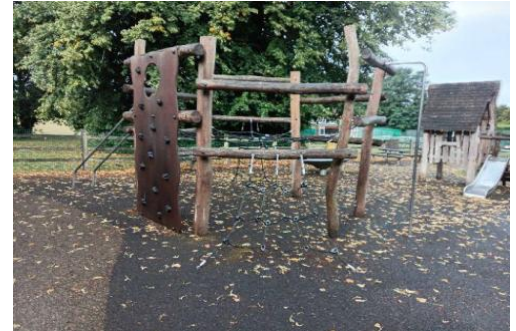
Item: Climbing Frame
Manufacturer: Kompan Ltd
Surface Type: Bonded Rubber Mulch
Item Quantity: 1
Equipment Compliance: No
Surface Area Compliance: Yes

The use of synthetic fillers in timber is not recommended; timber being a natural material will expand and contract as the moisture content changes and the use of fillers can exacerbate the length and depth of these cracks or shakes in the timber. The only treatment that is normally required is the removal of any rough or sharp edges unless the structural integrity of the item is affected. - Remove any rough or sharp edges and monitor timber for any further deterioration

There is algae or moss on the surface of the equipment resulting in slippery conditions - Clean and treat appropriately

There is or are fixings missing on the climbing panel - Replace all missing fixings

The rope ladder tread has been damaged - Monitor for any further deterioration and replace as required

There is/are finger entrapment/s in the climbing panel and the item fails to meet the requirements of BS EN 1176 Part 1 4.2.7.6 Entrapment of fingers - Monitor - No action given the risk assessment

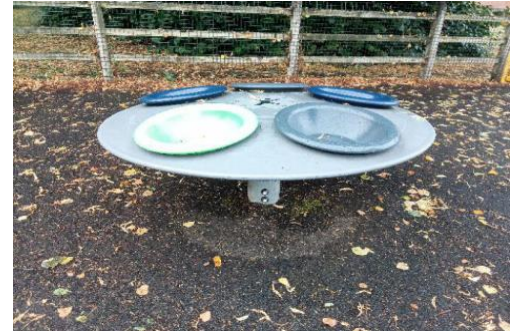
Item: Roundabout
Manufacturer: Kompan Ltd
Surface Type: Bonded Rubber Mulch
Item Quantity: 1
Equipment Compliance: No
Surface Area Compliance: Yes

The multi-play forms a projecting obstacle / hard object within the falling space of the equipment, in contravention of the requirements of BS EN 1176 Part 1 - Monitor - No remedial work recommended

The free space overlaps the falling space between the roundabout and adjacent equipment in contravention of the requirements of BS EN 1176:2017 Part 1 - Monitor - No remedial work recommended

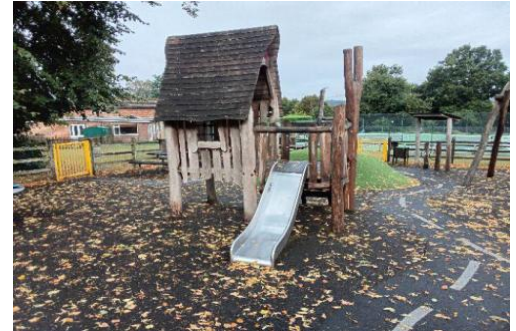
Item: Multi Play (Junior)
Manufacturer: Kompan Ltd
Surface Type: Bonded Rubber Mulch
Item Quantity: 1
Equipment Compliance: Yes
Surface Area Compliance: Yes

There are a number of dents in the slide surface - Monitor for any further deterioration and repair as required

The use of synthetic fillers in timber is not recommended; timber being a natural material will expand and contract as the moisture content changes and the use of fillers can exacerbate the length and depth of these cracks or shakes in the timber. The only treatment that is normally required is the removal of any rough or sharp edges unless the structural integrity of the item is affected. - Remove any rough or sharp edges and monitor timber for any further deterioration

There are gaps opening between the surfacing and the edging surround or between the joints in the surfacing - Monitor for any further deterioration and repair as required

There is or are fixings missing on the slide - Replace all missing fixings

A number of handgrip fixing(s) have worked loose - Secure all loose fixings

There is/are bolt cap covers missing or damaged on the item - Replace missing or damaged bolt cap covers

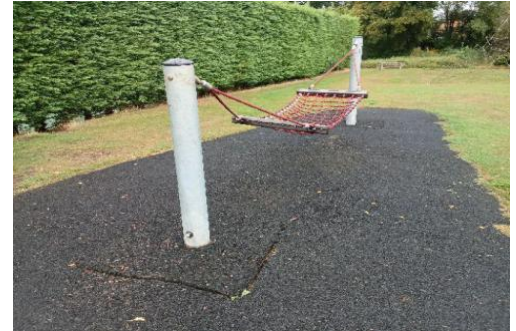
Item: Hammock Swing
Manufacturer: Kompan Ltd
Surface Type: Bonded Rubber Mulch
Item Quantity: 1
Equipment Compliance: Yes
Surface Area Compliance: Yes

There are gaps opening between the surfacing and the edging surround or between the joints in the surfacing - Monitor for any further deterioration and repair as required

A number of eyebolt fixing(s) have worked loose - Secure all loose fixings

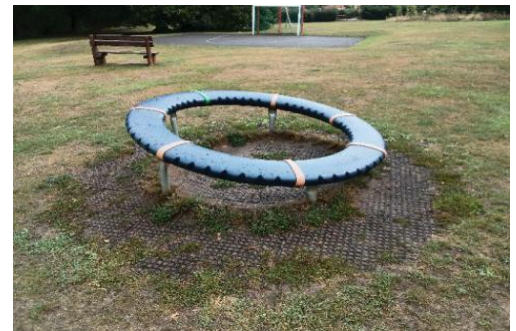
Item: Supernova
Manufacturer: Kompan Ltd
Surface Type: Grass Matrix Tiles
Item Quantity: 1
Equipment Compliance: Yes
Surface Area Compliance: Yes

There is weed / vegetation growth within the surface - Remove weed / vegetation growth

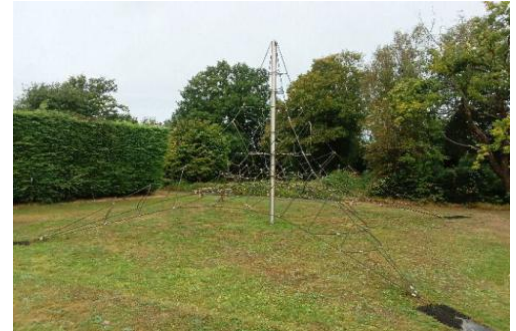
Item: Space Net
Manufacturer: Tayplay Ltd
Surface Type: Grass Matrix Tiles
Item Quantity: 1
Equipment Compliance: Yes
Surface Area Compliance: Yes

There is moderate damage to the surface - Repair the damaged areas of surfacing

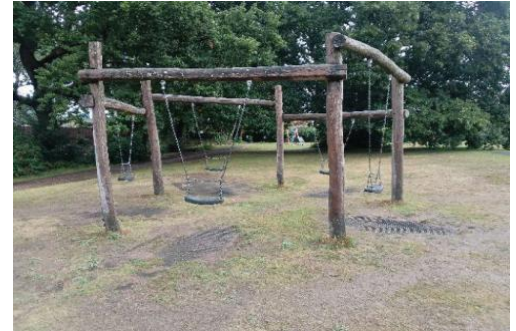
Item: Contact Swing - Type 4
Manufacturer: Kompan Ltd
Surface Type: Grass Matrix Tiles
Item Quantity: 1
Equipment Compliance: Yes
Surface Area Compliance: Yes

This design of swing joint has been known to fail on the weld connecting the joint to the threaded stud - We would recommend that the joint be dismantled and checked on a regular basis or consulting with manufacturer on whether a Secondary Safety Device can be fitted

There is algae or moss on the surface of the equipment that can lead to the onset of rot - Monitor condition of the timbers (rot), clean and treat appropriately

There is some notable evidence of chain wear - Monitor for any further deterioration and replace when 40% worn

The chain links are worn excessively (50%) and require renewing - Replace worn chains

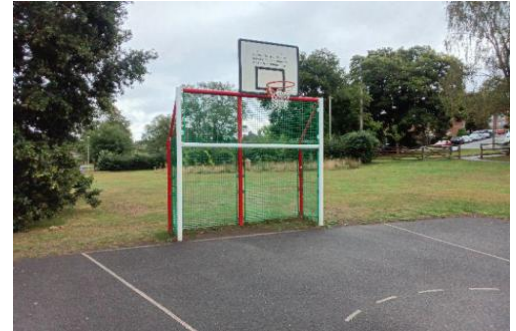
Item: Goalmouth and Basketball Post
Manufacturer: Action Play and Leisure
Surface Type: Bitmac
Item Quantity: 1
Equipment Compliance: Yes
Surface Area Compliance: N/A

The net is loose - Secure

The surface has eroded in some areas and may be slippery
 in wet conditions - Reinstate the surface

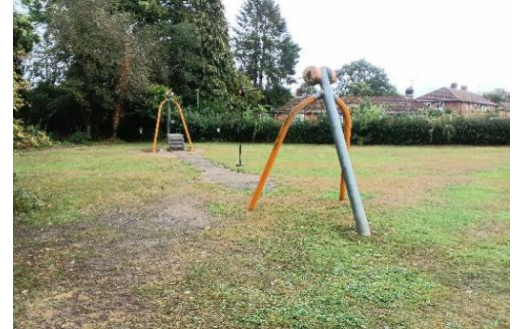
Item: Cable Runway
Manufacturer: Hags
Surface Type: Grass Matrix Tiles
Item Quantity: 1
Equipment Compliance: Yes
Surface Area Compliance: Yes

We have completed a visual inspection of the suspension links, cable and fixing points from ground level, however it is not possible to fully inspect these areas without either hiring equipment to gain access or removing the cable and suspension and inspecting at ground level. We recommend that the main cable and fixing security is thoroughly inspected at least in accordance with the manufacturers recommendations to check for wear, damage, security or internal rusting; this will help to ensure the continued safe use of the equipment - Inspect in accordance with the manufacturers recommendations

The cableway seat has been damaged - Monitor for any further deterioration and replace as required

There is some wear to the shackles. - Monitor for any further deterioration and replace when 40% worn

The platform surface is showing signs of wear - Monitor for any further deterioration and repair as required

The surface has eroded in some areas and may be slippery in wet conditions - Reinstate the surface

The seat connection cannot be inspected without dismantling the seat - Dismantle the seat to inspect the seat connection for wear

There is some notable evidence of chain wear - Monitor for any further deterioration and replace when 40% worn

The seat suspension cover has been damaged - Monitor for any further deterioration and replace as required

The traveller casing is beginning to separate - Repair / replace traveller as required

The surface is lifting at the edges and creating trip points - Repair perimeter of surfacing to remove trip points

Hard fixing pins have been installed in the grass mat tiles within the impact area of the equipment. Grass mat pins should only be installed at the perimeter of the tiles, and outside of any equipment impact areas. NOTE - where grass mat wear pads have been provided and the impact area includes surrounding surfaces, the grass mats should be tucked into the turf, and not pinned - Remove pins from impact areas

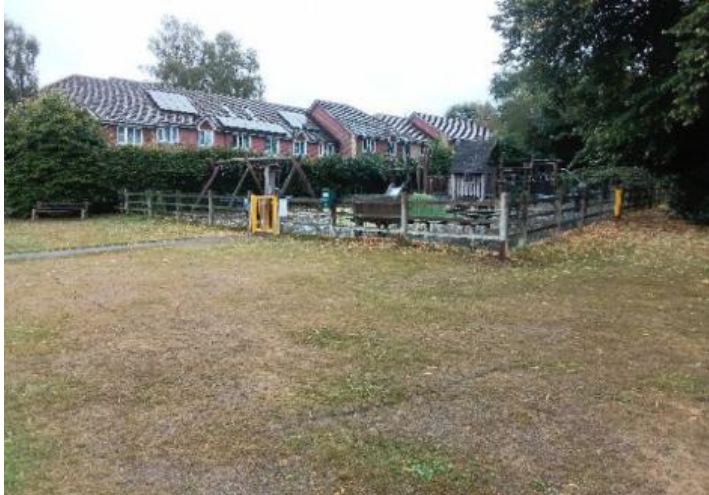
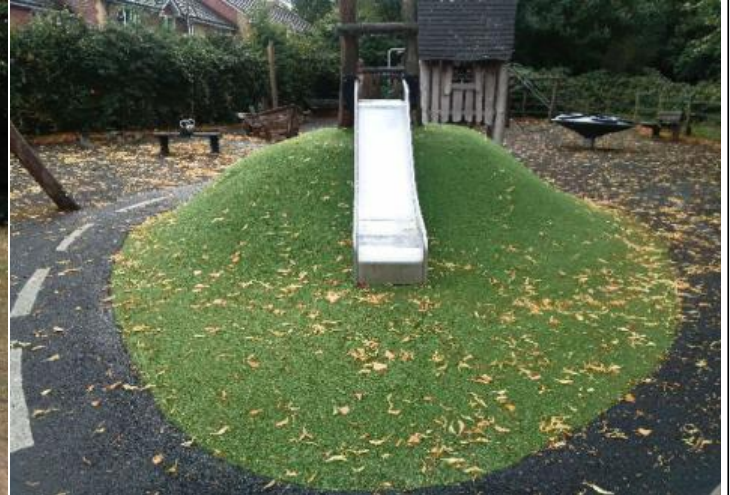
Finding: There is some tree debris on the surfacing

Action: Remove and maintain

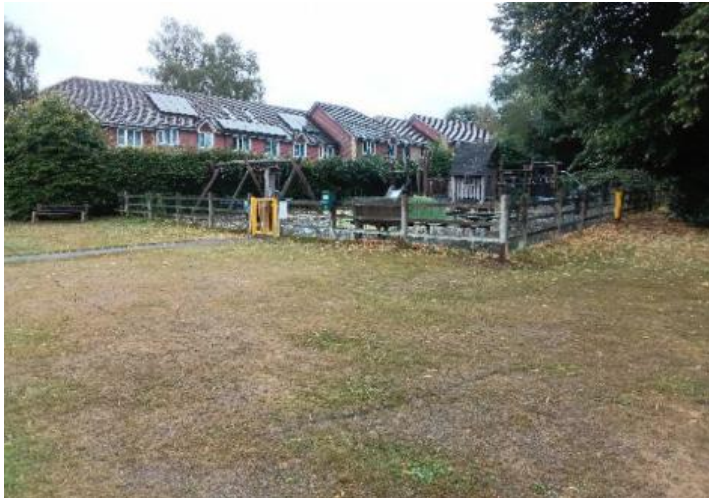
Finding: There is some damage to the wet pour surfacing

Action: Monitor for any further deterioration and repair as required

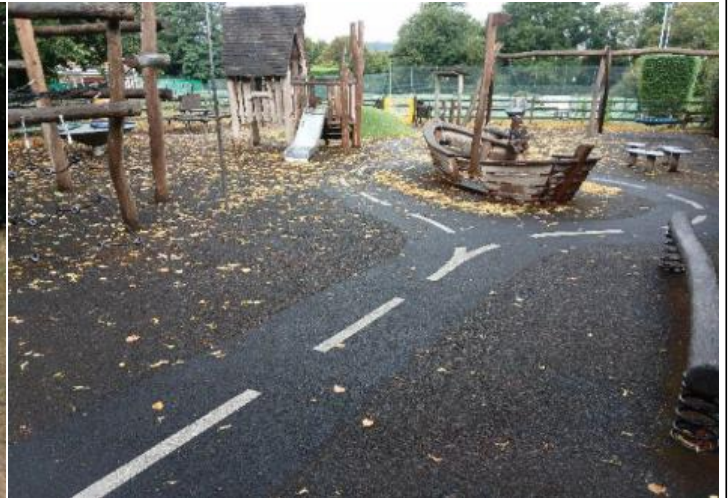
Finding: The surface has subsided in some areas

Action: Monitor for any further deterioration and repair as required

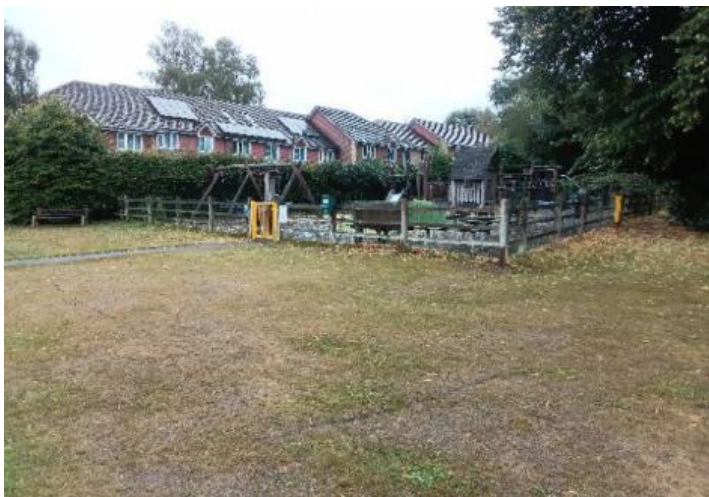
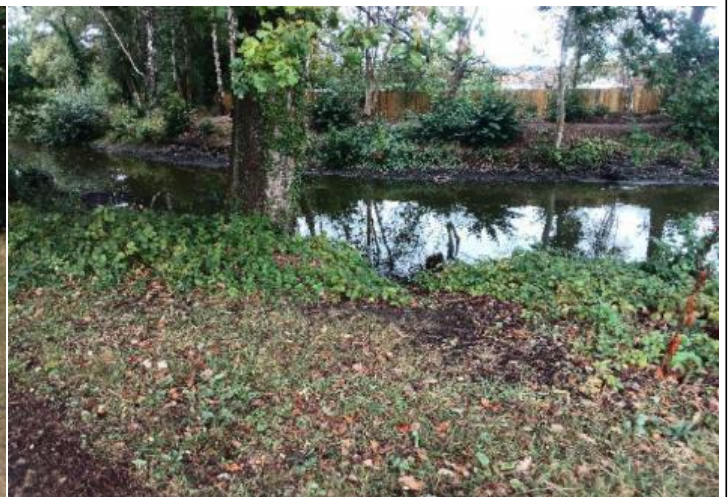
Finding: NOTE - There is a body of water or a water basin in close proximity to the playground. Risk assessment of this is a specialist field and outside the scope of our inspection.

Action: Contact our official water safety partner the RLSS (Royal Life Saving Society) at www.rlss.org.uk and / or ensure that the appropriate risk assessment is in place

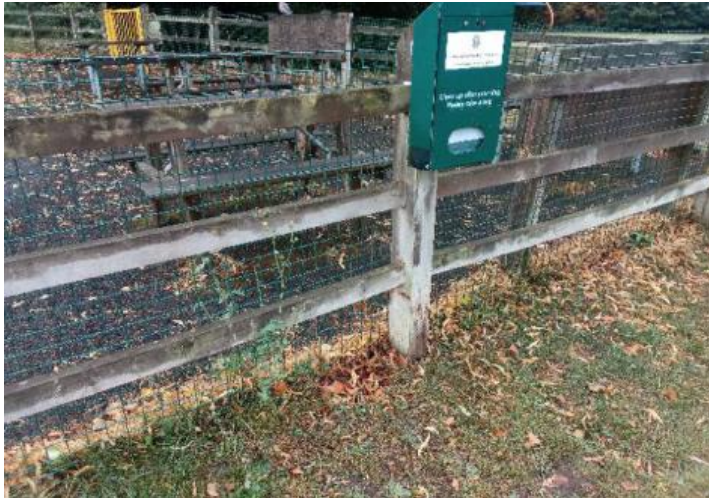
Finding: There is some evidence of rot in the timber

Action: Monitor for any further deterioration and replace as required

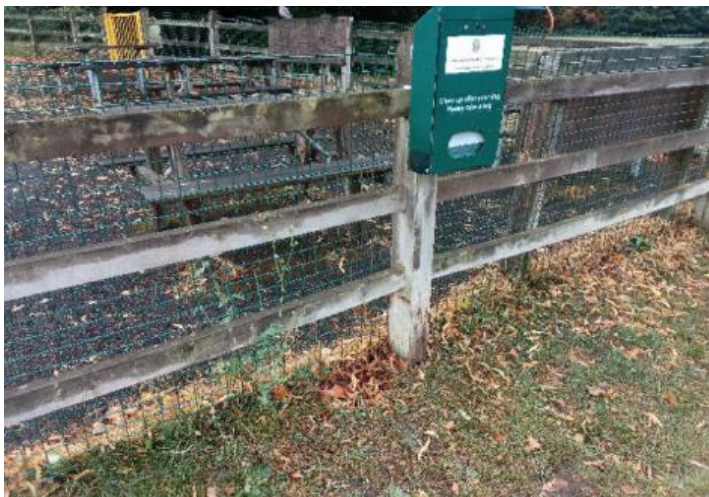
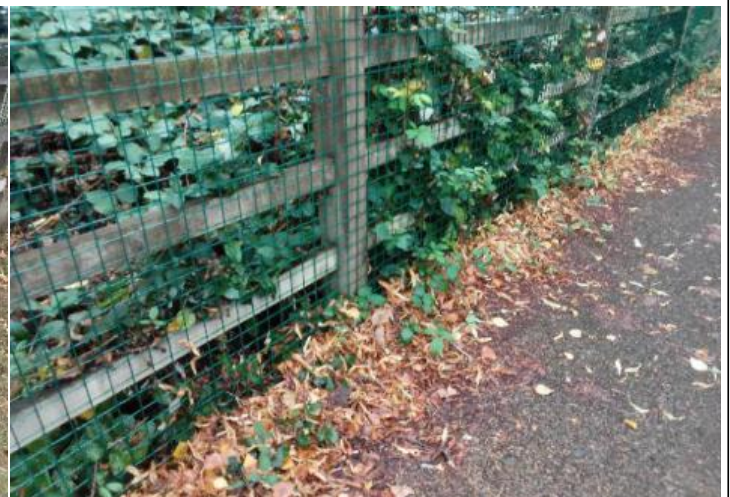
Finding: The adjacent foliage is overhanging

Action: Cut back and maintain

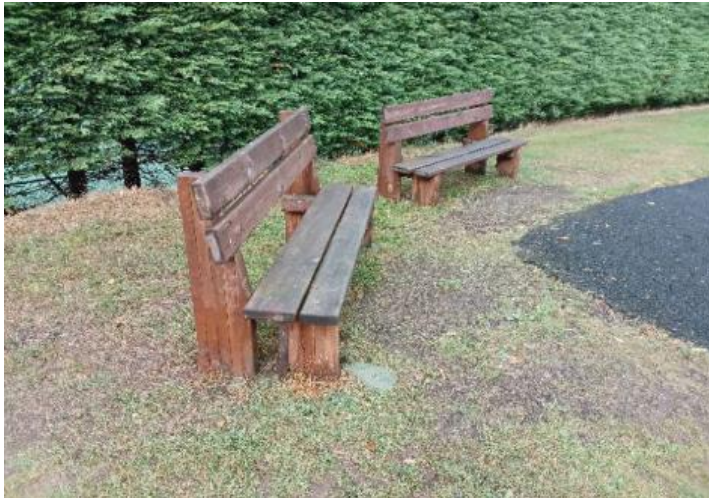
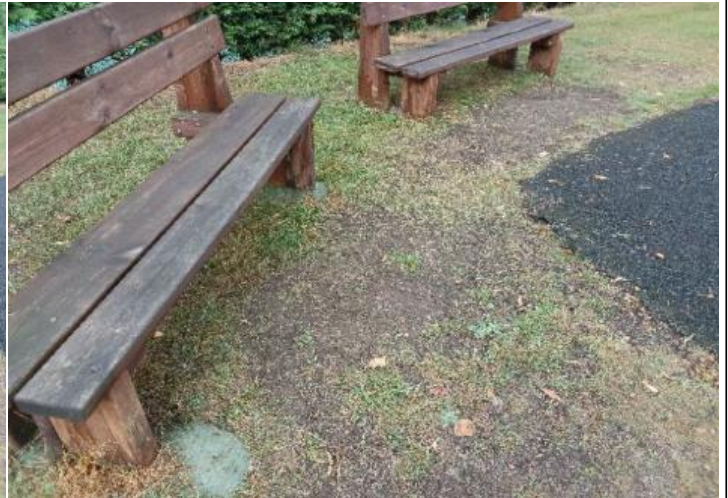
Finding: The area around the item has eroded and may become slippery

Action: Reinststate eroded area

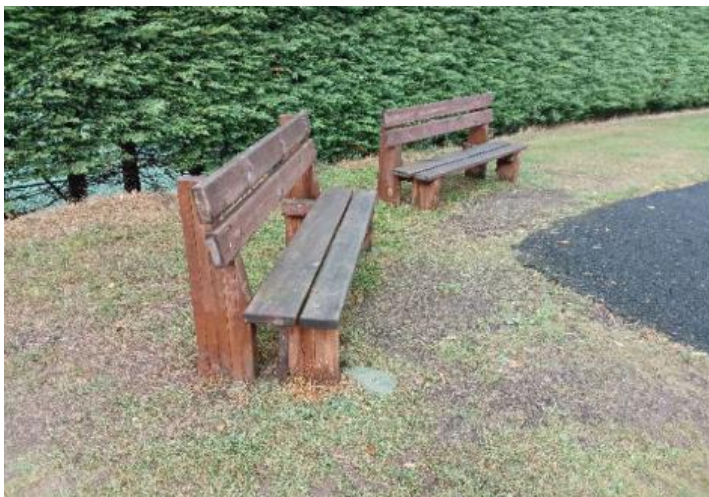
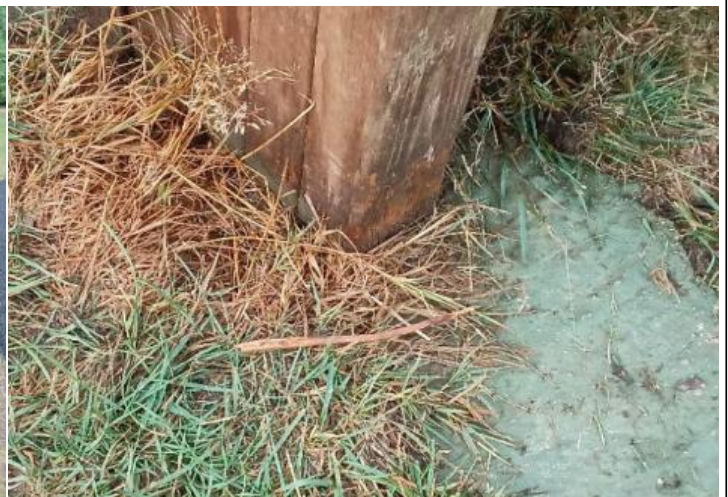
Finding: There is some strimmer / machinery damage apparent on the posts, this can penetrate the preservative applied to the timber and accelerate the rotting process

Action: Monitor for any deterioration (rot) and replace as required

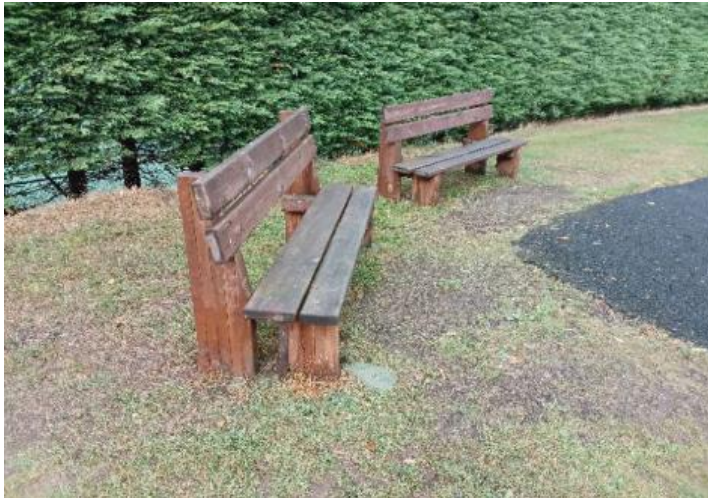
Finding: The surface has eroded and the foundations are exposed

Action: Reinstate surrounding surfaces to cover the foundations

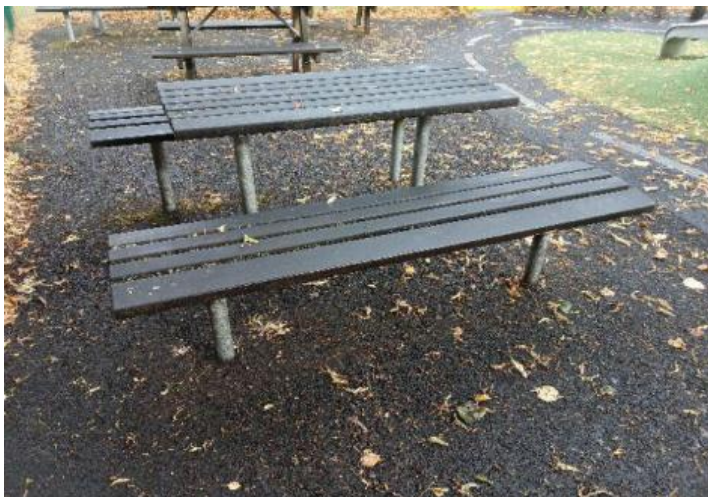
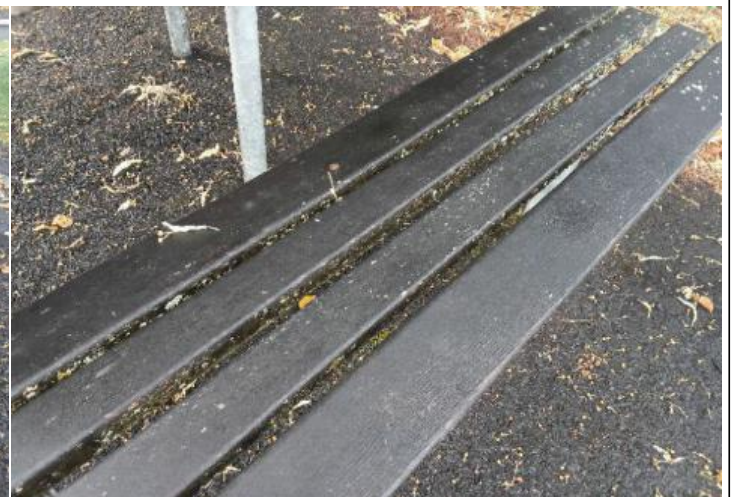
Finding: There is algae or moss on the surface of the equipment

Action: Clean and treat appropriately

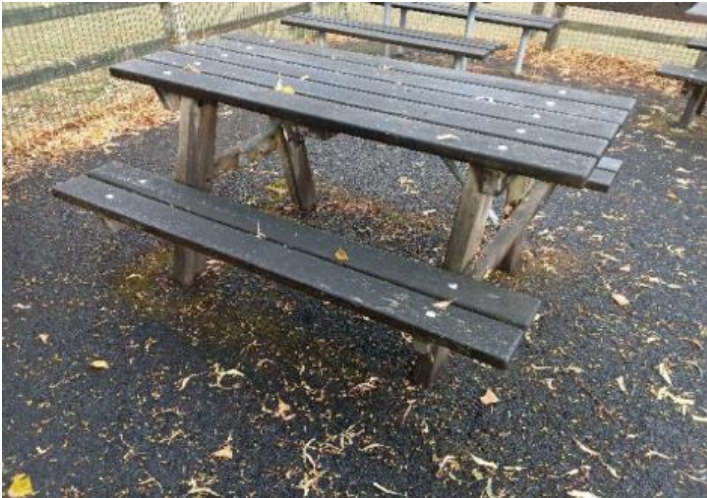
Finding: There is some evidence of fire damage to the item **Action:** Monitor for any further deterioration and repair as required

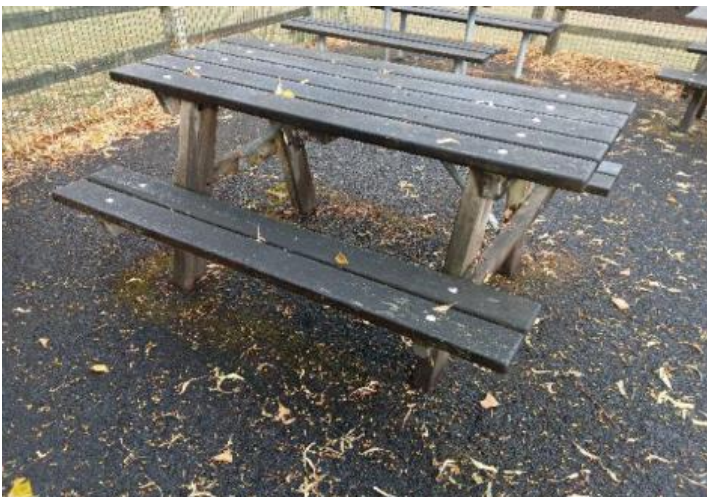
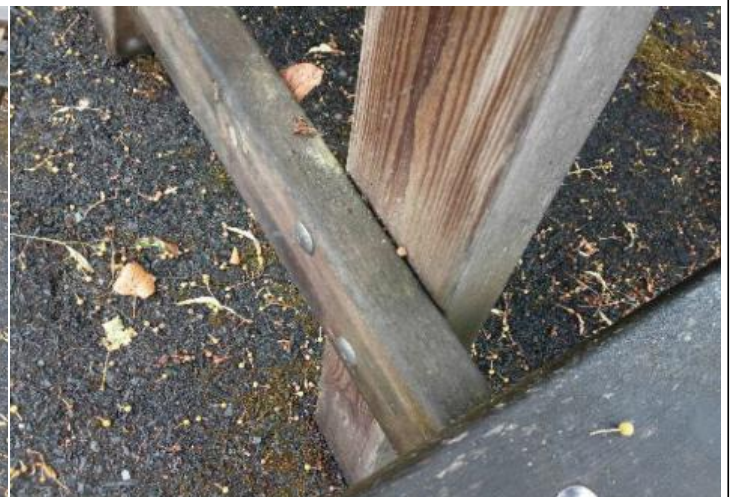
Finding: A number of fixing(s) have worked loose **Action:** Secure all loose fixings

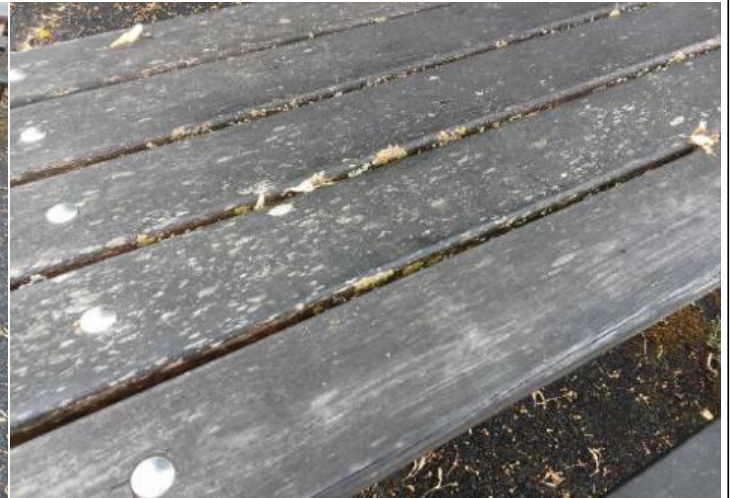
Finding: There is algae or moss on the surface of the equipment

Action: Clean and treat appropriately

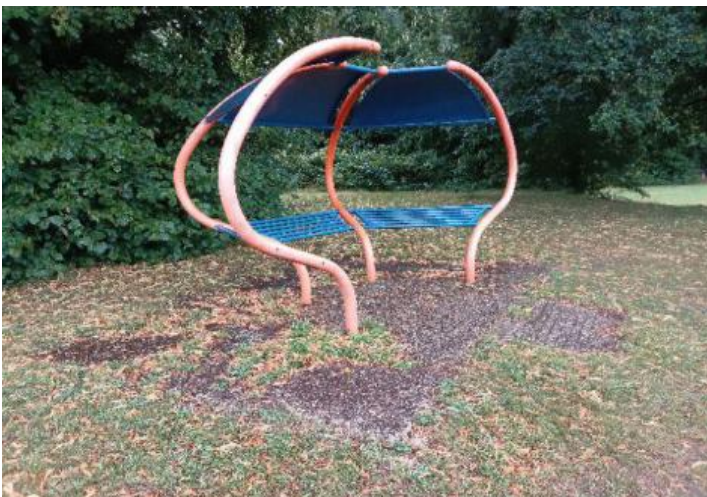
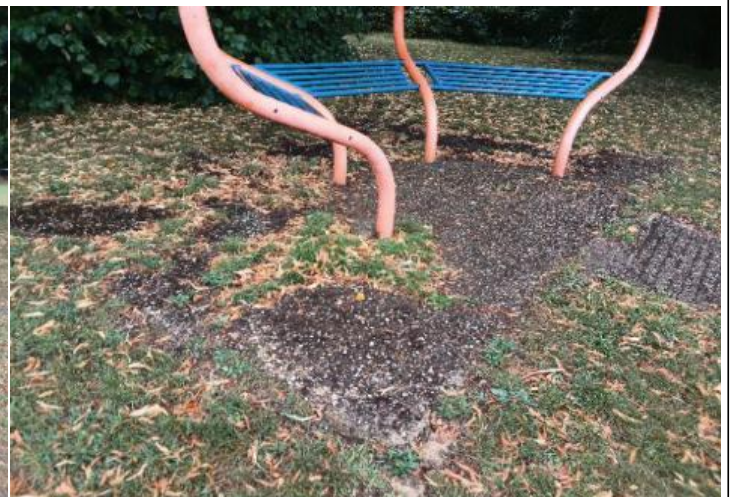
Finding: There is weed / vegetation growth within the surface

Action: Remove weed / vegetation growth

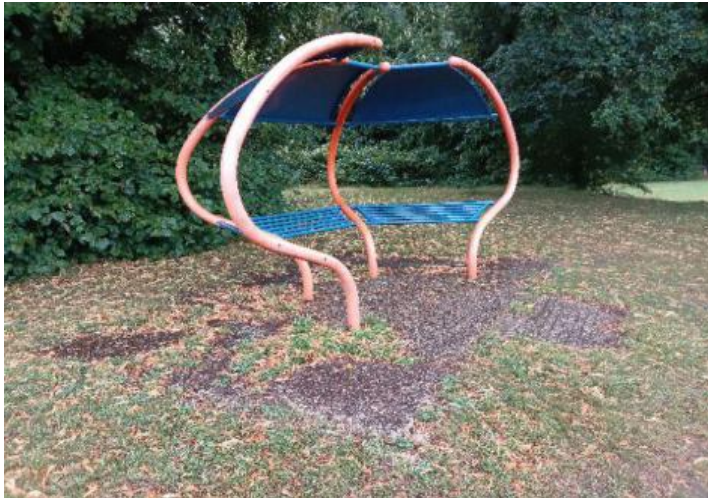
Finding: The paintwork on this item has been damaged or worn exposing the metal underneath which is rusting / corroding

Action: Treat affected areas and repaint

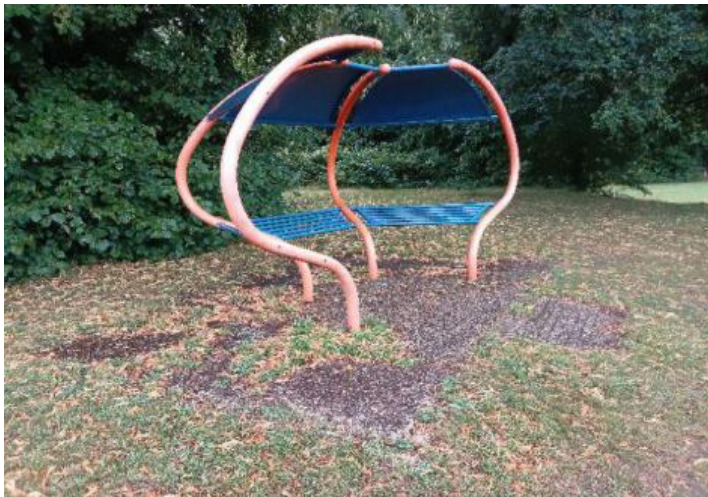
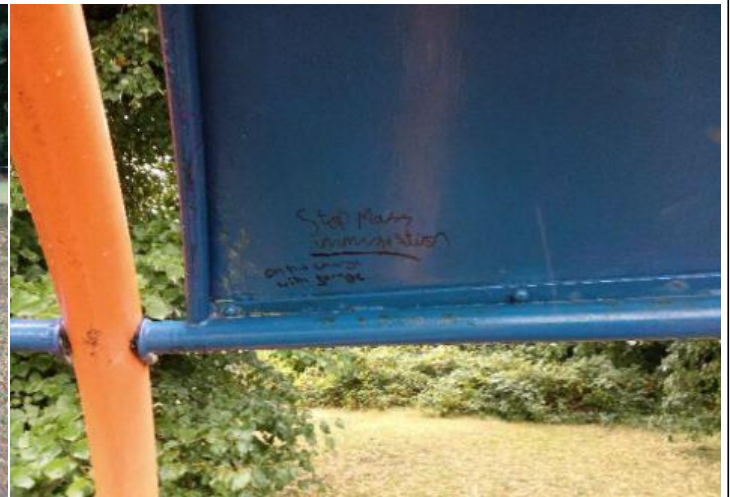
Finding: There is some graffiti present

Action: Remove the graffiti

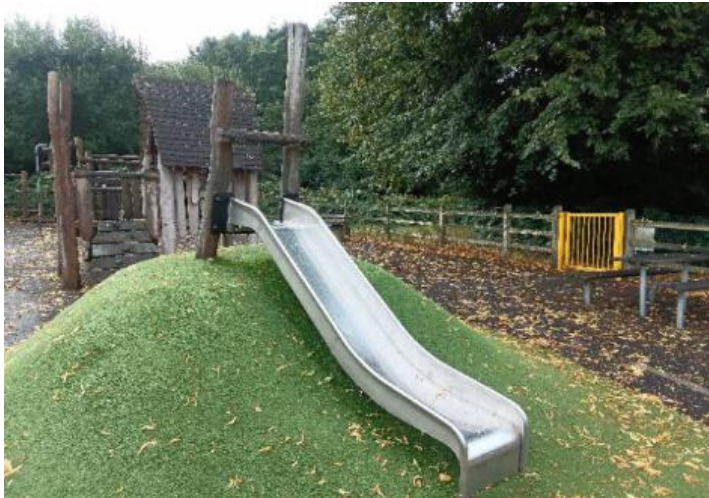
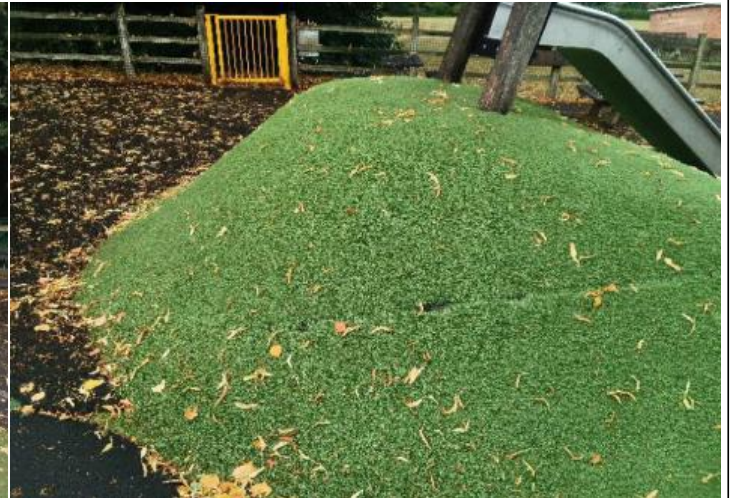
Finding: The mound is particularly steep and is likely to present difficulties to users during access

Action: Monitor and consider modifying the design if deemed necessary

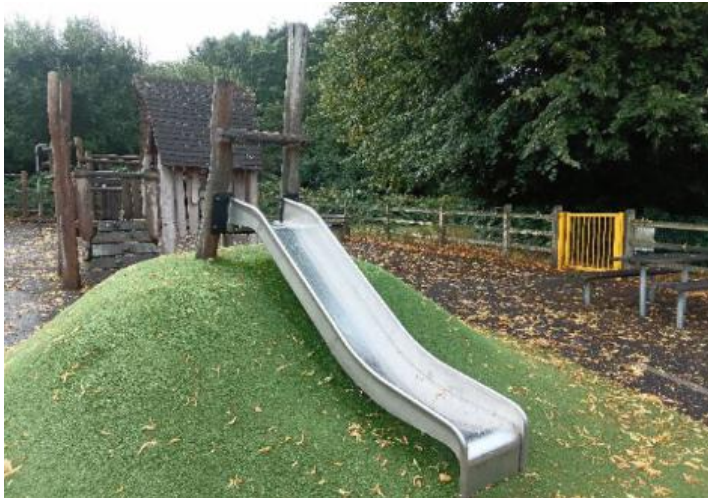
Finding: There are a number of dents in the slide surface

Action: Monitor for any further deterioration and repair as required

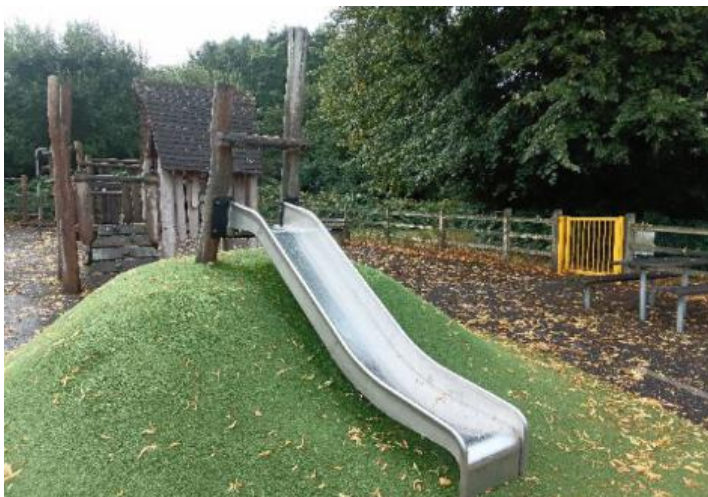
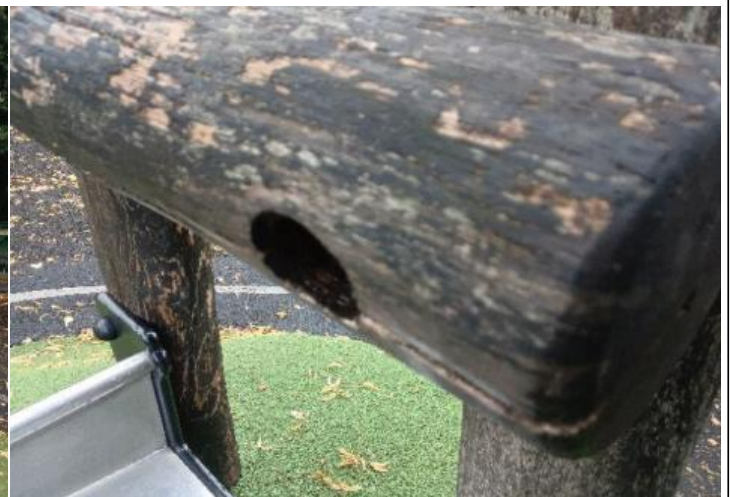
Item: Other - Embankment Slide
Manufacturer: Kompan Ltd

Finding: There is/are bolt cap covers missing or damaged on the item

Action: Replace missing or damaged bolt cap covers

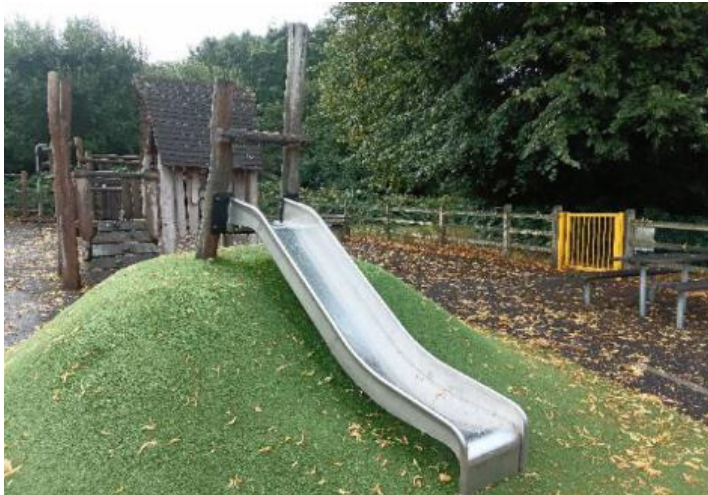
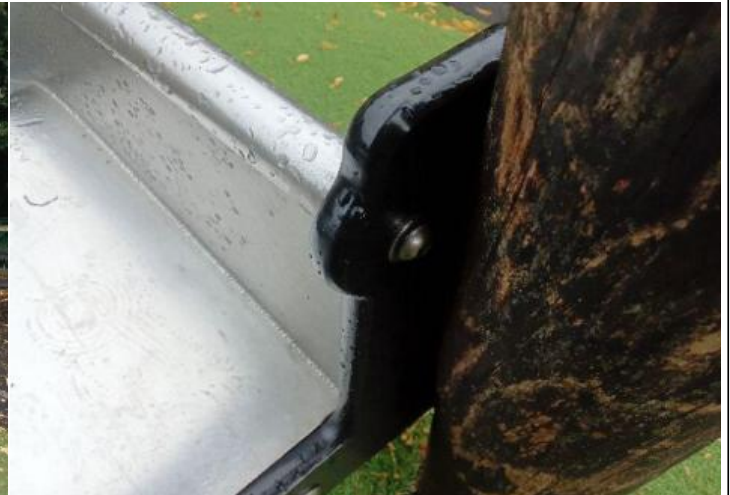
Item: Other - Embankment Slide
Manufacturer: Kompan Ltd

Finding: A number of fixing(s) have worked loose

Action: Secure all loose fixings

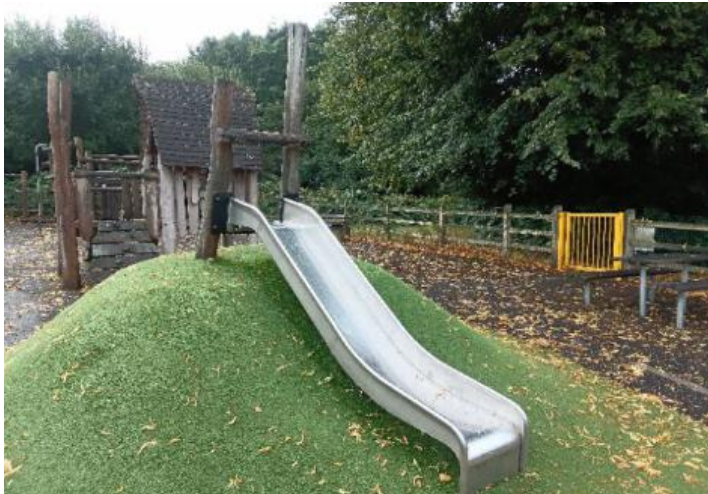
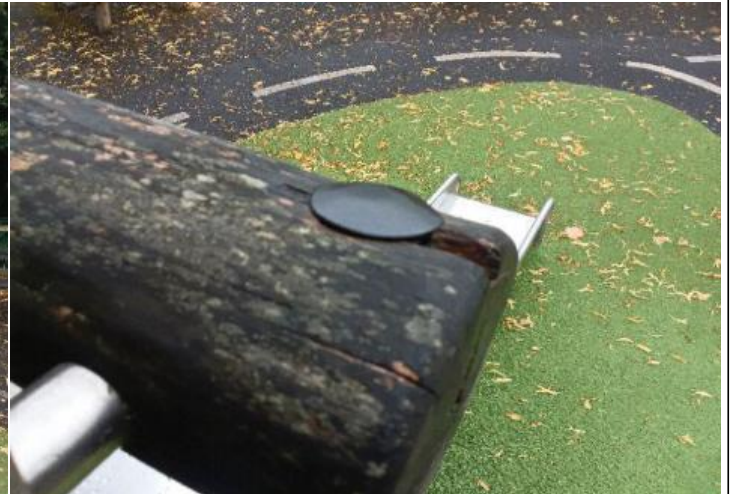
Item: Other - Embankment Slide
Manufacturer: Kompan Ltd

Finding: There is some minor damage to the timbers

Action: Monitor for any further deterioration and replace as required

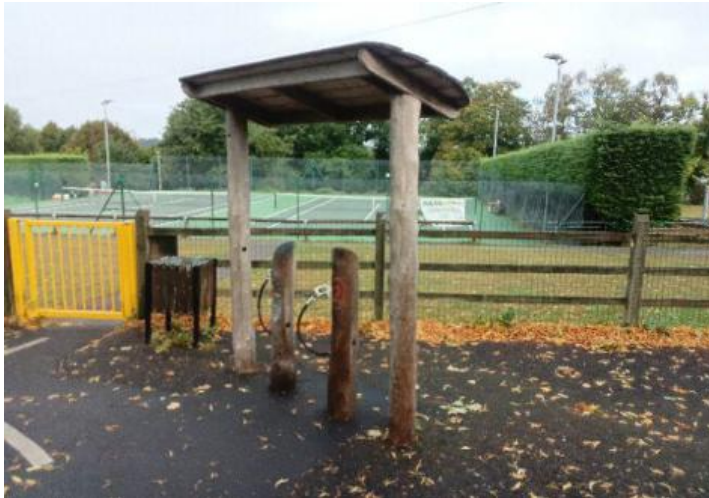
Item: Other - Misc Item
Manufacturer: Kompan Ltd

Finding: The use of synthetic fillers in timber is not recommended; timber being a natural material will expand and contract as the moisture content changes and the use of fillers can exacerbate the length and depth of these cracks or shakes in the timber. The only treatment that is normally required is the removal of any rough or sharp edges unless the structural integrity of the item is affected.

Action: Remove any rough or sharp edges and monitor timber for any further deterioration

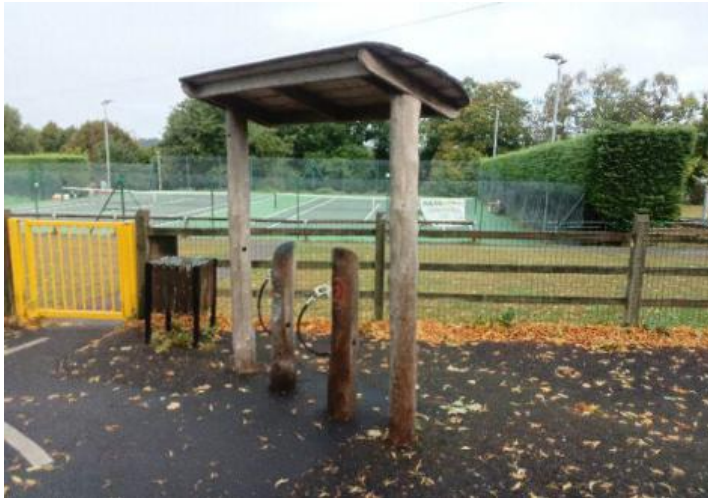
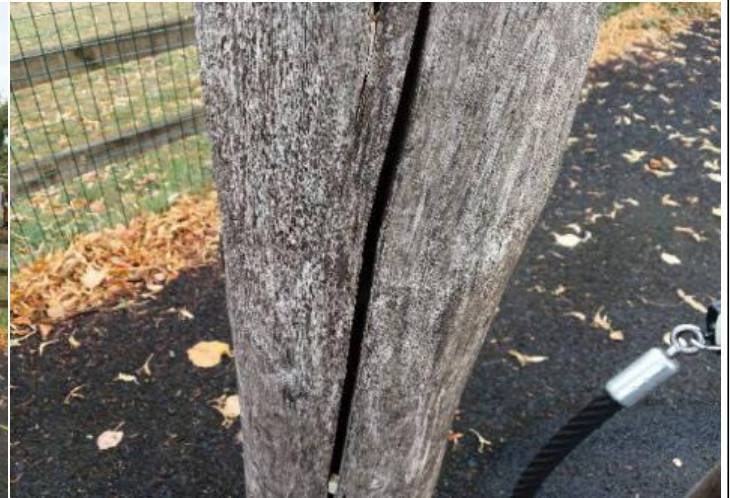
Item: Other - Misc Item
Manufacturer: Kompan Ltd

Finding: There are splits running through the timber

Action: Monitor and ensure any rough or splintering edges are sanded down
