LISS PARISH COUNCIL

Minutes of the meeting of the Facilities Committee held on 14th July 2025, 7pm,
Village Hall

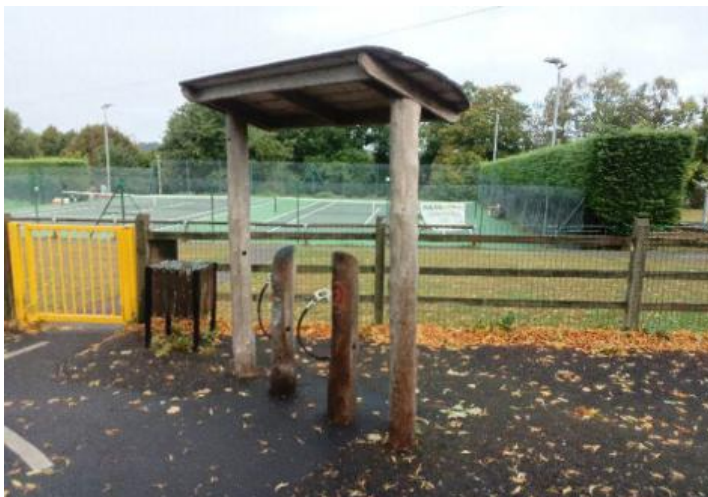
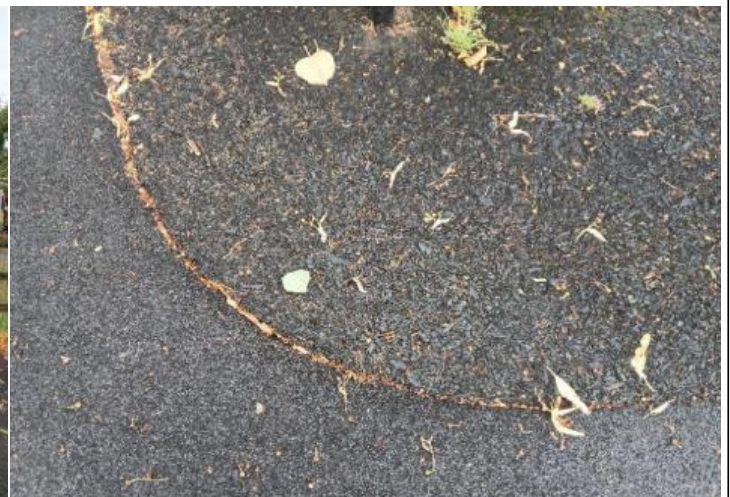
Item: Other - Misc Item
Manufacturer: Kompan Ltd

Finding: There are gaps opening between the surfacing and the edging surround or between the joints in the surfacing

Action: Monitor for any further deterioration and repair as required

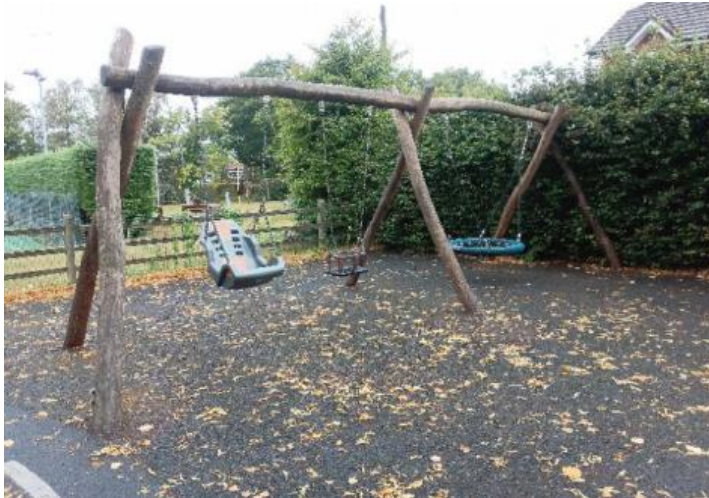
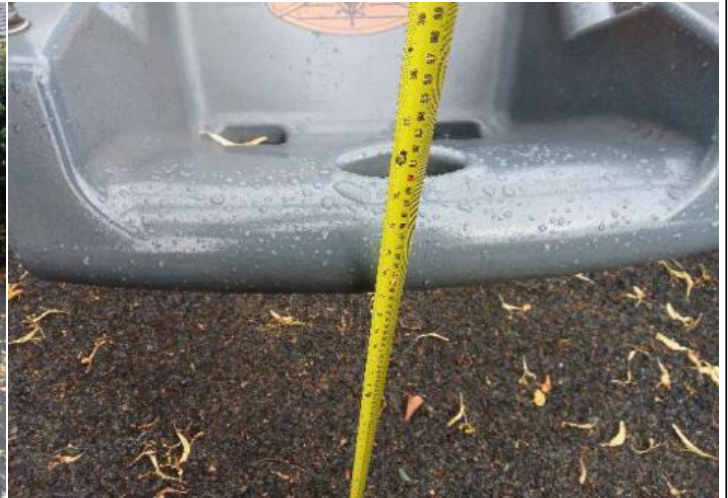
Item: Swings - 2 Bay 2 Cradle 1 Basket
Manufacturer: Kompan Ltd

Finding: NOTE: The inclusive seat is particularly high at 800mm which may make access and egress difficult for smaller users (We recommend a seat height of 400-500mm)

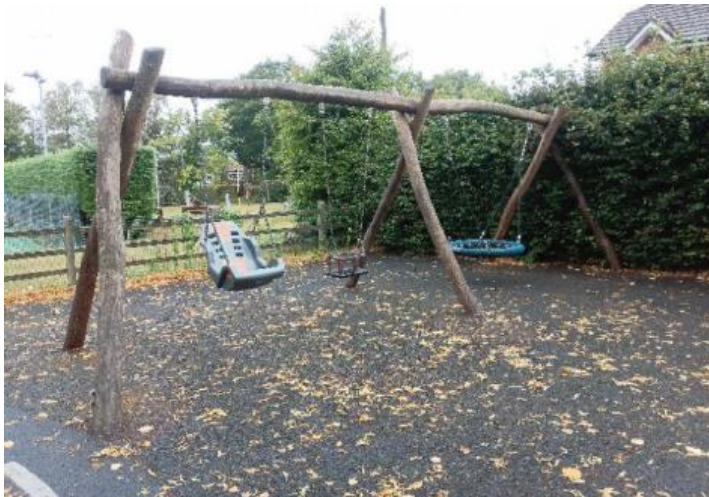
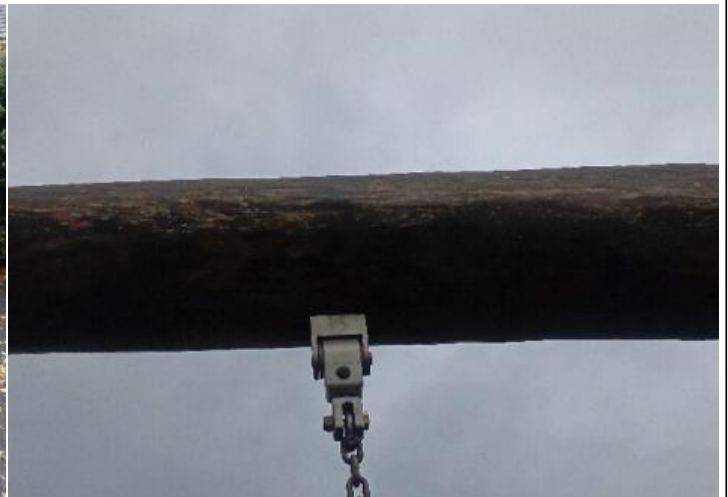
Item: Swings - 2 Bay 2 Cradle 1 Basket
Manufacturer: Kompan Ltd

Finding: This design of swing joint has been known to fail on the weld connecting the joint to the threaded stud

Action: We would recommend that the joint be dismantled and checked on a regular basis or consulting with manufacturer on whether a Secondary Safety Device can be fitted

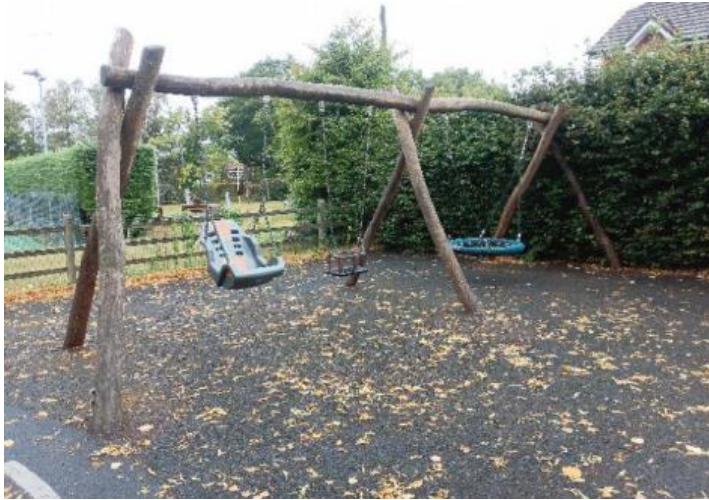
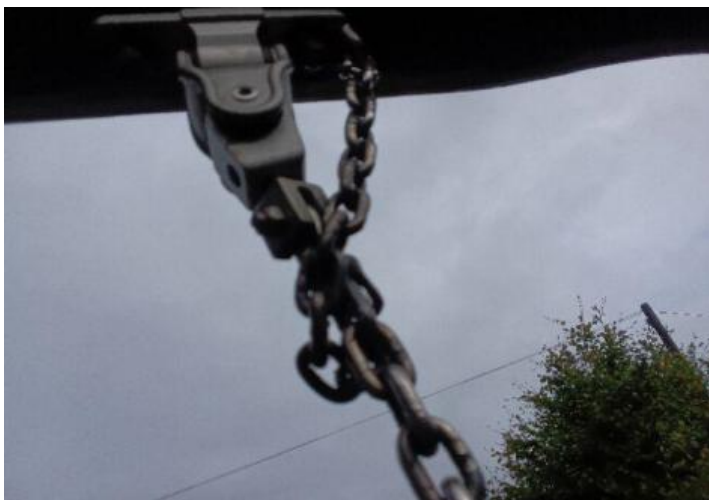
Item: Swings - 2 Bay 2 Cradle 1 Basket
Manufacturer: Kompan Ltd

Finding: There is some notable evidence of chain wear

Action: Monitor for any further deterioration and replace when 40% worn

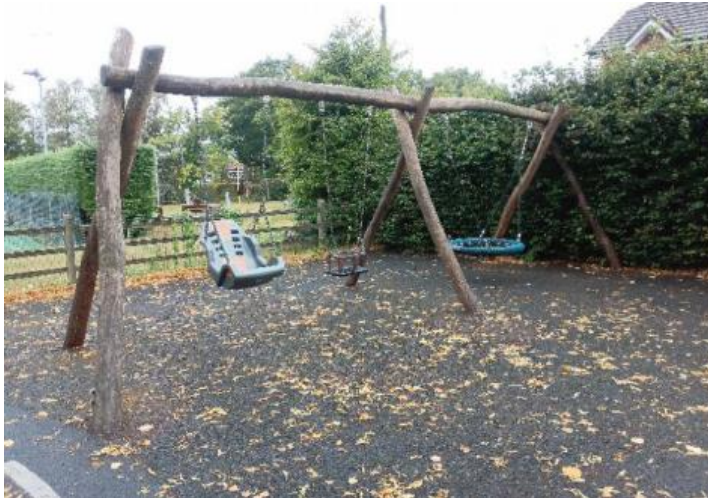
Item: Swings - 2 Bay 2 Cradle 1 Basket
Manufacturer: Kompan Ltd

Finding: The swing seat connectors are loose

Action: Tighten to secure

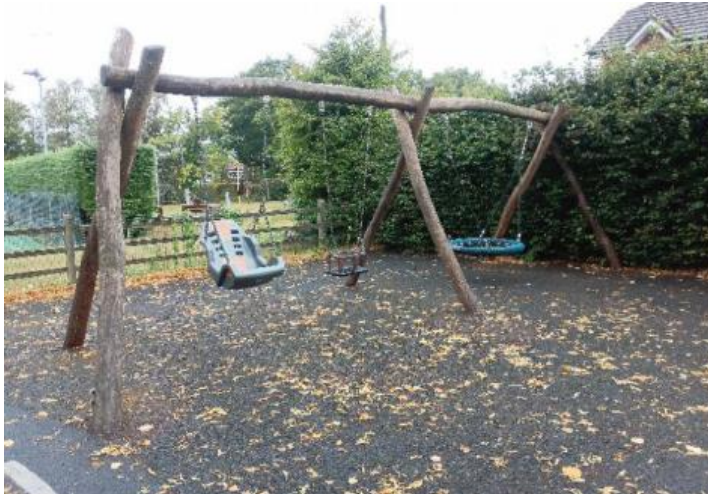
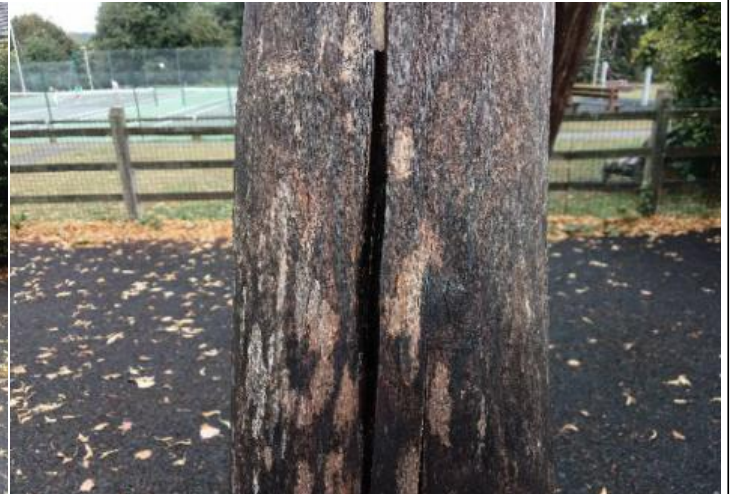
Item: Swings - 2 Bay 2 Cradle 1 Basket
Manufacturer: Kompan Ltd

Finding: There are splits running through the timber

Action: Monitor and ensure any rough or splintering edges are sanded down

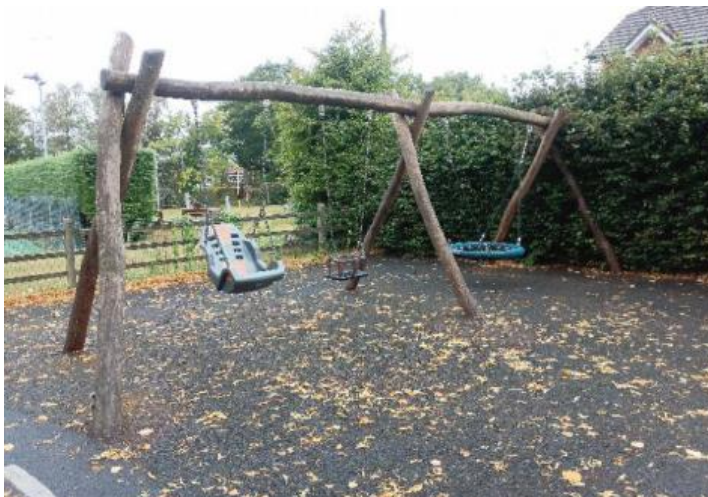
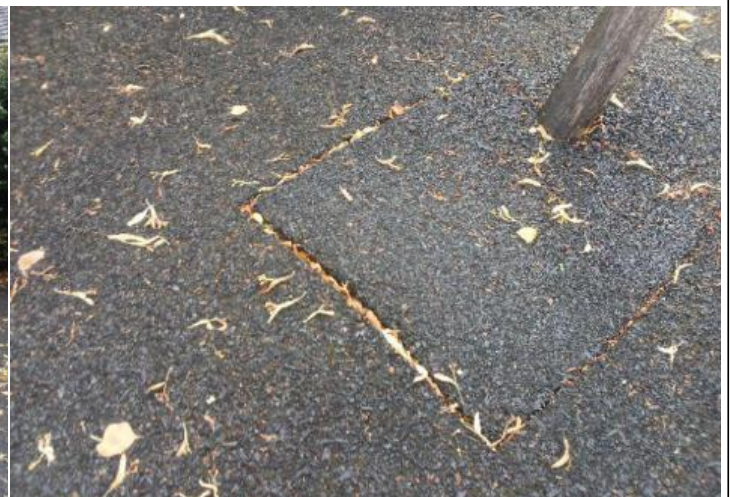
Item: Swings - 2 Bay 2 Cradle 1 Basket
Manufacturer: Kompan Ltd

Finding: There are gaps opening between the surfacing and the edging surround or between the joints in the surfacing **Action:** Monitor for any further deterioration and repair as required

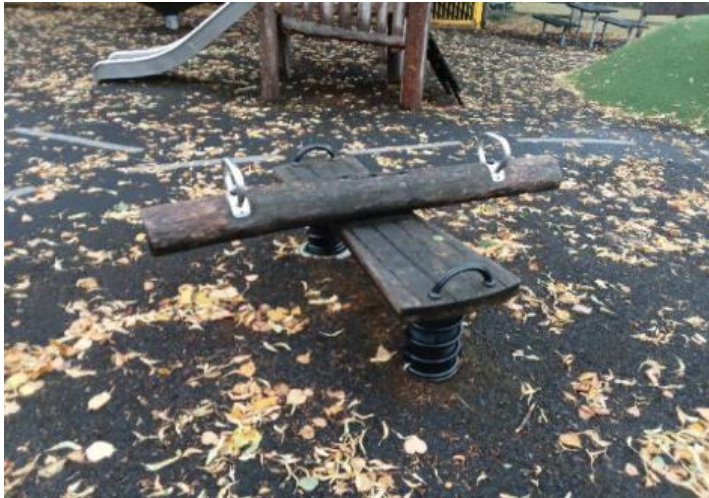
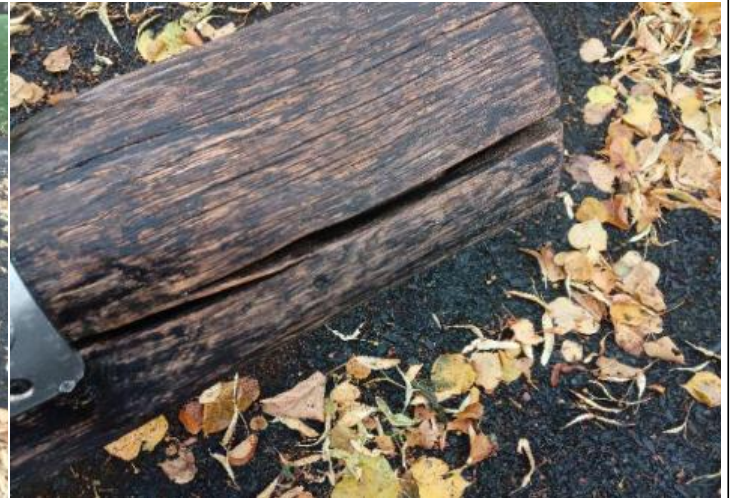
Item: Rocking Equipment - Spring See-Saw
Manufacturer: Kompan Ltd

Finding: There are splits running through the timber

Action: Monitor and ensure any rough or splintering edges are sanded down

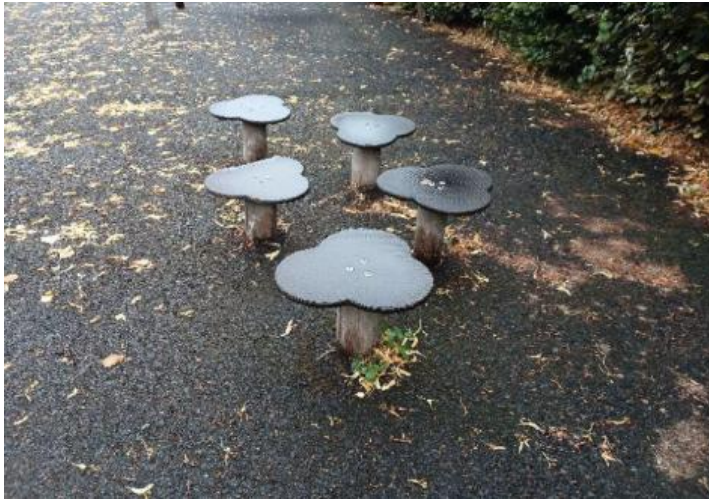
Item: Activity Equipment - Stepping Posts
Timber
Manufacturer: Kompan Ltd

Finding: There are areas or parts of the platforms that have rotted
Action: Replace all affected timbers

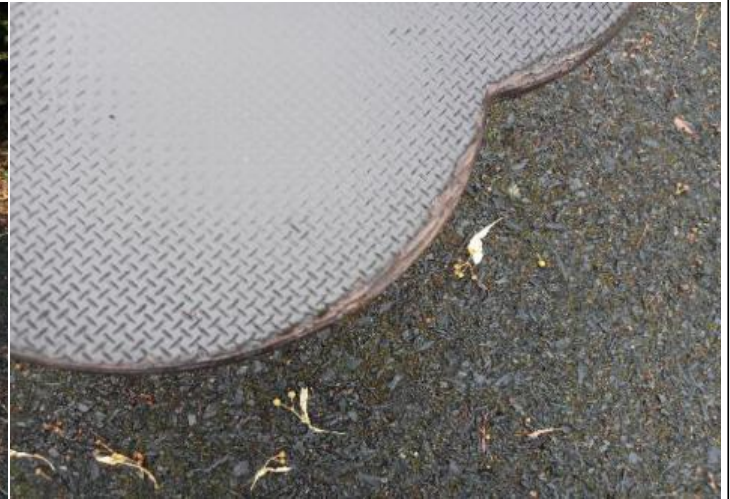
Item: Activity Equipment - Stepping Posts
Manufacturer: Kompan Ltd

Finding: Parts of the timber are rough or splintered

Action: Remove all rough or sharp edges

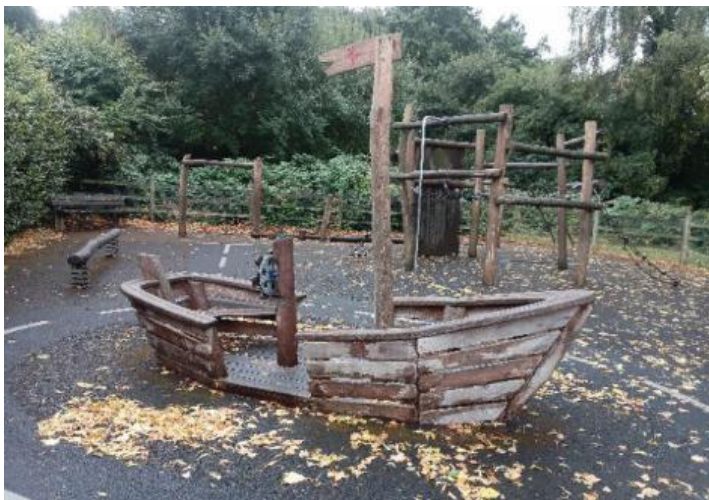
Item: Activity Equipment - Ship
Manufacturer: Kompan Ltd

Finding: A number of mast fixing(s) have worked loose

Action: Secure all loose fixings

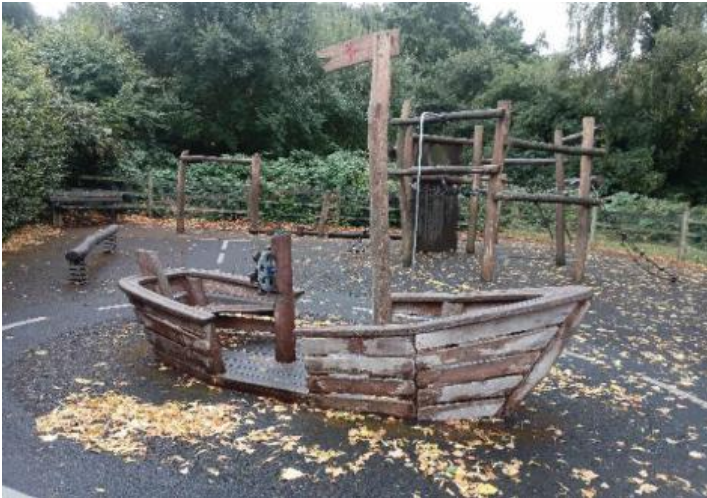
Item: Activity Equipment - Ship
Manufacturer: Kompan Ltd

Finding: There is/are bolt cap covers missing or damaged on the item

Action: Replace missing or damaged bolt cap covers

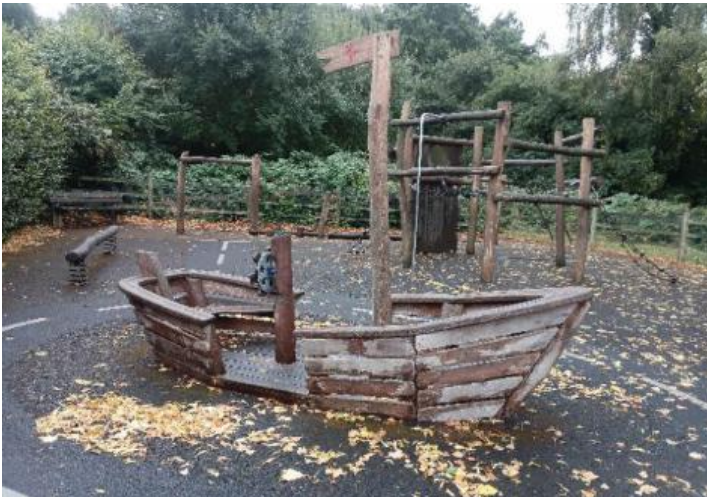
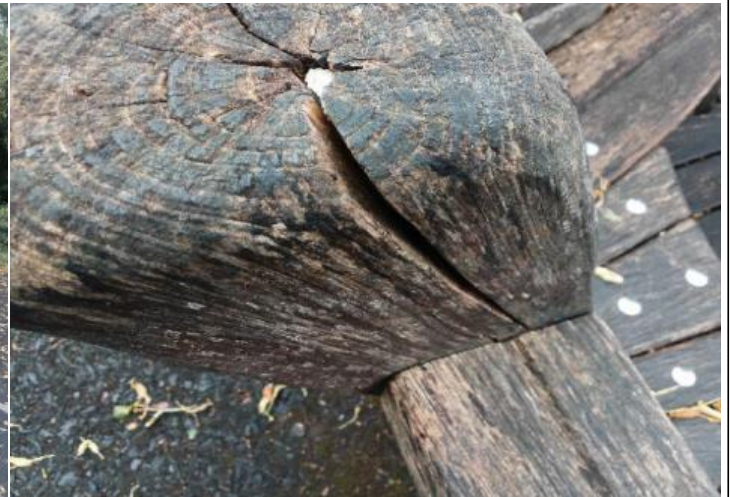
Item: Activity Equipment - Ship
Manufacturer: Kompan Ltd

Finding: There are splits running through the timber

Action: Monitor and ensure any rough or splintering edges are sanded down

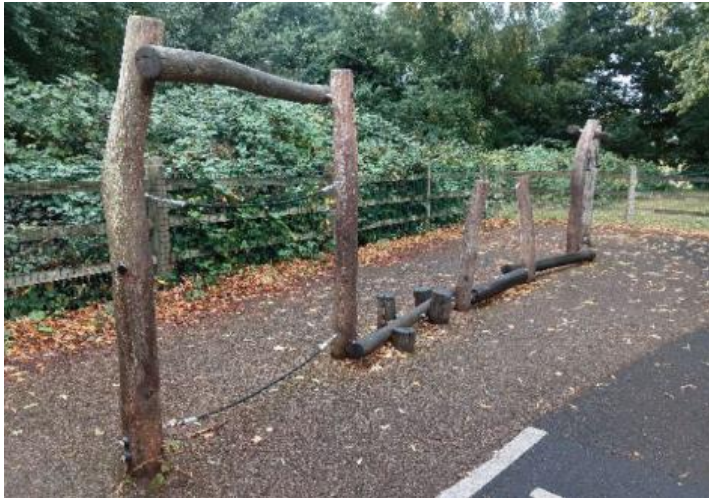
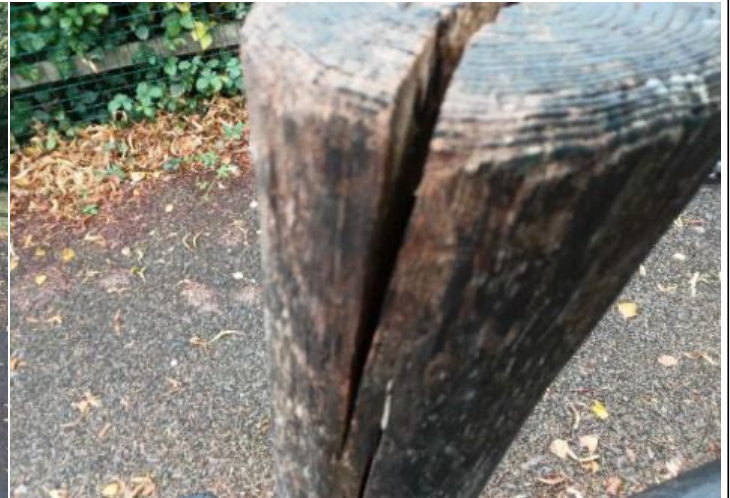
Item: Activity Equipment - Activity Trail
Manufacturer: Kompan Ltd

Finding: There are splits running through the timber

Action: Monitor and ensure any rough or splintering edges are sanded down

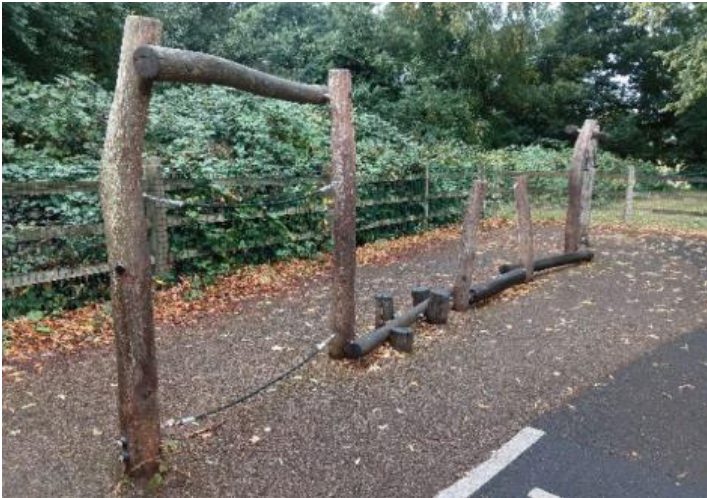
Item: Activity Equipment - Activity Trail
Manufacturer: Kompan Ltd

Finding: The use of synthetic fillers in timber is not recommended; timber being a natural material will expand and contract as the moisture content changes and the use of fillers can exacerbate the length and depth of these cracks or shakes in the timber. The only treatment that is normally required is the removal of any rough or sharp edges unless the structural integrity of the item is affected.

Action: Remove any rough or sharp edges and monitor timber for any further deterioration

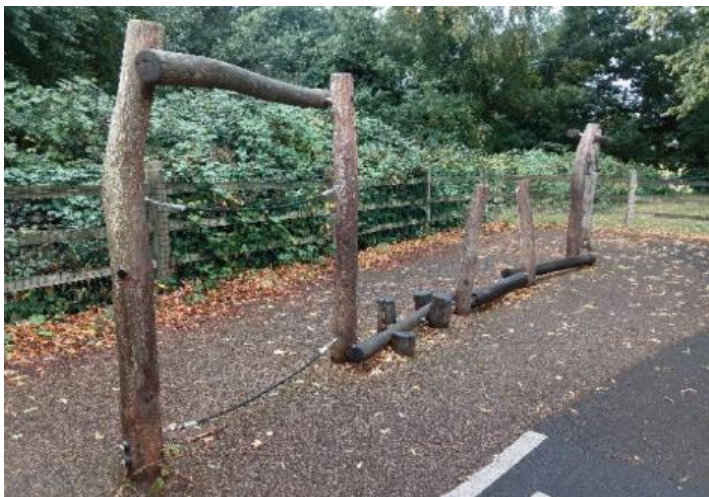
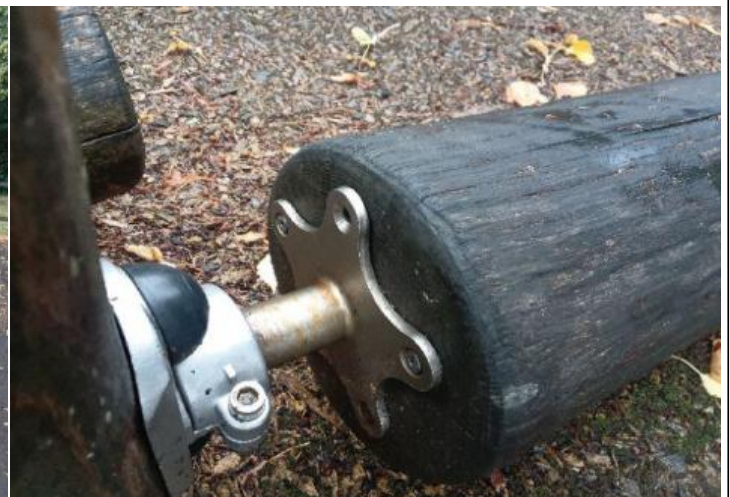
Item: Activity Equipment - Activity Trail
Manufacturer: Kompan Ltd

Finding: There is or are fixings missing on the rotating beam

Action: Replace all missing fixings

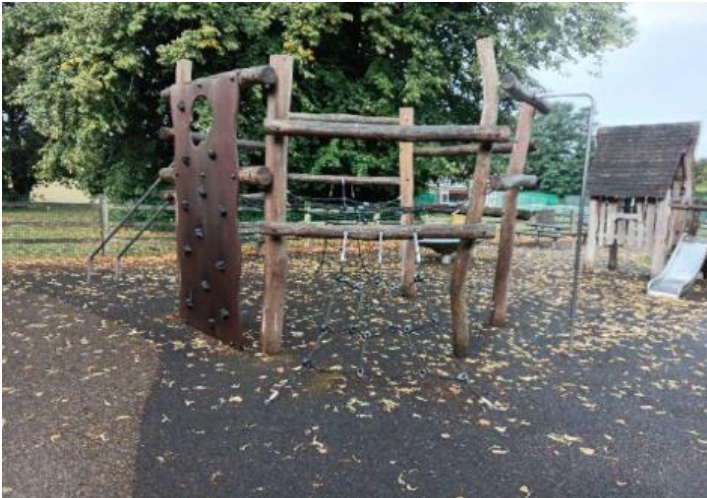
Item: Activity Equipment - Climbing Frame
Manufacturer: Kompan Ltd

Finding: The use of synthetic fillers in timber is not recommended; timber being a natural material will expand and contract as the moisture content changes and the use of fillers can exacerbate the length and depth of these cracks or shakes in the timber. The only treatment that is normally required is the removal of any rough or sharp edges unless the structural integrity of the item is affected.

Action: Remove any rough or sharp edges and monitor timber for any further deterioration

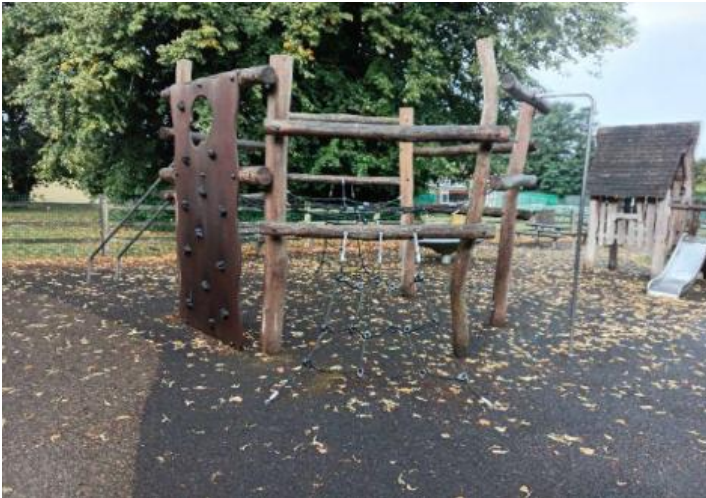
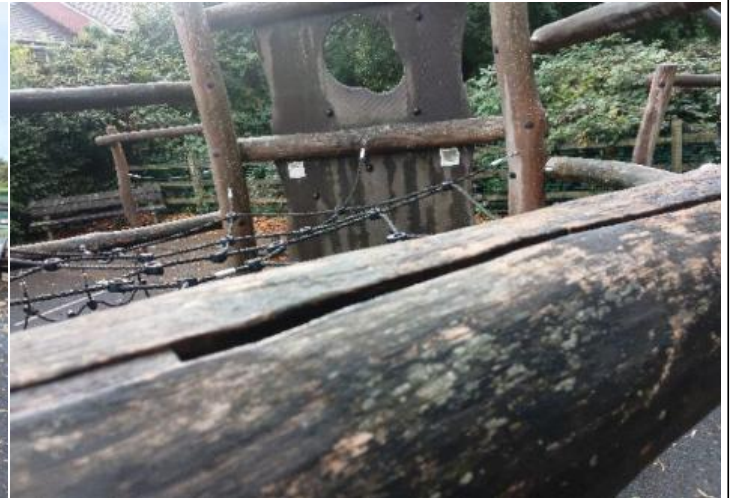
Item: Activity Equipment - Climbing Frame
Manufacturer: Kompan Ltd

Finding: There are splits running through the timber

Action: Monitor and ensure any rough or splintering edges are sanded down

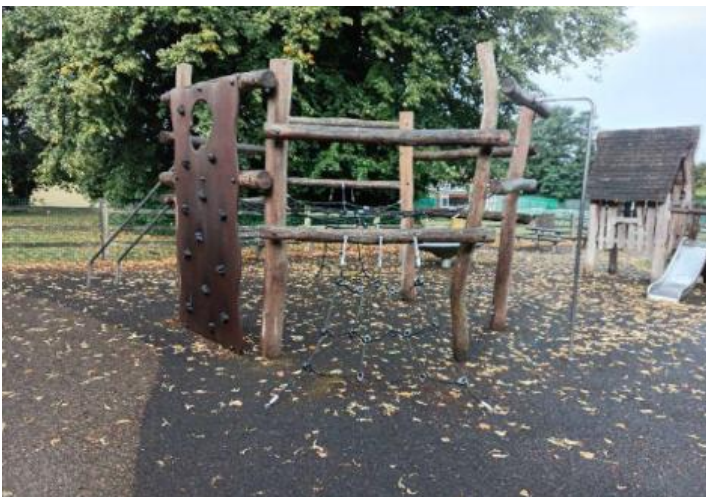
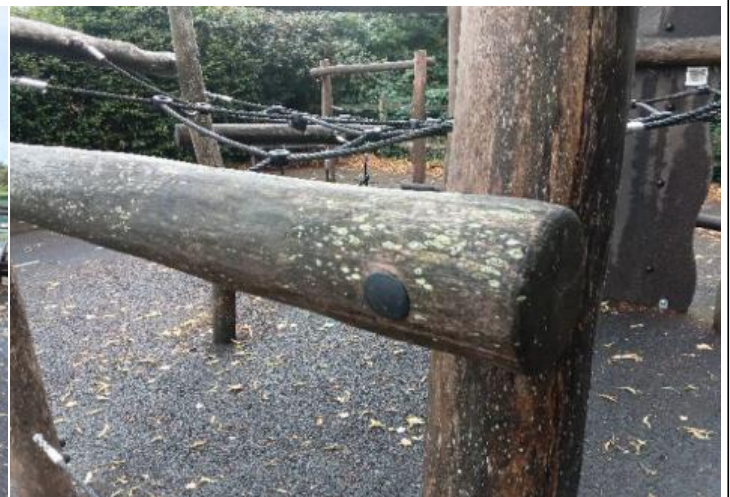
Item: Activity Equipment - Climbing Frame
Manufacturer: Kompan Ltd

Finding: There is algae or moss on the surface of the equipment resulting in slippery conditions

Action: Clean and treat appropriately

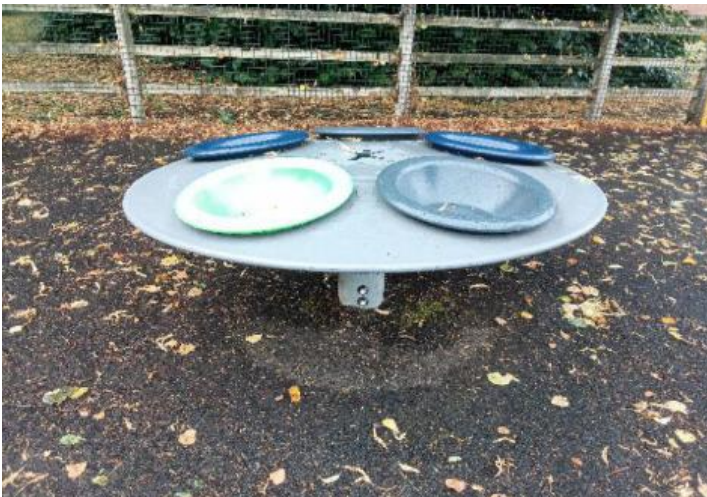
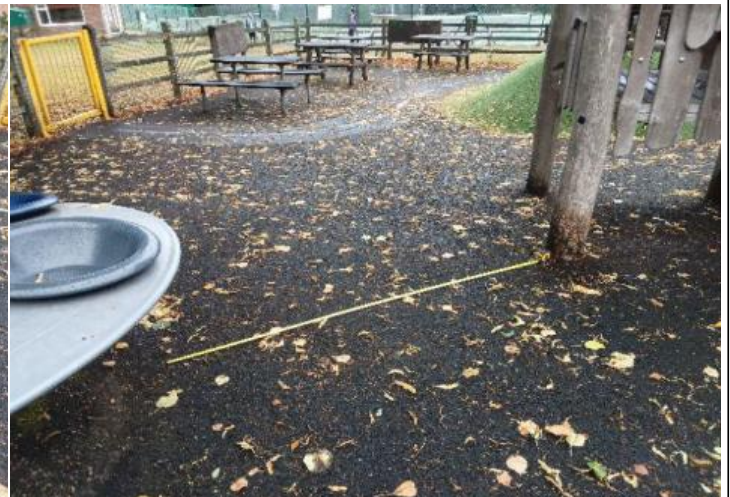
Item: Rotor Play - Roundabout
Manufacturer: Kompan Ltd

Finding: The multi-play forms a projecting obstacle / hard object within the falling space of the equipment, in contravention of the requirements of BS EN 1176 Part 1

Action: Monitor - No remedial work recommended

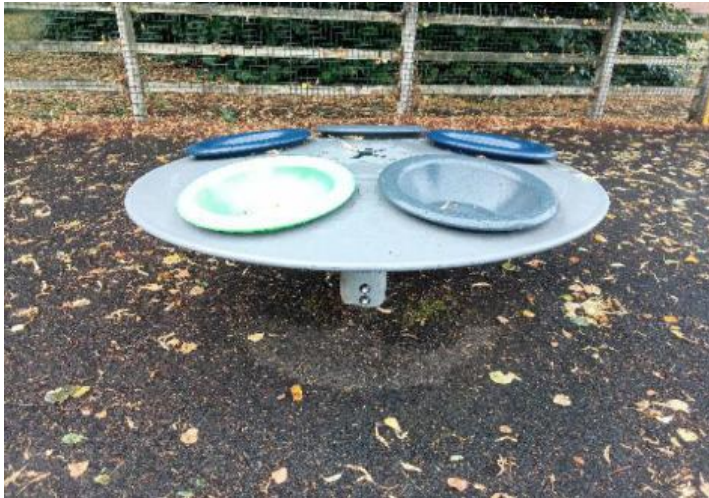
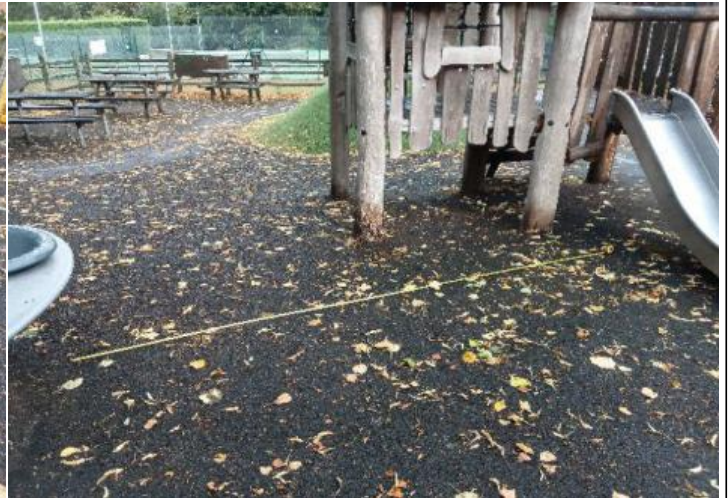
Item: Rotor Play - Roundabout
Manufacturer: Kompan Ltd

Finding: The free space overlaps the falling space between the roundabout and adjacent equipment in contravention of the requirements of BS EN 1176:2017 Part 1

Action: Monitor - No remedial work recommended

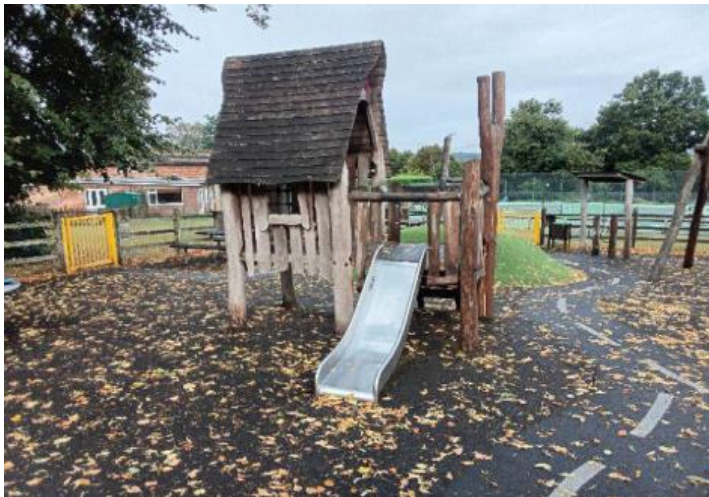
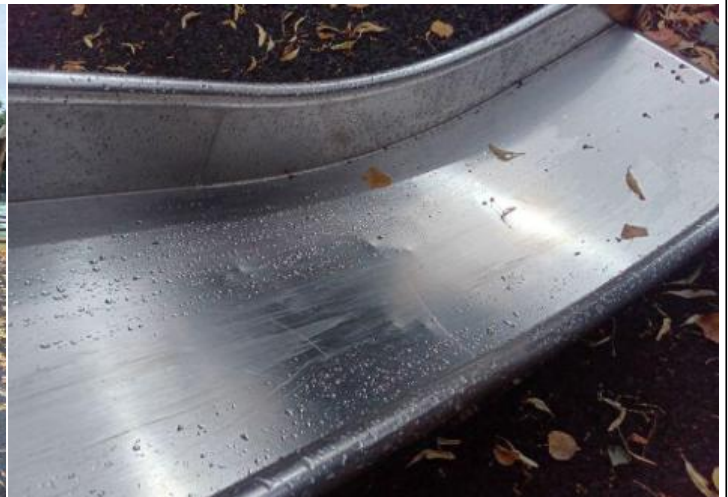
Item: Activity Equipment - Multi Play (Junior)
Manufacturer: Kompan Ltd

Finding: There are a number of dents in the slide surface

Action: Monitor for any further deterioration and repair as required

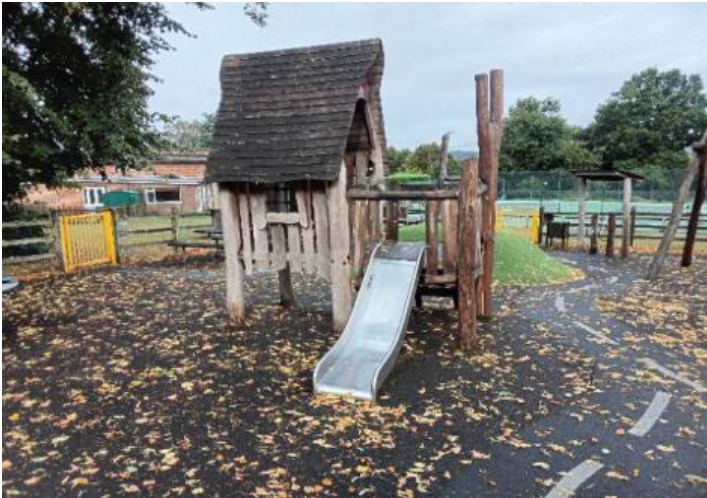
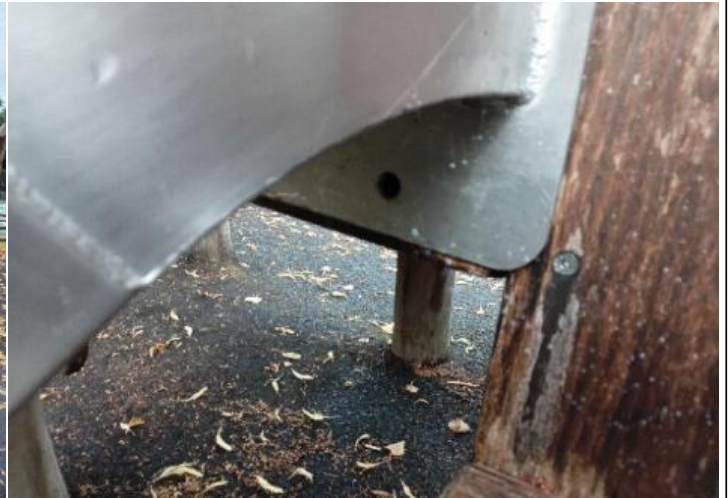
Item: Activity Equipment - Multi Play (Junior)
Manufacturer: Kompan Ltd

Finding: There is or are fixings missing on the slide

Action: Replace all missing fixings

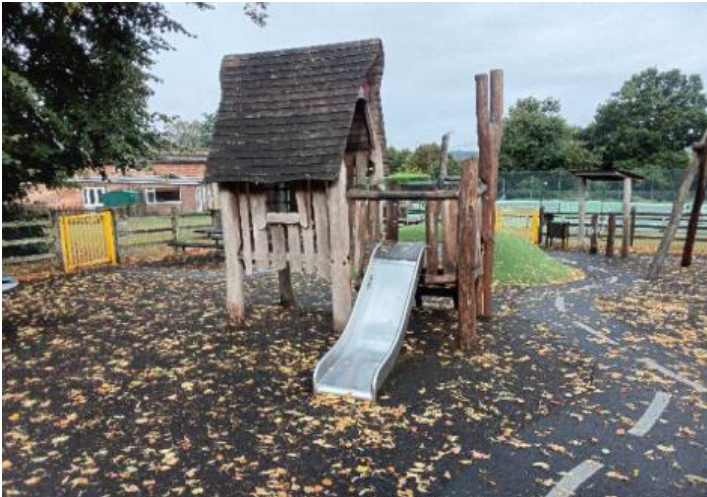
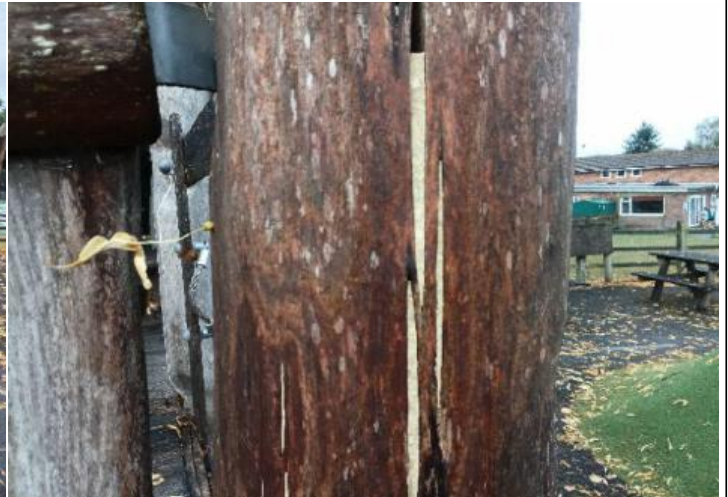
Item: Activity Equipment - Multi Play (Junior)
Manufacturer: Kompan Ltd

Finding: The use of synthetic fillers in timber is not recommended; timber being a natural material will expand and contract as the moisture content changes and the use of fillers can exacerbate the length and depth of these cracks or shakes in the timber. The only treatment that is normally required is the removal of any rough or sharp edges unless the structural integrity of the item is affected.

Action: Remove any rough or sharp edges and monitor timber for any further deterioration

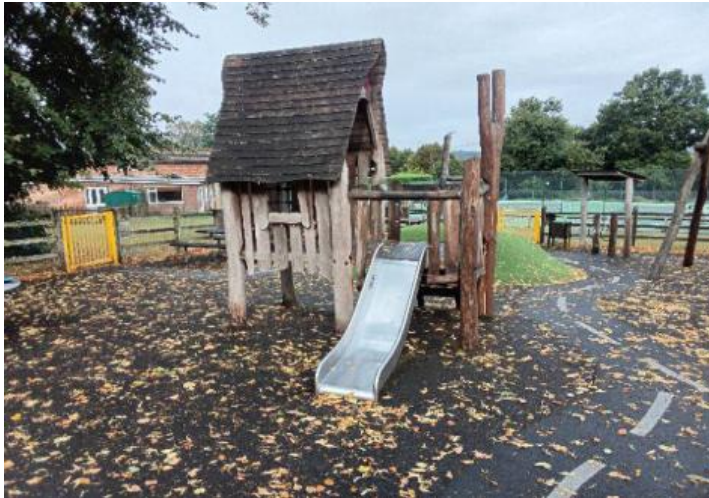
Item: Activity Equipment - Multi Play (Junior)
Manufacturer: Kompan Ltd

Finding: A number of handgrip fixing(s) have worked loose **Action:** Secure all loose fixings

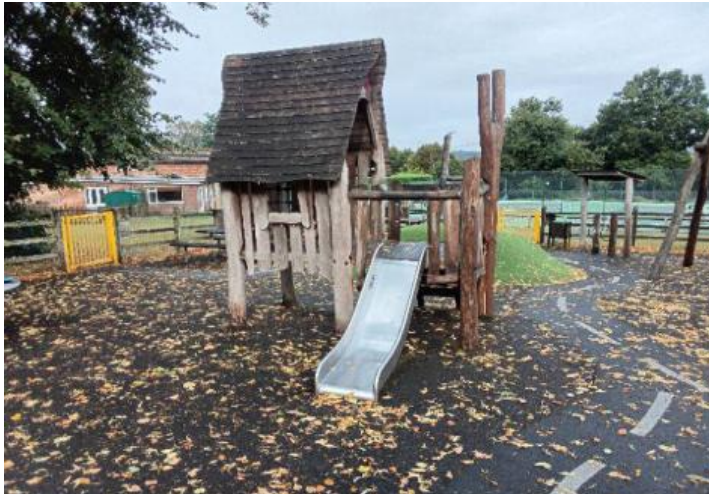
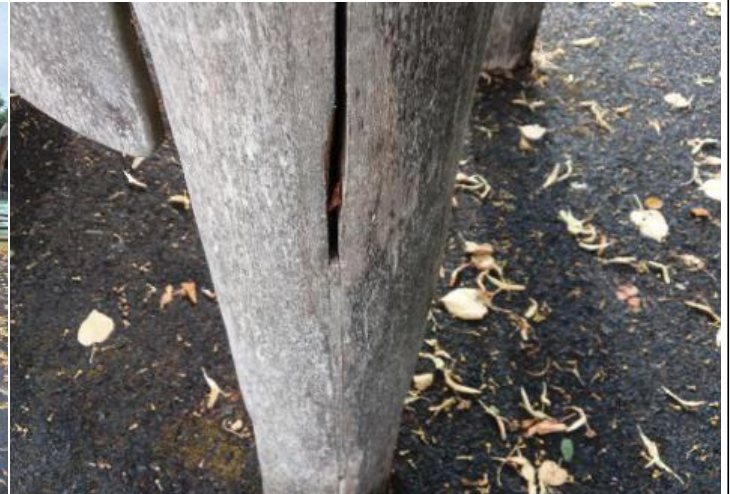
Item: Activity Equipment - Multi Play (Junior)
Manufacturer: Kompan Ltd

Finding: There are splits running through the timber **Action:** Monitor and ensure any rough or splintering edges are sanded down

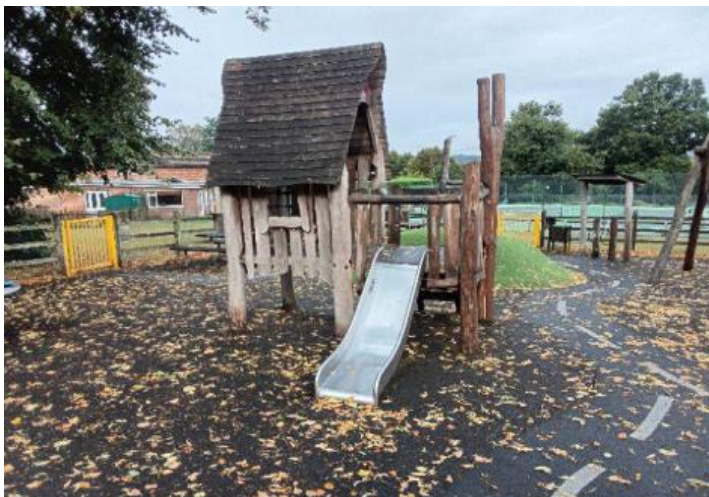
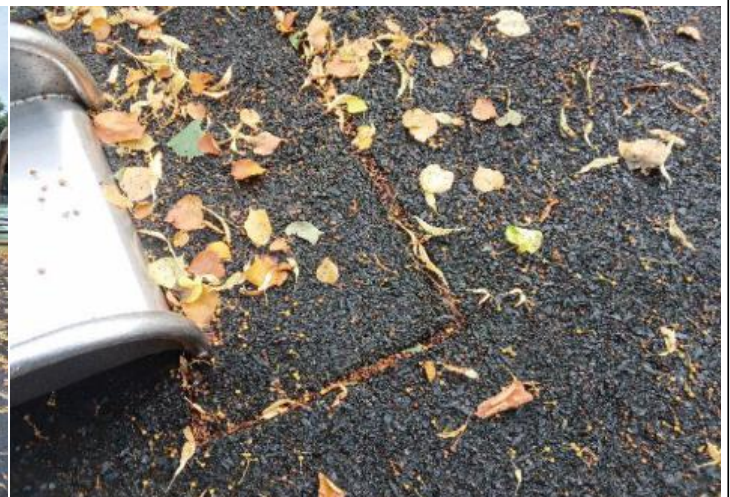
Item: Activity Equipment - Multi Play (Junior)
Manufacturer: Kompan Ltd

Finding: There are gaps opening between the surfacing and the edging surround or between the joints in the surfacing

Action: Monitor for any further deterioration and repair as required

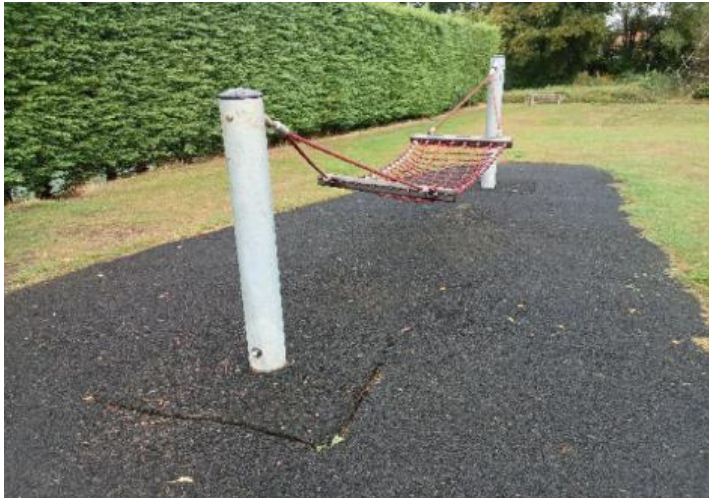
Item: Swings - Hammock Swing
Manufacturer: Kompan Ltd

Finding: There are gaps opening between the surfacing and the edging surround or between the joints in the surfacing **Action:** Monitor for any further deterioration and repair as required

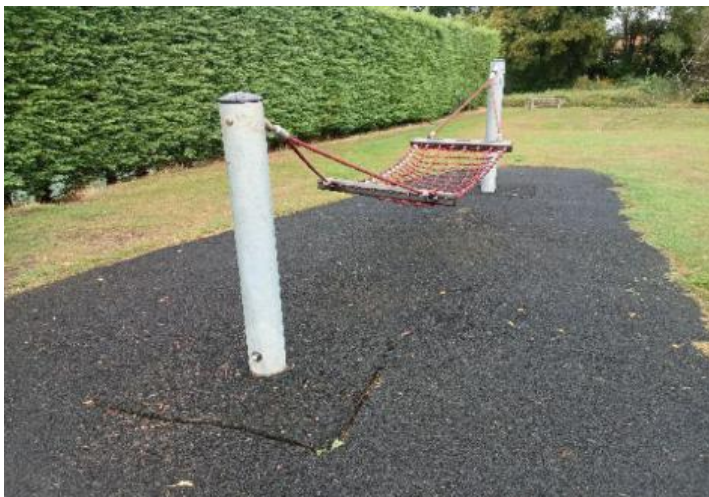
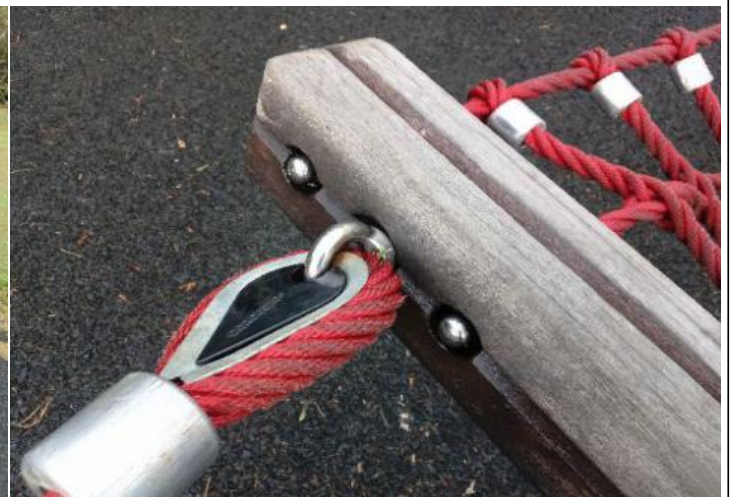
Item: Swings - Hammock Swing
Manufacturer: Kompan Ltd

Finding: A number of eyebolt fixing(s) have worked loose **Action:** Secure all loose fixings

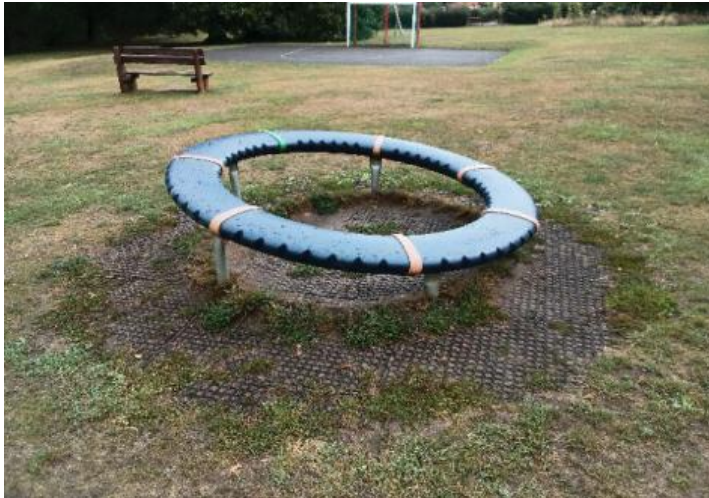
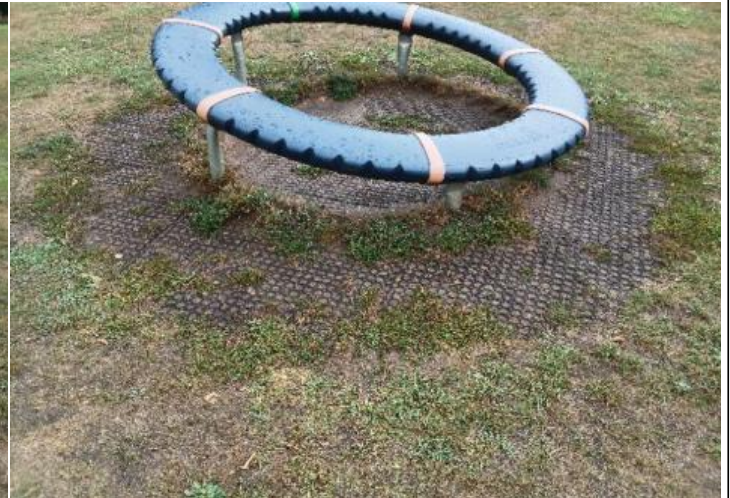
Item: Rotor Play - Supernova
Manufacturer: Kompan Ltd

Finding: There is weed / vegetation growth within the surface

Action: Remove weed / vegetation growth

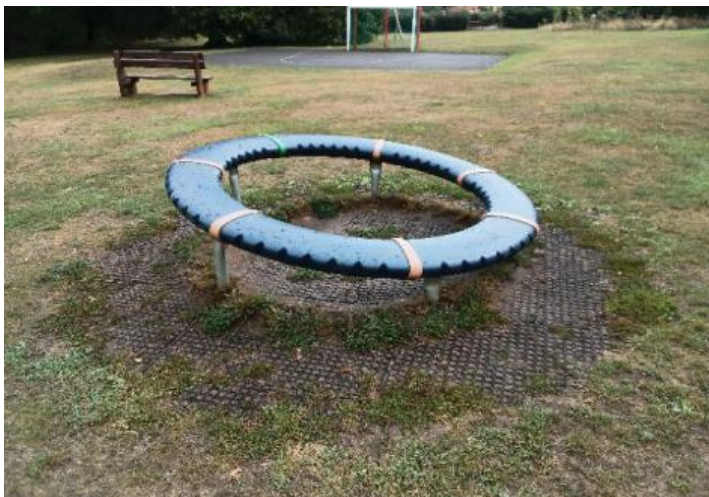
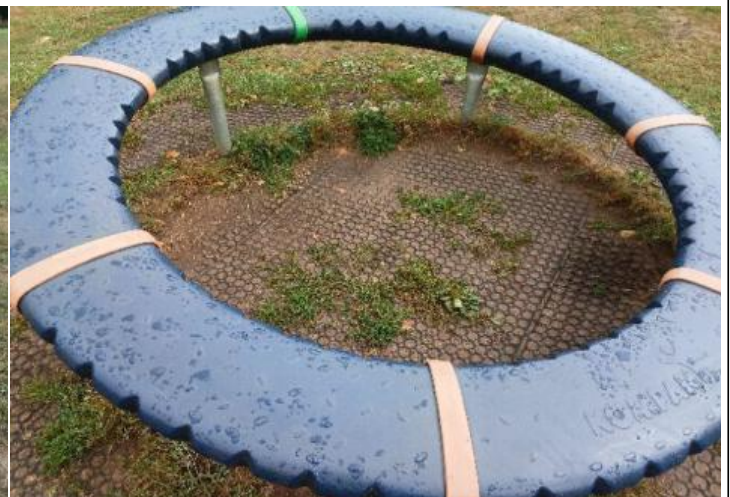
Item: Rotor Play - Supernova
Manufacturer: Kompan Ltd

Finding: The grass mats are silted up, the soil is compacted and the area will become very slippery when the soil is wet.

Action: Reinstate as required

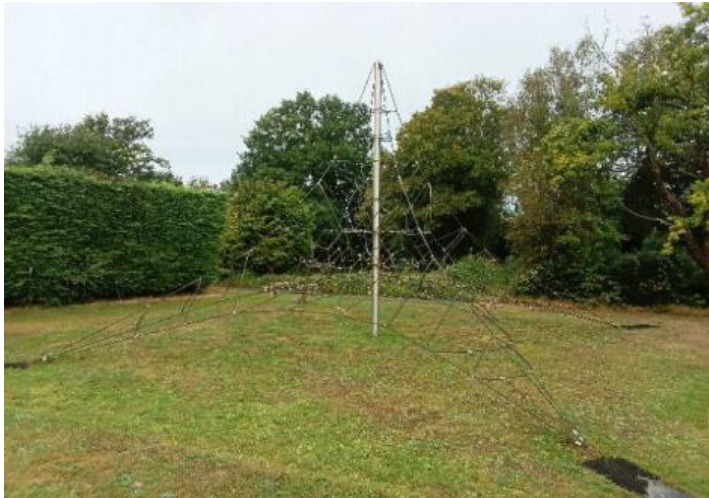
Item: Activity Equipment - Space Net
Manufacturer: Tayplay Ltd

Finding: There is moderate damage to the surface

Action: Repair the damaged areas of surfacing

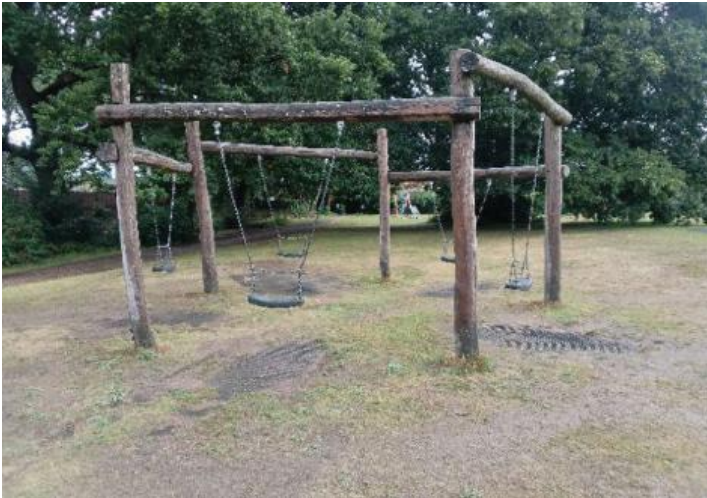
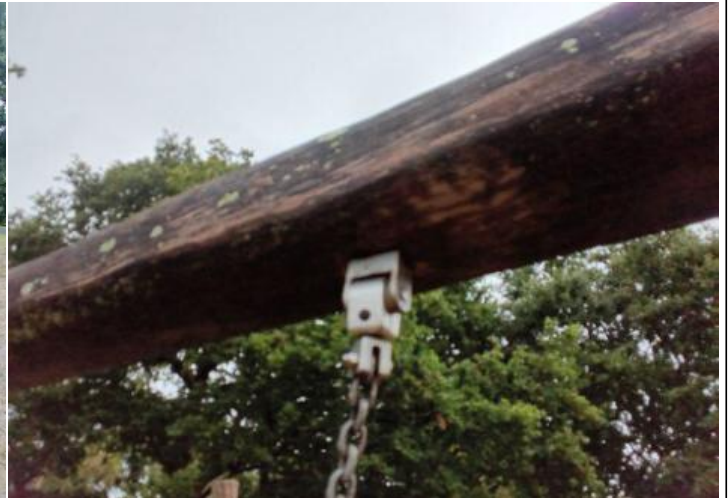
Item: Swings - Contact Swing - Type 4
Manufacturer: Kompan Ltd

Finding: This design of swing joint has been known to fail on the weld connecting the joint to the threaded stud

Action: We would recommend that the joint be dismantled and checked on a regular basis or consulting with manufacturer on whether a Secondary Safety Device can be fitted

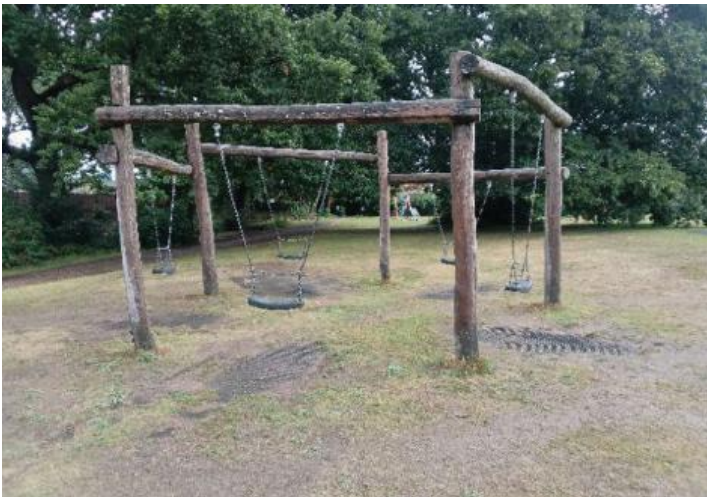
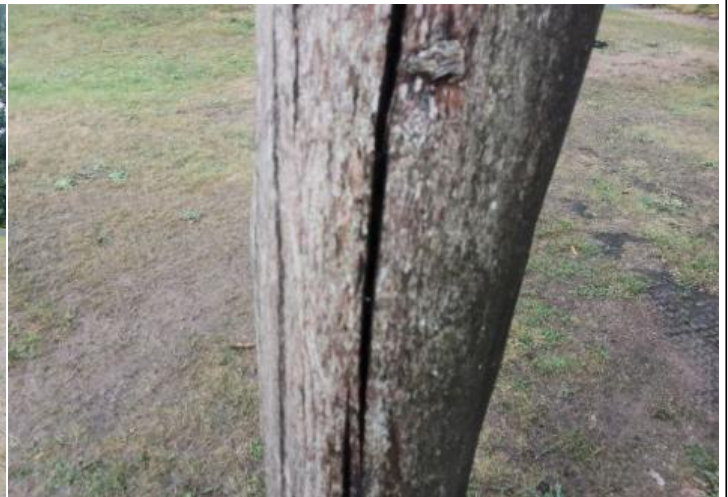
Item: Swings - Contact Swing - Type 4
Manufacturer: Kompan Ltd

Finding: There are splits running through the timber

Action: Monitor and ensure any rough or splintering edges are sanded down
