LISS PARISH COUNCIL

Minutes of the meeting of the Facilities Committee held on 14th July 2025, 7pm,
Village Hall

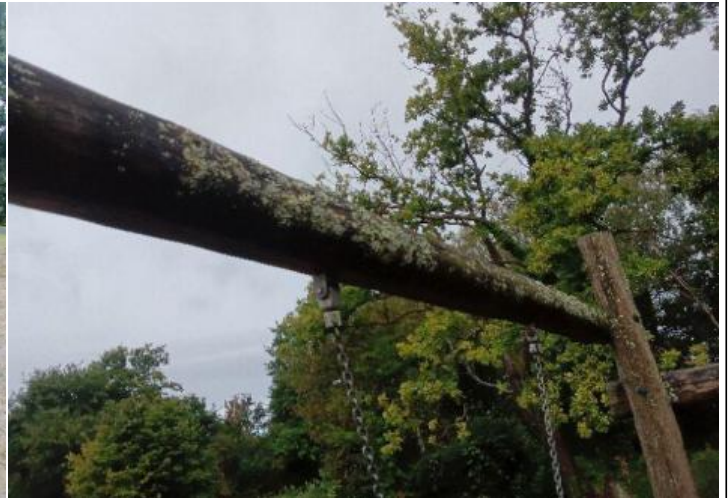
Item: Swings - Contact Swing - Type 4
Manufacturer: Kompan Ltd

Finding: There is algae or moss on the surface of the equipment that can lead to the onset of rot

Action: Monitor condition of the timbers (rot), clean and treat appropriately

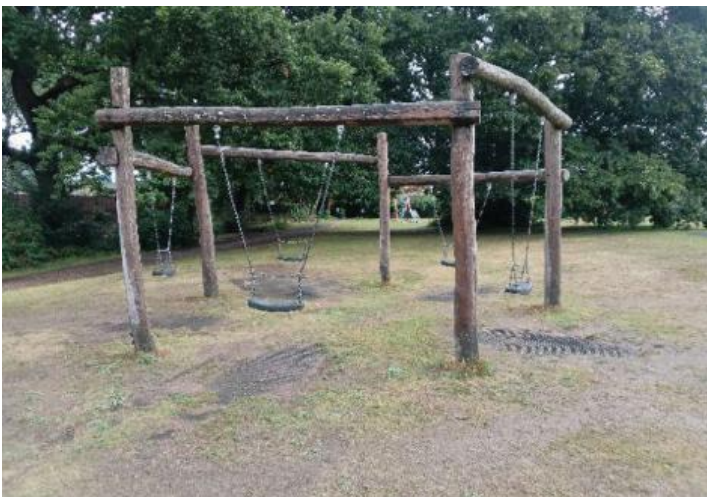
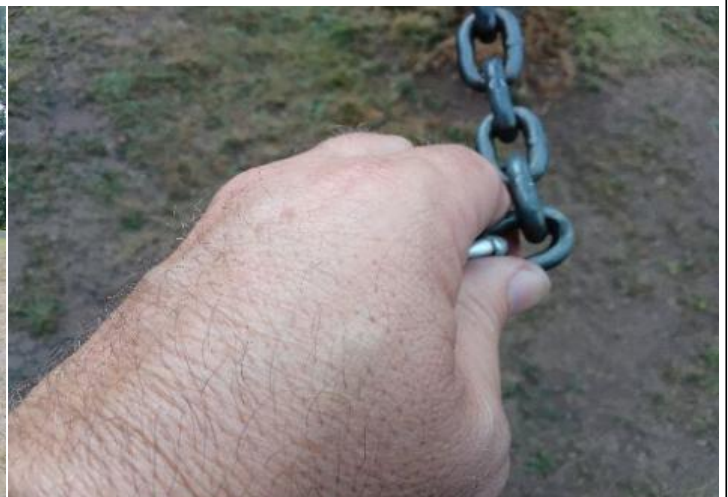
Item: Swings - Contact Swing - Type 4
Manufacturer: Kompan Ltd

Finding: There is some notable evidence of chain wear

Action: Monitor for any further deterioration and replace when 40% worn

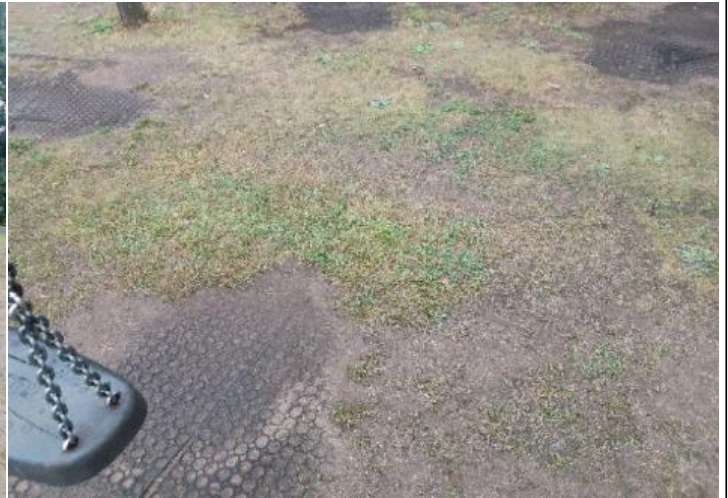
Item: Swings - Contact Swing - Type 4
Manufacturer: Kompan Ltd

Finding: The grass mats are silted up and the soil is compacted; this may have an effect on the impact absorbing properties of the surface. Consideration should be given to HIC testing the surface to verify impact attenuating properties (<https://playinspections.co.uk/inspection-services/safety-surface-testing/>)

Action: Contact our office for a quotation for this service

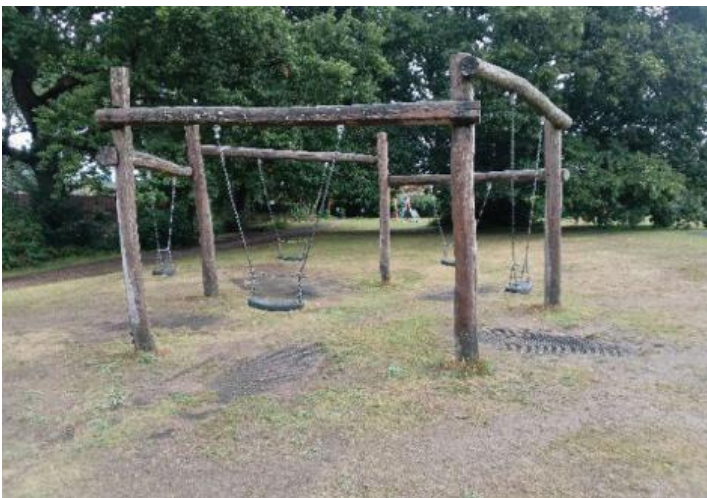
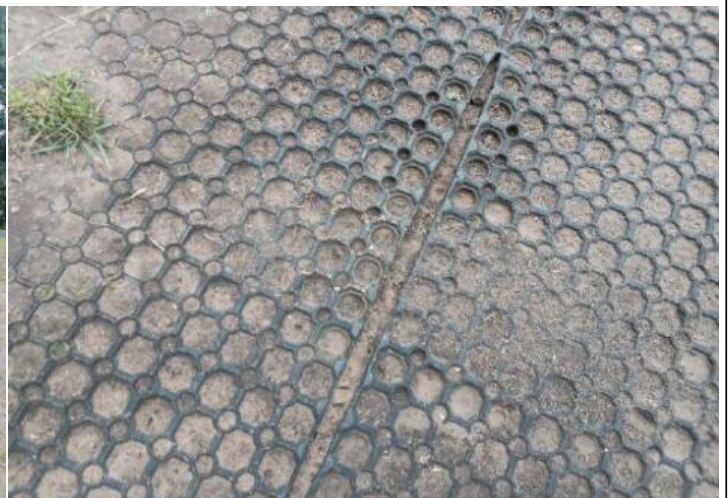
Item: Swings - Contact Swing - Type 4
Manufacturer: Kompan Ltd

Finding: There are gaps opening between the grass mat tiles

Action: Provide additional ties or secure / reinstate surface

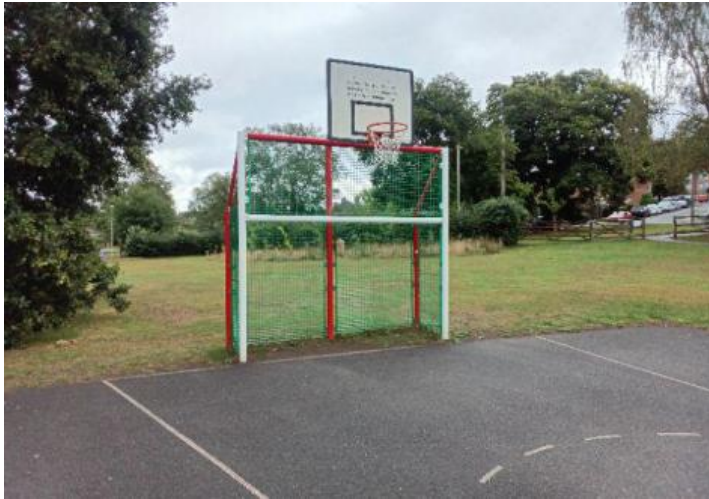
Item: Multi Use Games Area - Goalmouth and Basketball Post
Manufacturer: Action Play and Leisure

Finding: The net is loose

Action: Secure

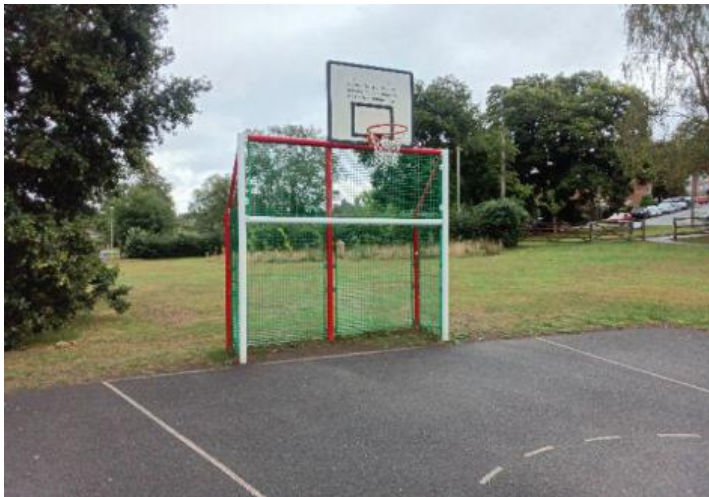
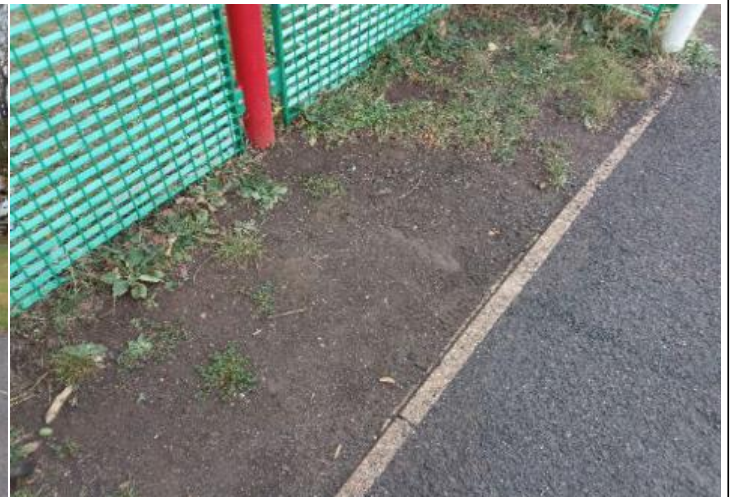
Item: Multi Use Games Area - Goalmouth and Basketball Post
Manufacturer: Action Play and Leisure

Finding: The surface has eroded in some areas and may be slippery in wet conditions

Action: Reinstate the surface

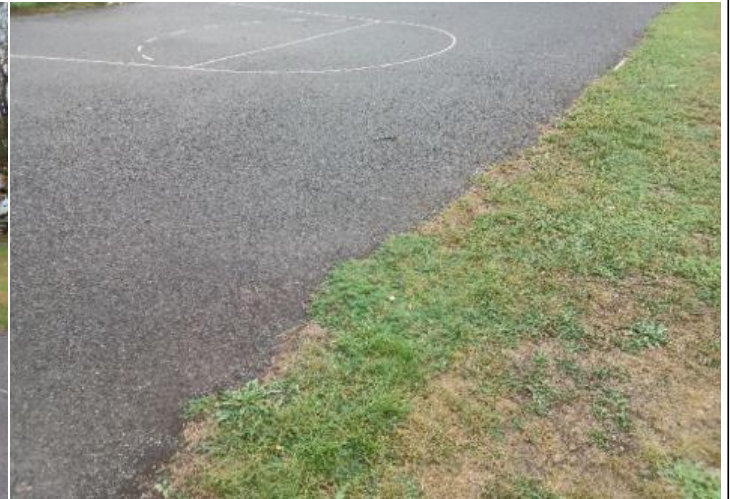
Item: Multi Use Games Area - Goalmouth and Basketball Post
Manufacturer: Action Play and Leisure

Finding: There is weed / vegetation growth within the surface

Action: Remove weed / vegetation growth

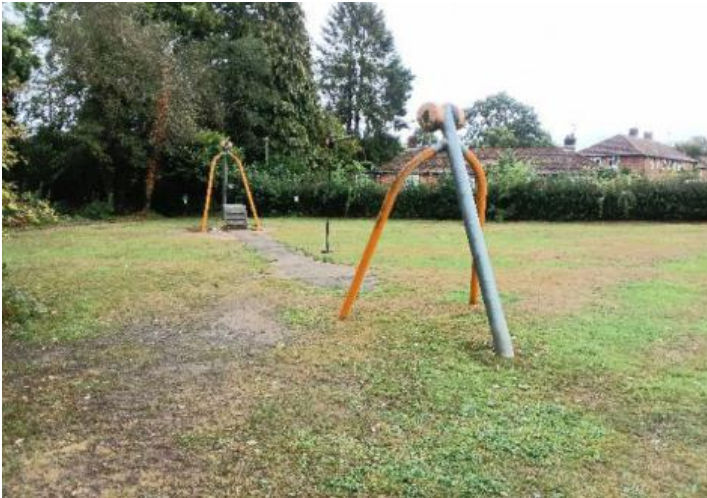
Item: Other - Cable Runway
Manufacturer: Hags

Finding: We have completed a visual inspection of the suspension links, cable and fixing points from ground level, however it is not possible to fully inspect these areas without either hiring equipment to gain access or removing the cable and suspension and inspecting at ground level. We recommend that the main cable and fixing security is thoroughly inspected at least in accordance with the manufacturers recommendations to check for wear, damage, security or internal rusting; this will help to ensure the continued safe use of the equipment

Action: Inspect in accordance with the manufacturers recommendations

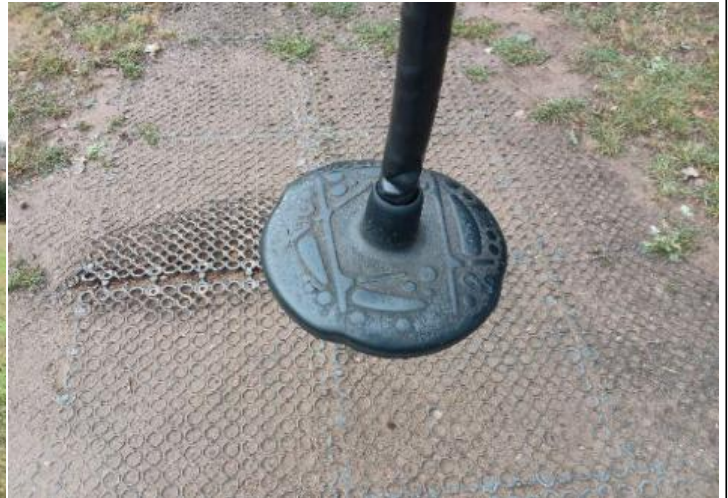
Item: Other - Cable Runway
Manufacturer: Hags

Finding: The seat connection cannot be inspected without dismantling the seat

Action: Dismantle the seat to inspect the seat connection for wear

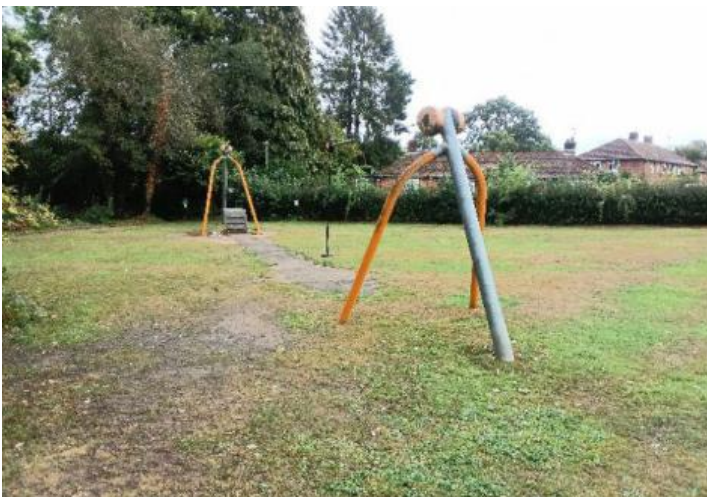
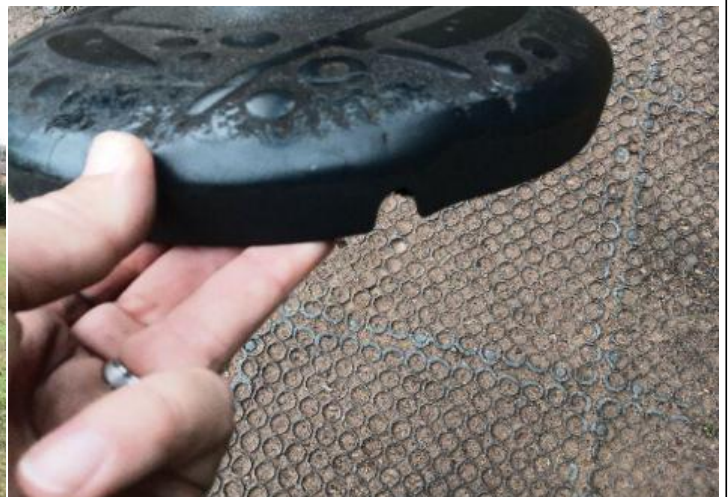
Finding: The cableway seat has been damaged

Action: Monitor for any further deterioration and replace as required

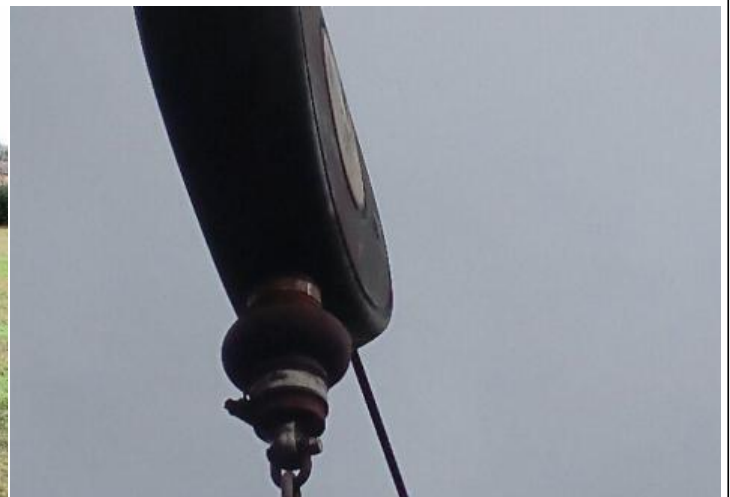
Finding: There is some wear to the shackles.

Action: Monitor for any further deterioration and replace when 40% worn

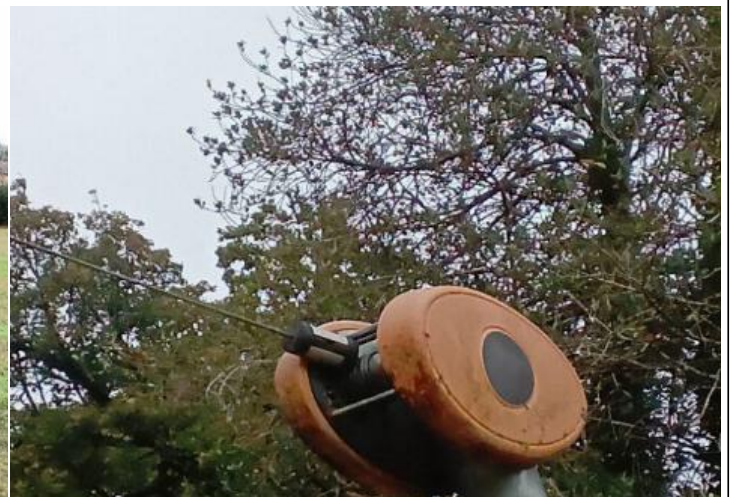
Finding: The cable stop above the start ramp is likely to encourage users to lean off the back of the platform

Action: Adjust

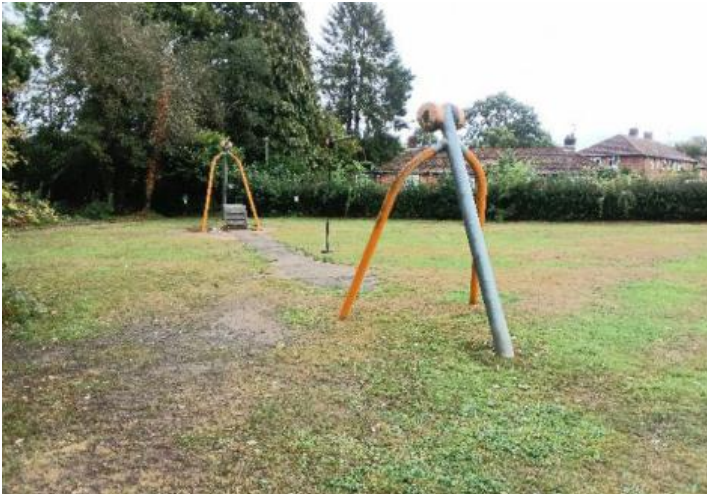
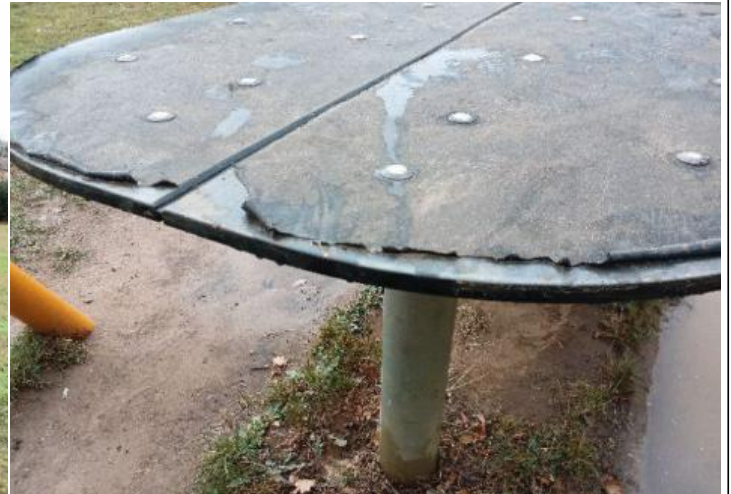
Finding: The platform surface is showing signs of wear

Action: Monitor for any further deterioration and repair as required

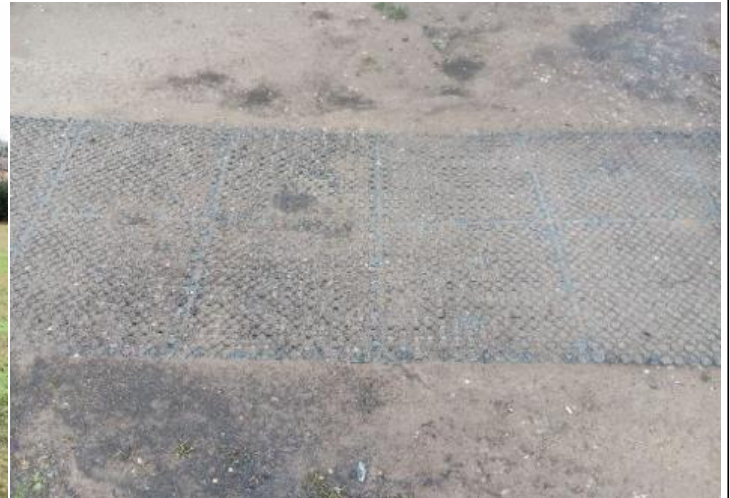
6 - Low Risk (Finding 11)

Finding: The grass mats are silted up, the soil is compacted and the area will become very slippery when the soil is wet. **Action:** Reinstate as required

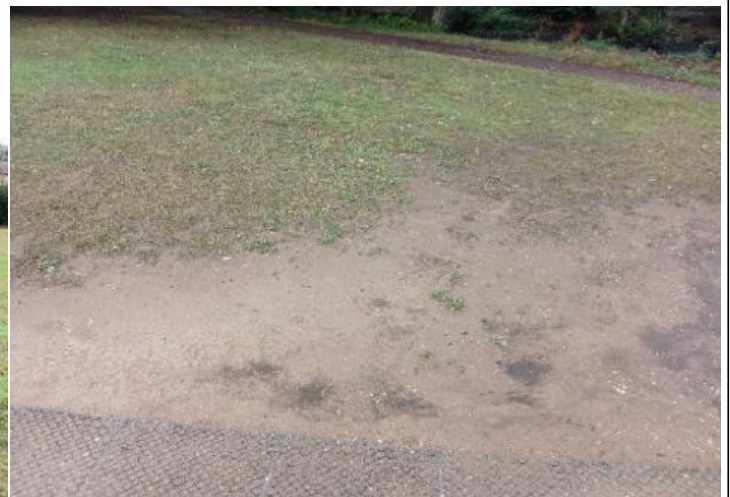
i 8 - Low Risk (Finding 12)

Finding: The surface has eroded in some areas and may be slippery in wet conditions **Action:** Reinstate the surface

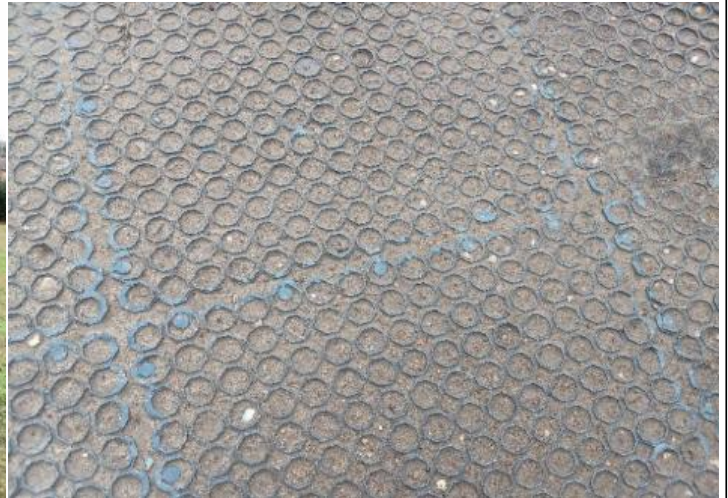
Finding: Hard fixing pins have been installed in the grass mat tiles within the impact area of the equipment. Grass mat pins should only be installed at the perimeter of the tiles, and outside of any equipment impact areas. NOTE - where grass mat wear pads have been provided and the impact area includes surrounding surfaces, the grass mats should be tucked into the turf, and not pinned

Action: Remove pins from impact areas

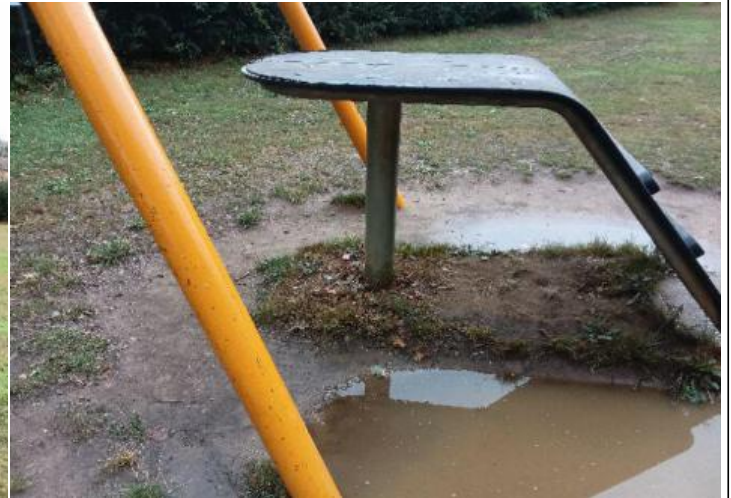
Finding: The grass has eroded within the impact area of the equipment and may not provide the necessary impact attenuating properties for the equipment fall height; the surface may also be slippery in wet weather

Action: Reinststate the grass or provide an all weather surface
